Shoreland Inventory of Comfort Lake, Chisago County, Minnesota in 2014

Date of Inventory: July 21, 2014

Prepared for:
Comfort Lake/Forest Lake
Watershed District

Prepared by:
Steve McComas
Jo Stuckert
Blue Water Science

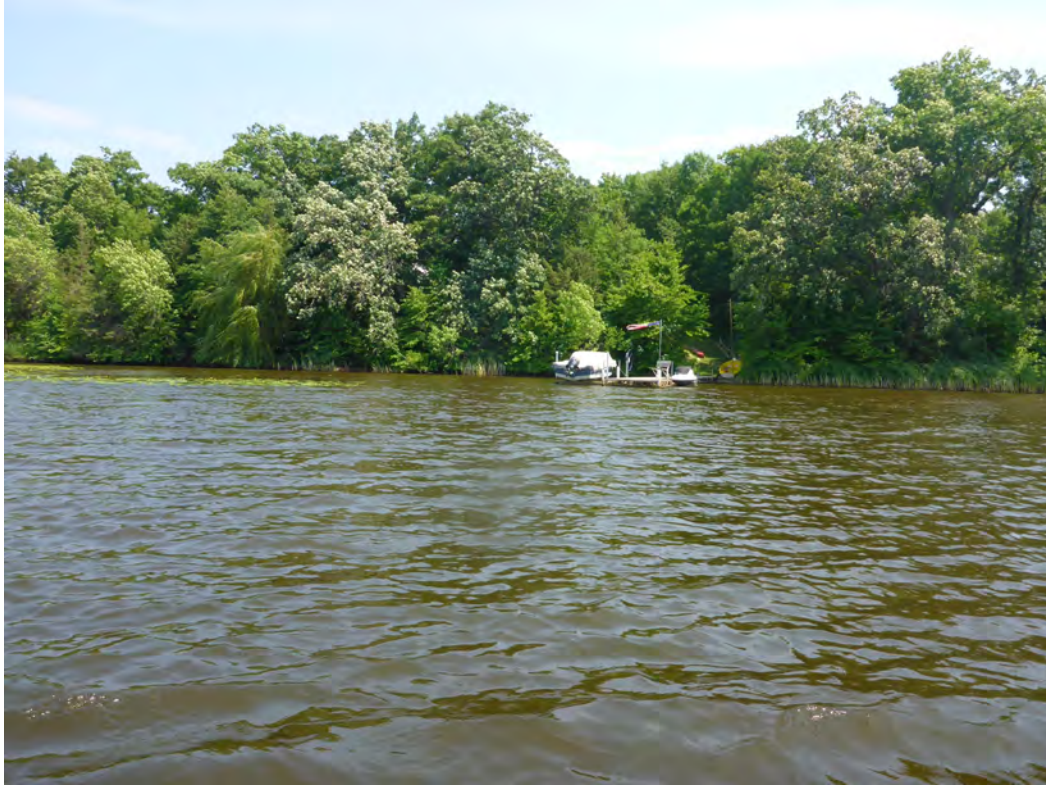
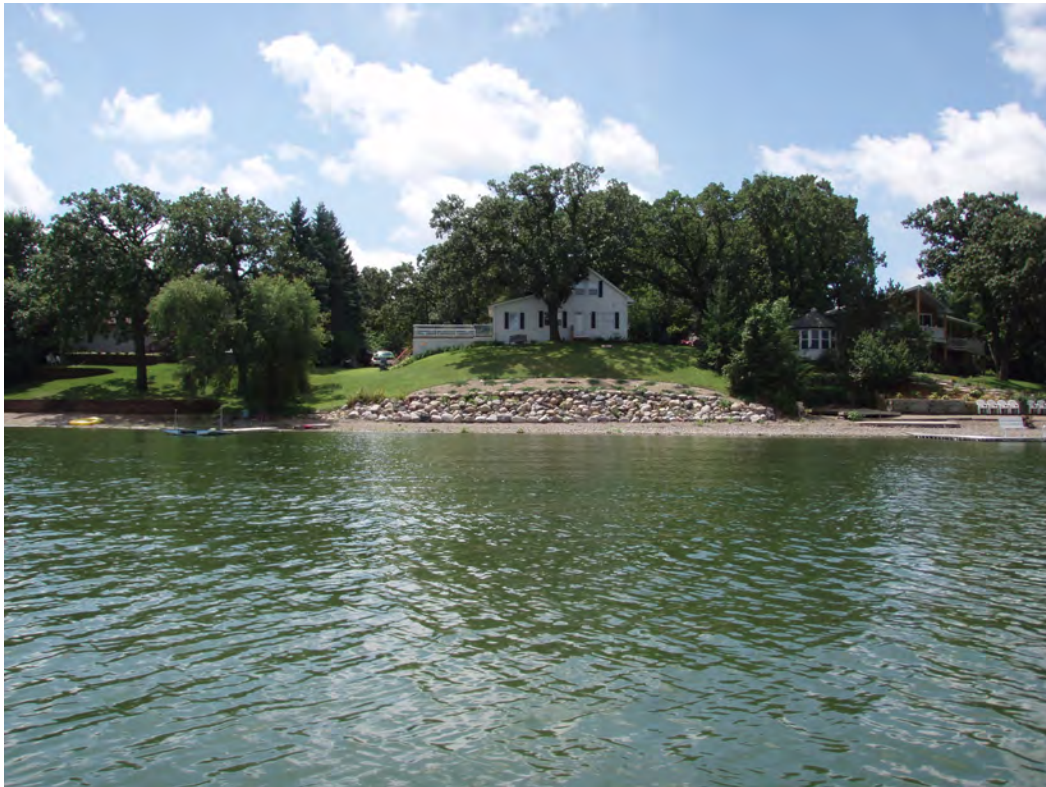
Figure 1. [top] This parcel would rate as having a shoreline with a buffer greater than 50% of the lot width and an understory with greater than 50% natural cover. [bottom] This parcel would not qualify as having a natural shoreline buffer greater than 50% of the lot width. Also the understory in the upland area would be rated as having less than 50% natural cover.

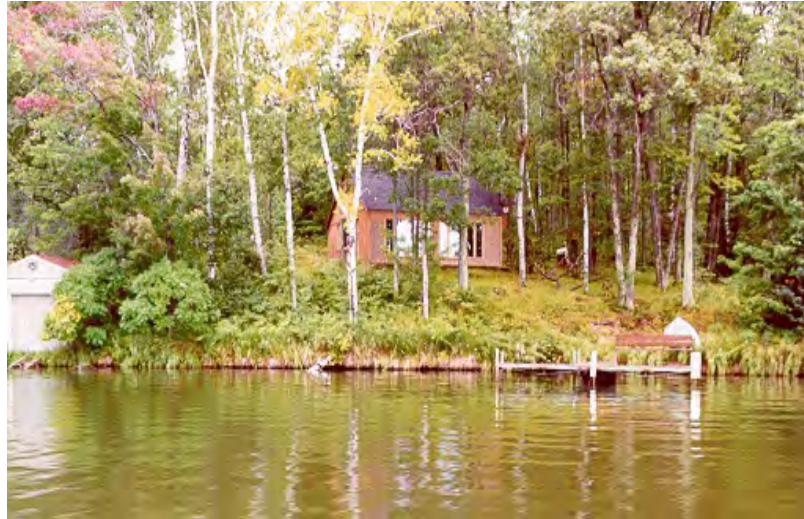
1. Naturalization: The easiest way to implement a natural shoreline setting is to select an area and leave it grow back naturally.

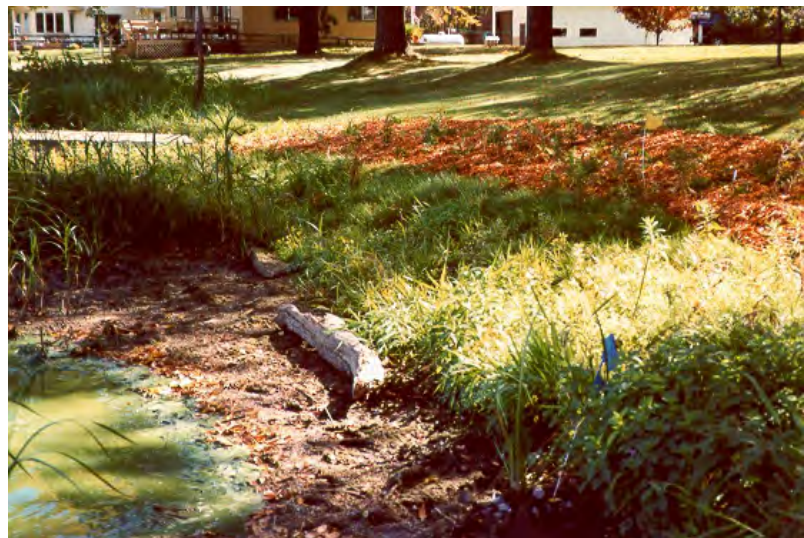
2. Accelerated Naturalization: To accelerate the naturalization, plant shrubs, wild flowers, or grasses into a shoreland area.

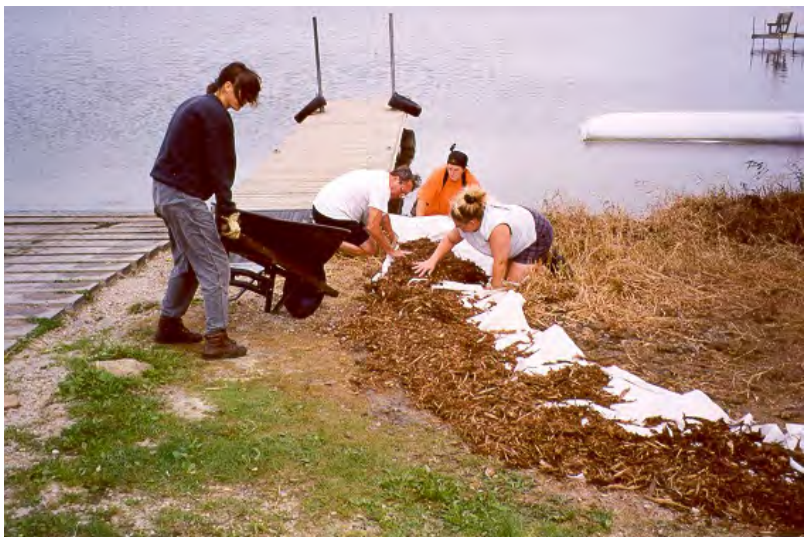
3. Restoration: This involves removing existing vegetation through the use of paper mats and/or mulching and planting a variety of native grasses, flowers, and shrubs into the shoreland area.
