Weekly Inspections

Erosion and Sediment Control Inspection Report

General Information							
Project Name	Beltz Park Improvements- 2025						
Permit No.	25-003	Location	Forest Lake				
Date of Inspection	2025-07-23	Start/End Time 4:51 pm to 5:15 pm (0.4 hours)					
Inspector's Name(s)	2025 Victoria D'Amico						
Inspector's Contact Information	Phone 651-313-8821 Email victoria.damico@clflwd.org						
Inspector's Qualifications	EI1001 Construction Installer						
Describe the Present Phase of Construction	Stormwater basin is filled with brown water and draining into the lake. The exact source of the issue was not clear entirely clear and should be further investivated. The measures below should be taken to reduce risk of further erosion into the lake.						
Type of Inspection: ☐ Regular ☐ Pre-sto	m event ☑ During storm event		□ Post-storm event				
	Weather I	nformation					
Has there been a storm event since the last in	spection?		☑ Yes □ No				
Approximate Amount of Precipitation (in): 2

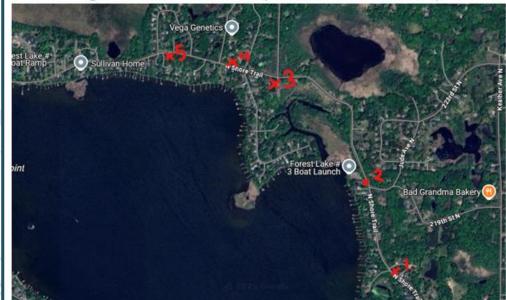
- 1. Erosion is traveling towards the wetland near the mailbox for 9642 NST, north of the road. A biolog must be installed along the road and the affected area downslope must be stabilized.
- 2. Ditches south of 3rd basin launch must have additional stabilization/ protection installed to prevent sediment laden water from traveling to the outlet south of the launch.
- 3. Stockpiles west of the Jeffrey Ave intersection must be removed or protected with a biolog in the ditch downstream within 7 days.
- 4. Biologs between Jason and Janero must be installed as shown on the plans.
- 5. Erosion near 8955 NST must be stabilized.

See the image below for locations and photos at the end of the report.

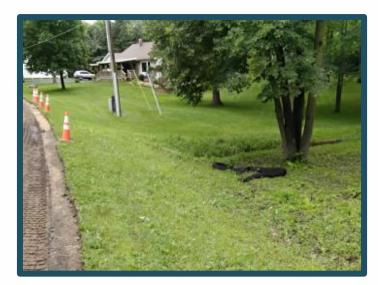
Photo from June 27, 2025 report requesting additional biolog ditch checks and stakes

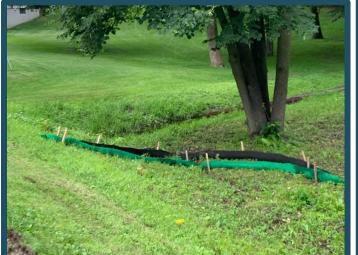
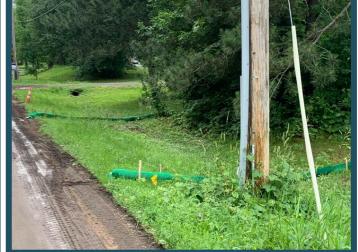
Response from the permittee later that day confirming the work was completed
