2014 Phosphorus Loads

Moody Lake Wetland Rehabilitation

Three Phase Rehabilitation Approach

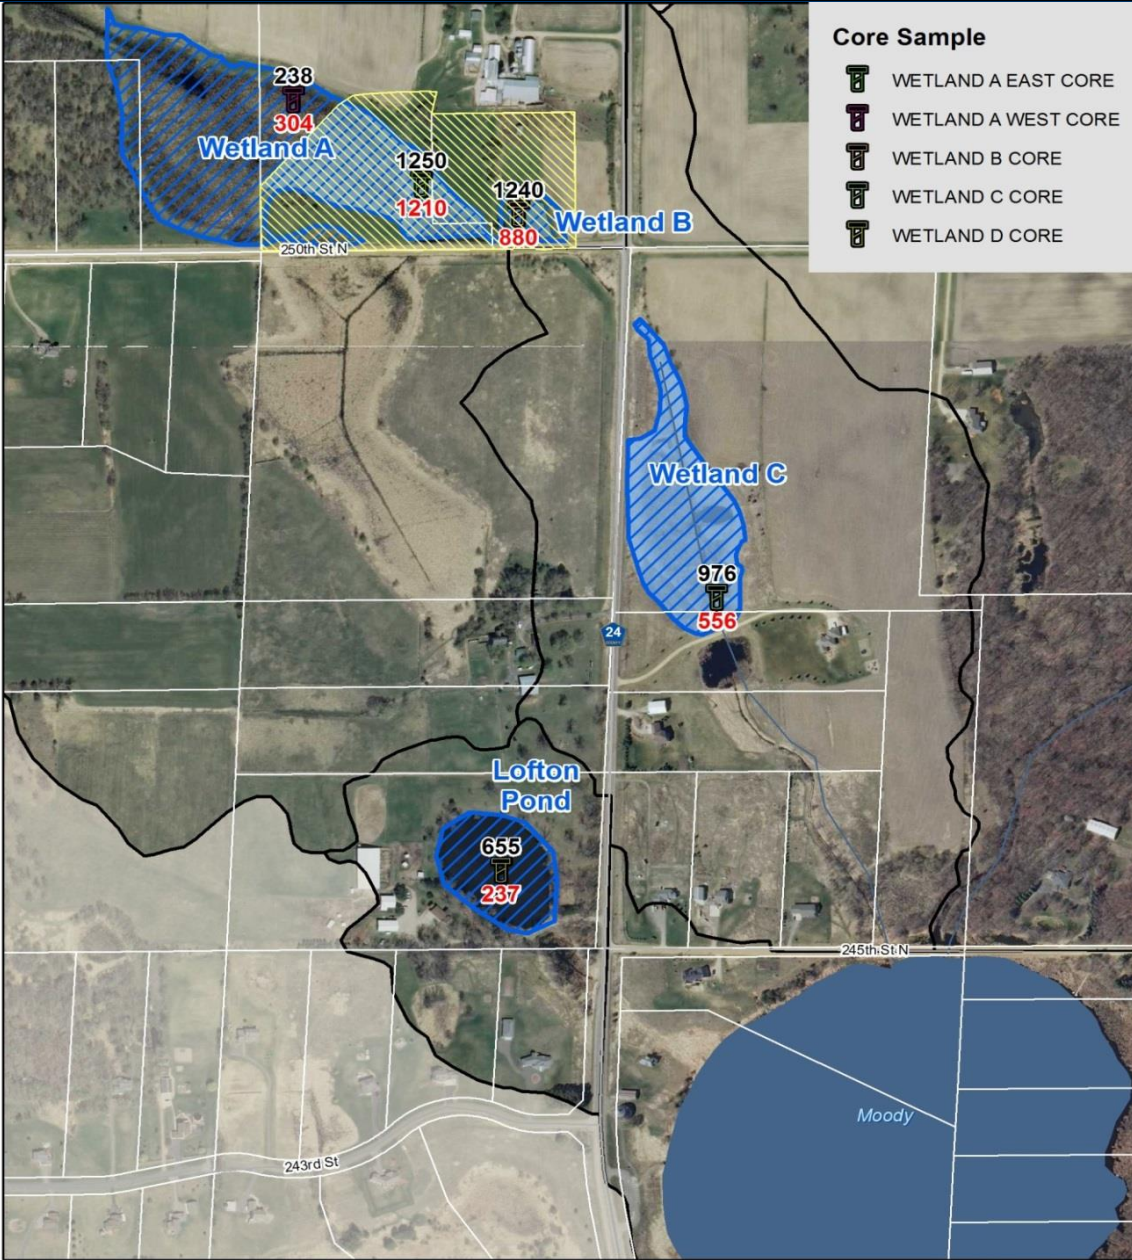
Core Sample

-   WETLAND A EAST CORE
-   WETLAND A WEST CORE
-   WETLAND B CORE
-   WETLAND C CORE
-   WETLAND D CORE
