Curlyleaf Pondweed Delineation and Assessment Surveys for Moody Lake, Chisago County, Minnesota, 2021

Curlyleaf Pondweed Delineation: April 16, 2021

Curlyleaf Pondweed Assessment: June 16, 2021

Comfort Lake/Forest Lake
Watershed District
Forest Lake, Minnesota

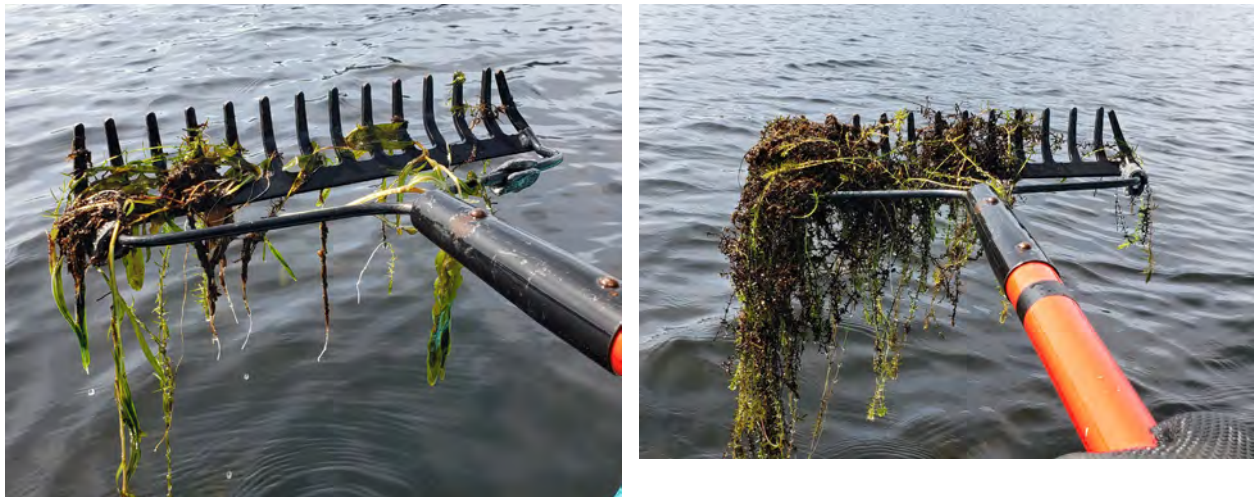
Figure 2. A sample rake with both curlyleaf pondweed and elodea was collected on April 16, 2021 (left) and a sample rake with elodea (right).

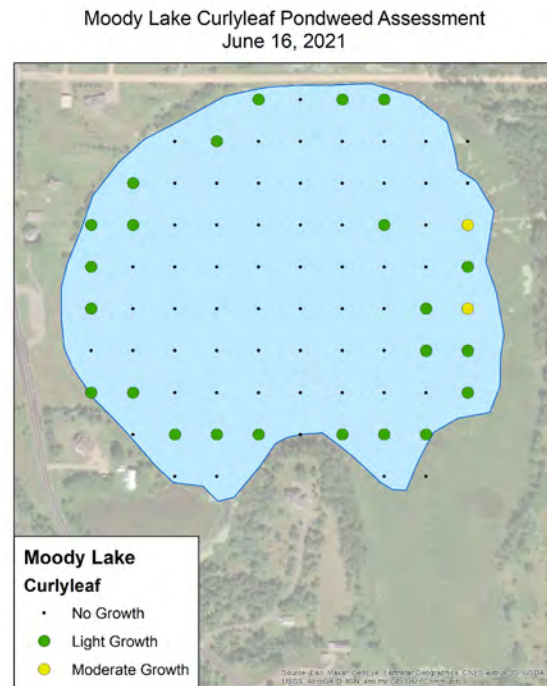
Figure 3. Curlyleaf pondweed coverage for Moody Lake on June 16, 2021. Key: black dots = no growth, green dot = light growth and yellow dots = moderate growth.

In early season surveys, projected CLP growth data is different than rake density ratings (Figure 3). Projected CLP growth can be a light density in April but grow into heavy growth by mid-June. Standard rake densities for CLP are shown in Figure 3, the map on the right.

Results of the June 16, 2021 assessment using a point intercept survey found there were 5 submerged plant species, coontail, curlyleaf pondweed, elodea, aquatic moss, and stringy pondweed with elodea being the dominant plant (Table 4 and Figure 3). Results from the assessment found native plants growing out to a depth of 11 feet (Table 5)(Figure 4).
