Curlyleaf Pondweed Delineation and Assessment and a Point Intercept Plant Survey For Comfort Lake, Chisago County, 2019

Delineation: May 1, 2019
Assessment: June 6, 2019
Summer Point Intercept Survey: August 28, 2019

Prepared for:
Comfort Lake/Forest
Lake Watershed District
Forest Lake, Minnesota

Prepared by:
Steve McComas
Blue Water Science
St. Paul, MN 55116

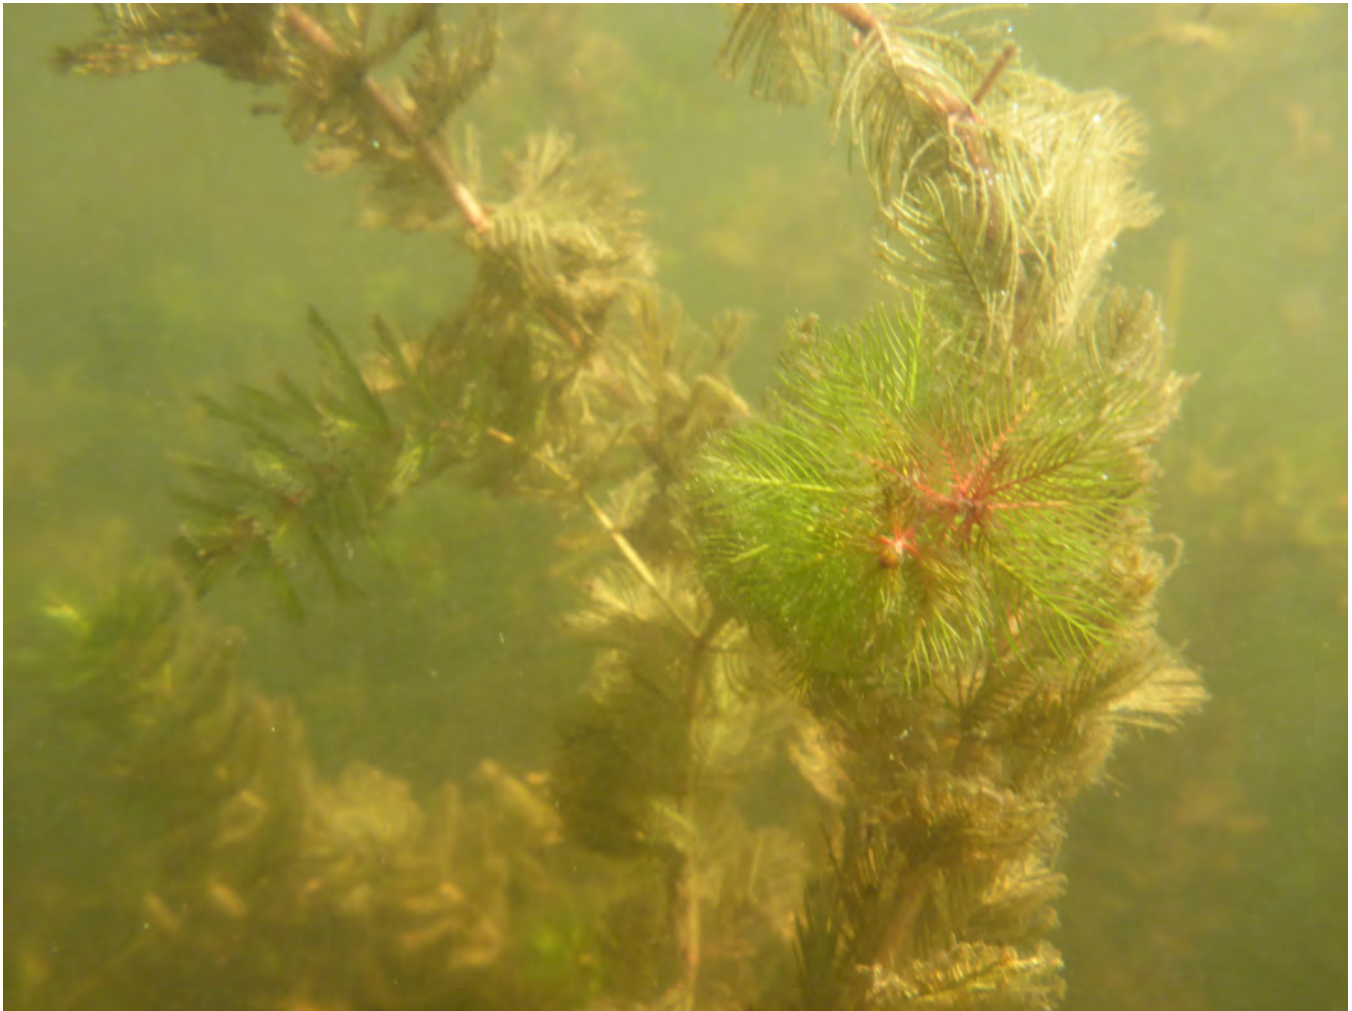
Underwater View of Eurasian Watermilfoil in Comfort Lake on August 28, 2019

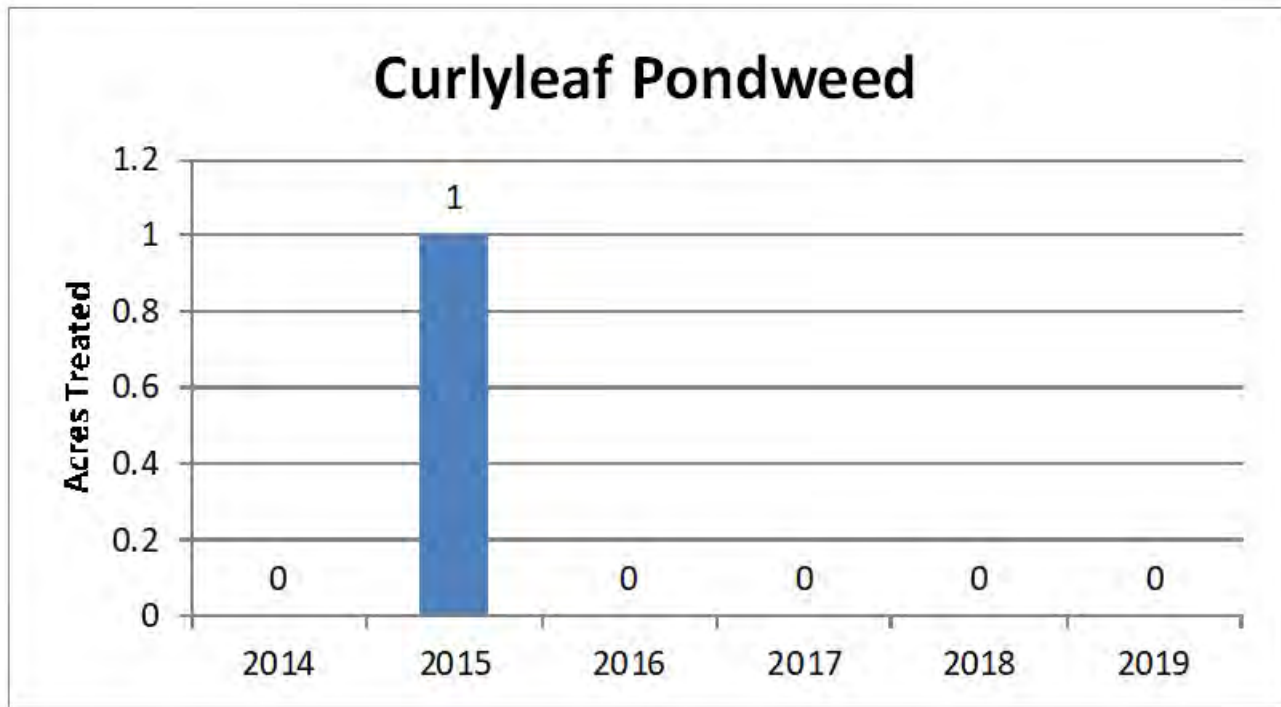
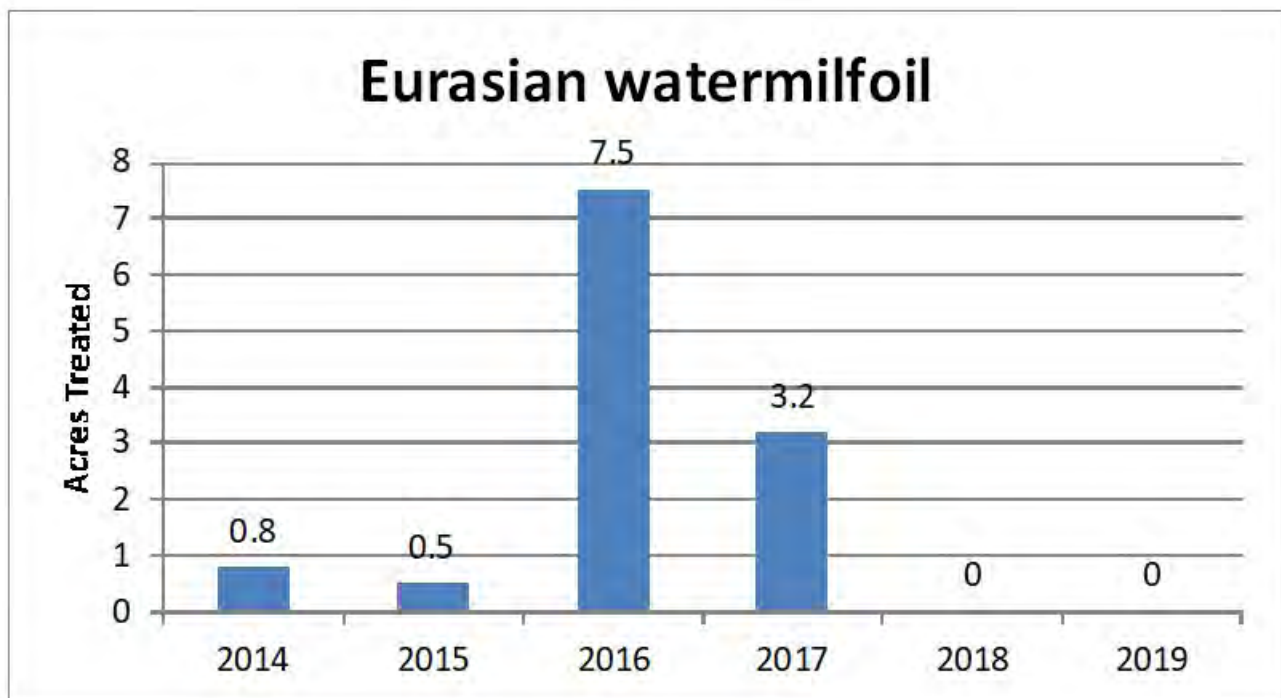
Figure S3. CLFLWD Sponsored Treatments: [top] Curlyleaf pondweed treated in 2014-2019. [bottom] Eurasian watermilfoil treated in 2014-2019.

Curlyleaf Pondweed and Eurasian Watermilfoil Treatments from 2014 Through 2019: A summary of CLP and EWM treatments from 2014-2019 is shown in Figure S3. Curlyleaf was only treated at 1 acre in 2015. Curlyleaf has been sparse in Comfort Lake. EWM was first observed in 2014 and it has spread around the lake in the last few years. A total of 7.5 acres was treated in 2016 and 3.2 acres were treated in 2017. Spot herbicide treatments were conducted in 2018 and 2019 around individual nearshore areas of lake residents. EWM is still relatively new in Comfort Lake and may expand further in the next few years.

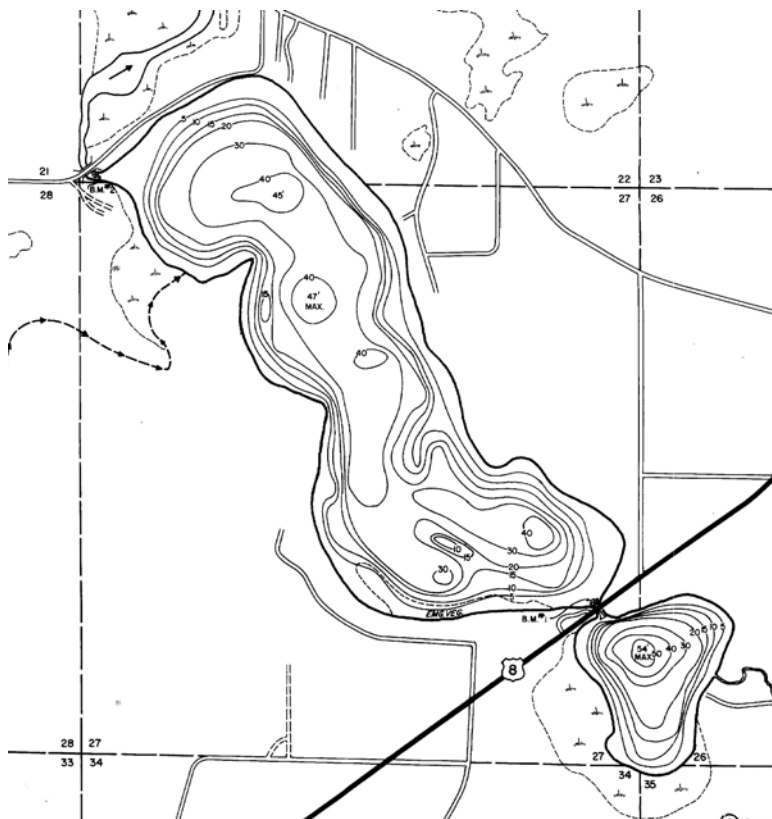
Figure 1. Contour map of Comfort Lake (source: MnDNR).

Comfort Lake has an area of 218 acres with a littoral area of 90 acres (MnDNR). The maximum depth of Comfort Lake is 37 feet. The extent of heavy growth of curlyleaf pondweed is unknown. The objectives of the curlyleaf surveys were to delineate the acreage of curlyleaf pondweed to treat and then treat is necessary and then after treatment, assess the effectiveness of the treatment. The objectives of the Eurasian watermilfoil (EWM) surveys were to delineate the acreage of EWM to treat and then treat is necessary and then after treatment, assess the effectiveness of the treatment. The objective of the point intercept survey was to determine the distribution and abundance of aquatic plants in Comfort Lake.

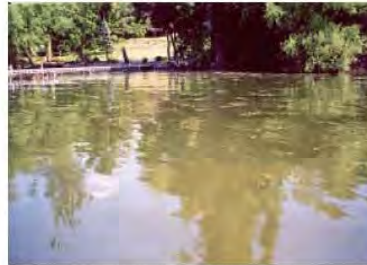
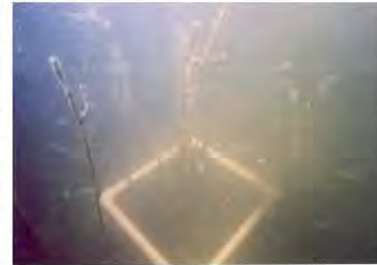
Light Growth Conditions

Plants rarely reach the surface.

Navigation and recreational activities are not generally hindered.

Stem density: 0 - 160 stems/m²
Biomass: 0 - 50 g-dry wt/m²
Estimated TP loading: <1.7 lbs/ac

MnDNR rake sample density equivalent for light growth conditions: 1.

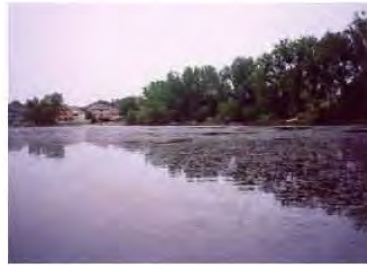
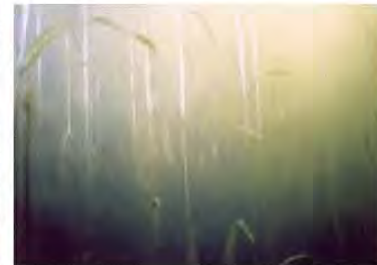
Moderate Growth Conditions

Broken surface canopy conditions.

Navigation and recreational activities may be hindered.

Lake users may opt for control.

Stem density: 100 - 280 stems/m²
Biomass: 50 - 100 g-dry wt/m²
Estimated TP loading: 2.2 - 3.8 lbs/ac

MnDNR rake sample density equivalent for moderate growth conditions: 2.

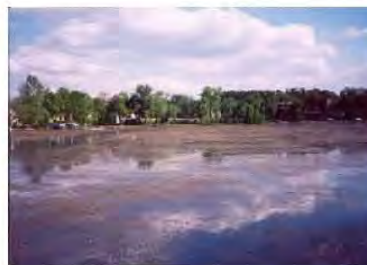
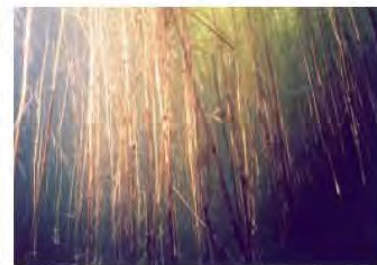
Heavy Growth Conditions

Solid or near solid surface canopy conditions.

Navigation and recreational activities are severely limited.

Control is necessary for navigation and/or recreation.

Stem density: 280+ stems/m²
Biomass: >100 g-dry wt/m²
Estimated TP loading: >6.7 lbs/ac

MnDNR rake sample density = 3.

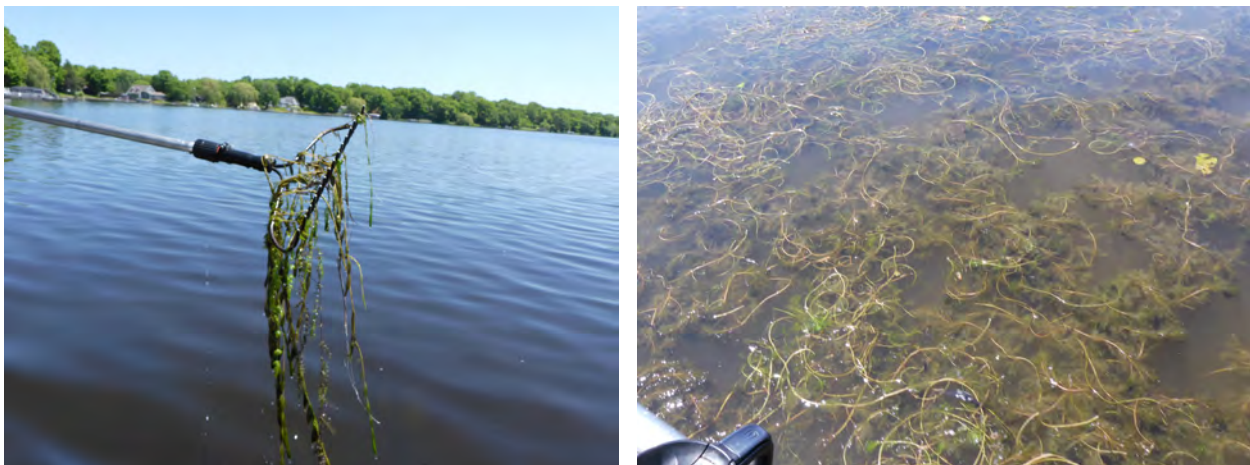
Figure 5. Eurasian watermilfoil was found around Comfort Lake on June 6, 2019. [left] Eurasian watermilfoil on a sample rake. [right] Eurasian watermilfoil reaching the surface in Comfort Lake.

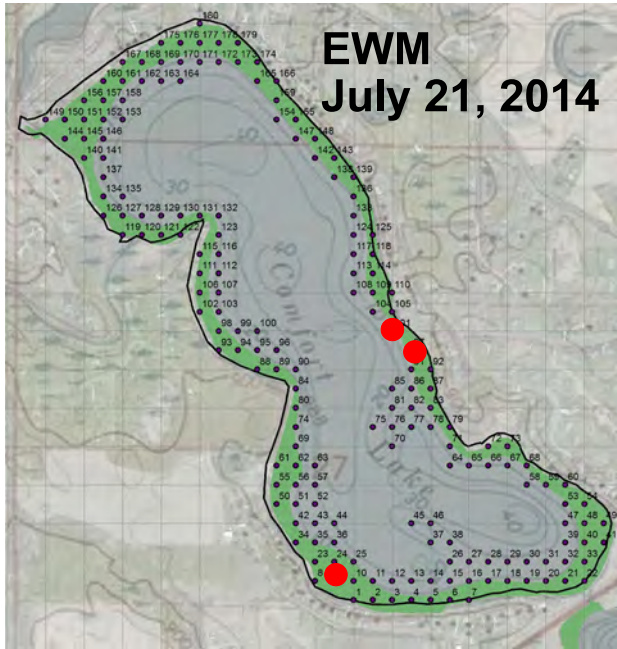
Figure 7a. EWM locations (red dots) on the July 21, 2014 point-intercept survey.

During the point-intercept survey on July 21, 2014, Eurasian watermilfoil (EWM) was identified at three sites (Figure 7a). EWM was verified by the MnDNR on August 6, 2014 at 13 sites (Figure 7b). Due to the lateness of the season, only the EWM area at the public access was treated (Figure 7c). EWM will be monitored in the next few years to characterize distribution and abundance.

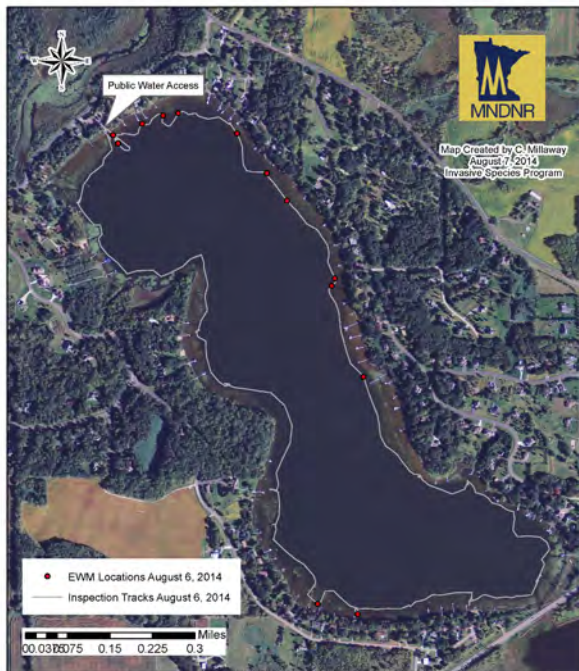
Comfort Lake, Chisago County (13005300)
Eurasian watermilfoil Inspection: August 6, 2014
Invasive Species Program

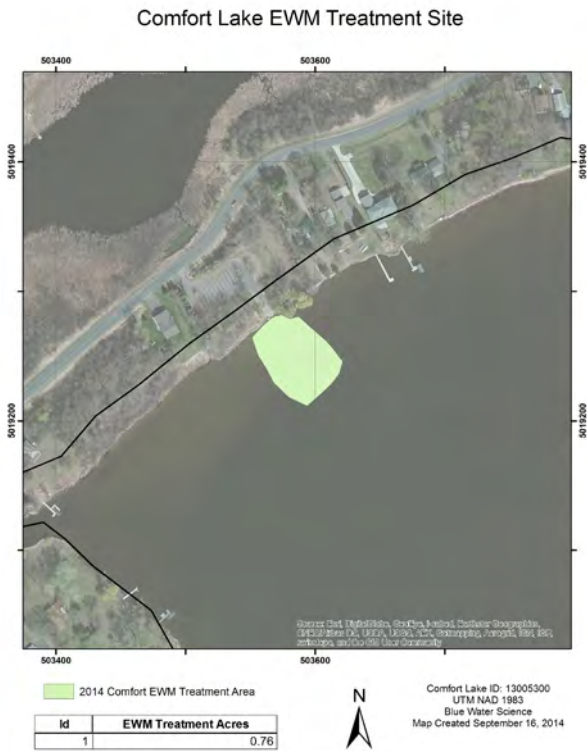
Figure 7c. EWM treatment area in front of the public access.

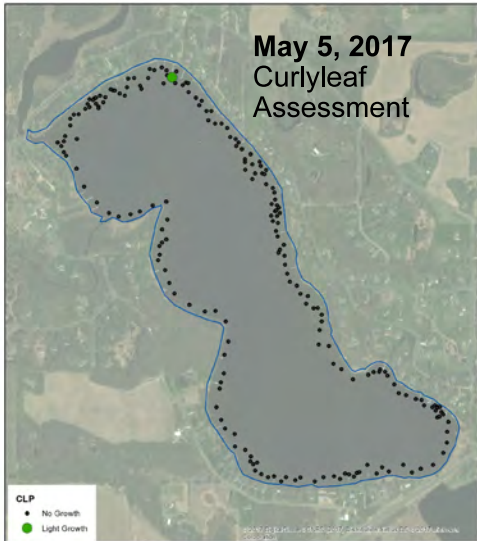
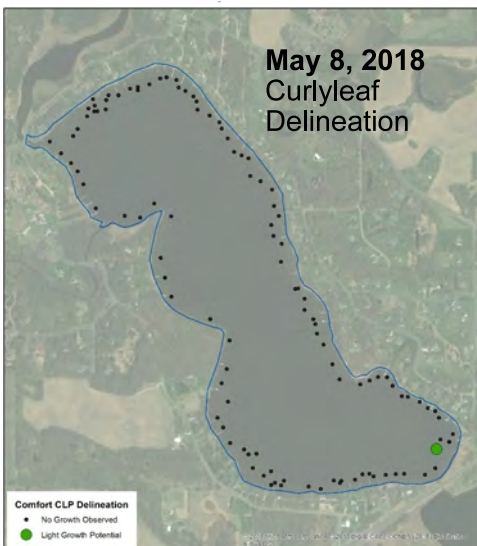
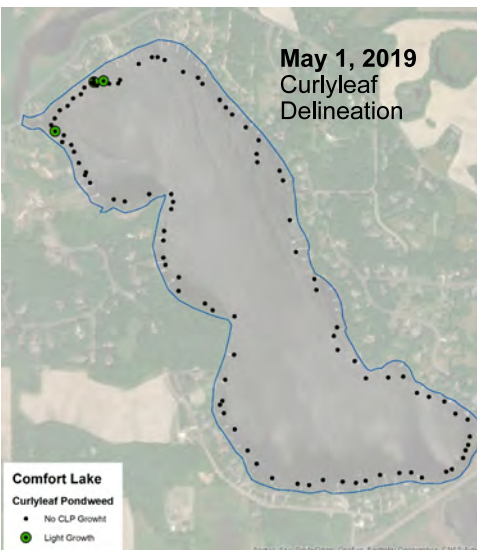
Curlyleaf pondweed and Eurasian watermilfoil maps for 2014 through 2019.

Curlyleaf Pondweed 2014-19

Eurasian Watermilfoil 2014-19

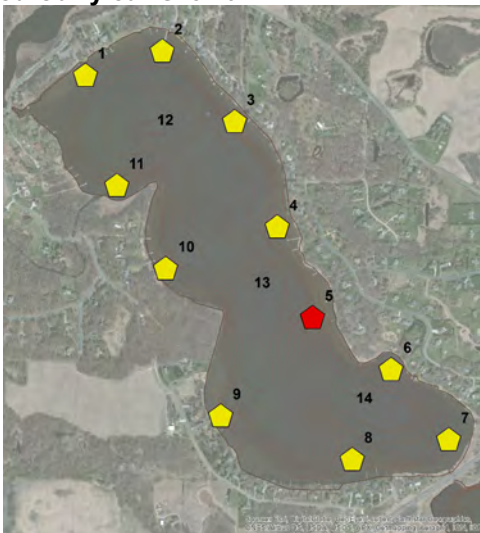
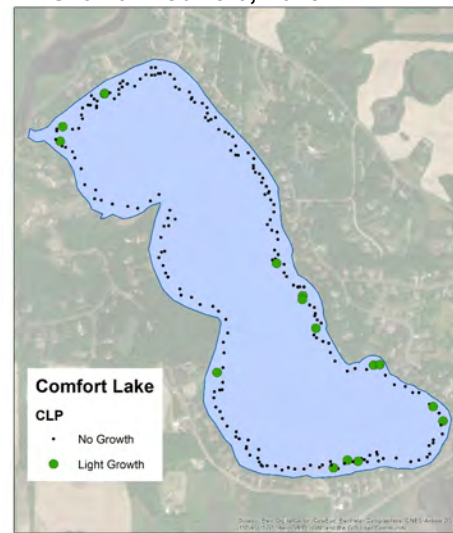
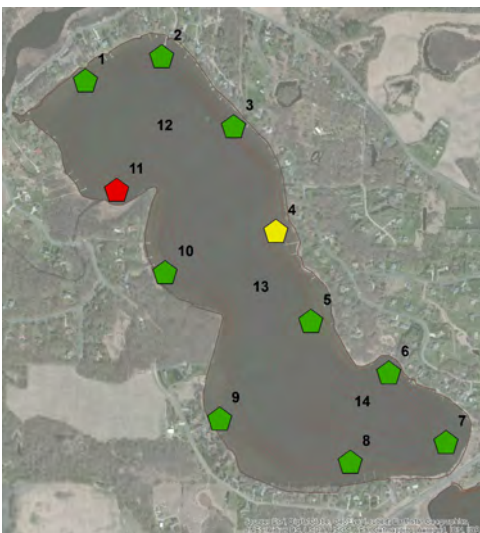
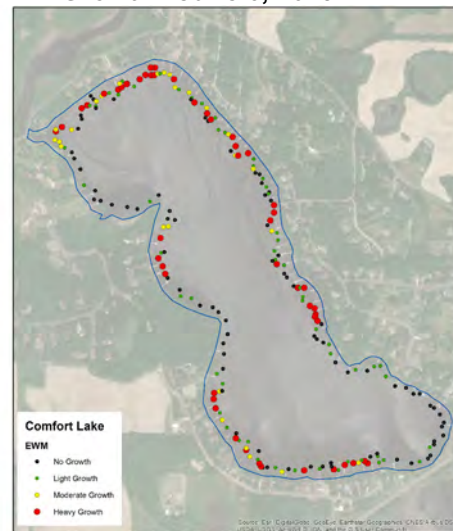
[top] Curlyleaf pondweed predicted (left) and actual (right) growth maps.

[bottom] Eurasian watermilfoil predicted (left) and actual (right) growth maps.

Lake sediment sampling has been used to predict lake bottom areas that have the potential to support heavy curlyleaf pondweed plant growth. Based on the key sediment parameters of pH, sediment bulk density, organic matter, and the Fe:Mn ratio (McComas, unpublished), the predicted growth characteristics of curlyleaf pondweed in Comfort Lake are shown below.

Lake sediment sampling also has been used to predict lake areas that have the potential to support various types of EWM growth. Based on the key sediment parameters of NH_4 and organic matter (McComas, unpublished), a map was prepared that predict the type of growth that could be expected in the future in Comfort Lake.
