Curlyleaf Pondweed and Eurasian Watermilfoil Delineation, Treatment, and Assessment for Bone Lake, Washington County, Minnesota in 2021

Prepared for:
**Comfort Lake/Forest Lake
 Watershed District
 Forest Lake, Minnesota**

Prepared by:
**Steve McComas
 Jo Stuckert
 Connor McComas
 Blue Water Science**

November 29, 2021

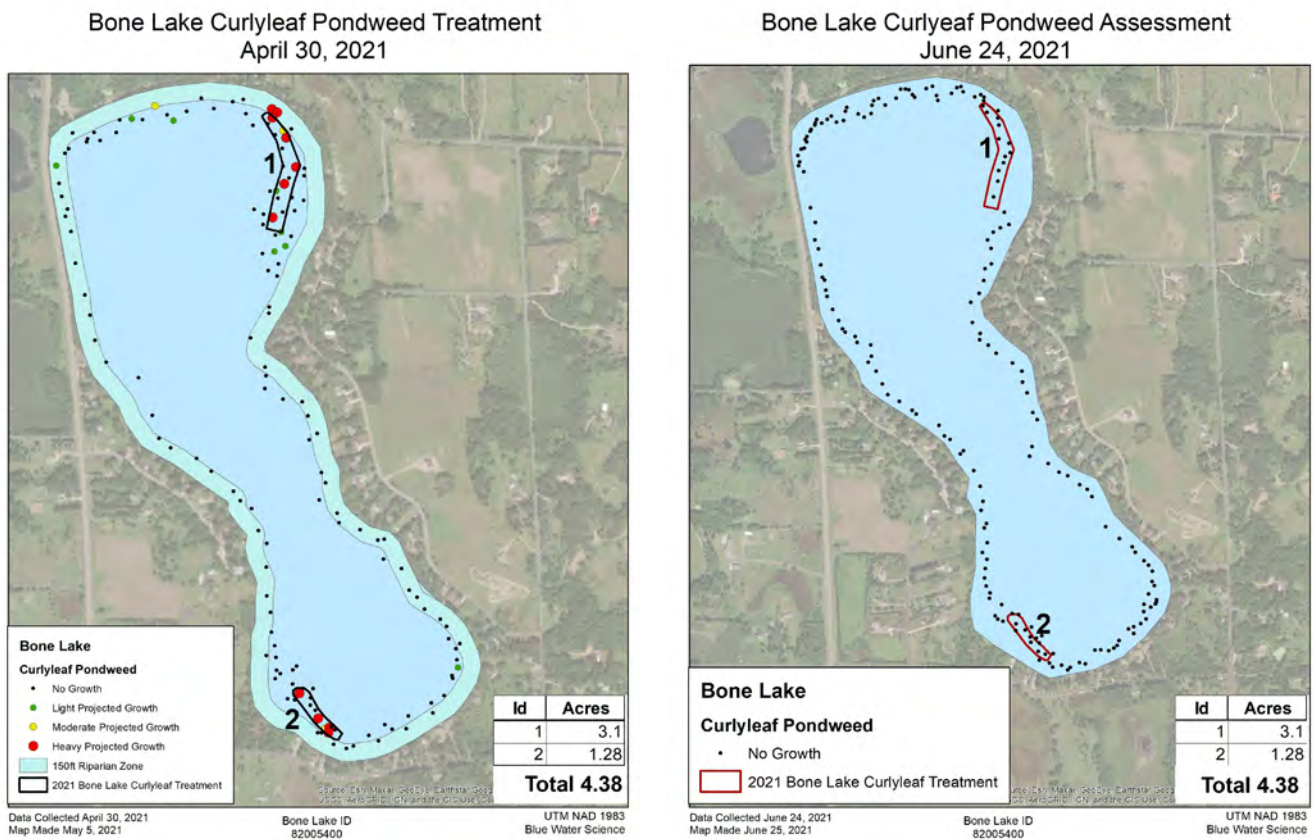
Figure S1. [left] CLP was found at 22 out of 153 sample sites in Bone Lake on April 30, 2021.

[right] CLP was not found at any of the 186 sample sites on June 24, 2021.

Key: green = light growth potential, yellow = moderate growth potential, red = heavy growth potential.

A CLP assessment was conducted on June 24, 2021, which was the time period of peak CLP growth in area lakes. CLP control in the treatment area was good (Figure S1).

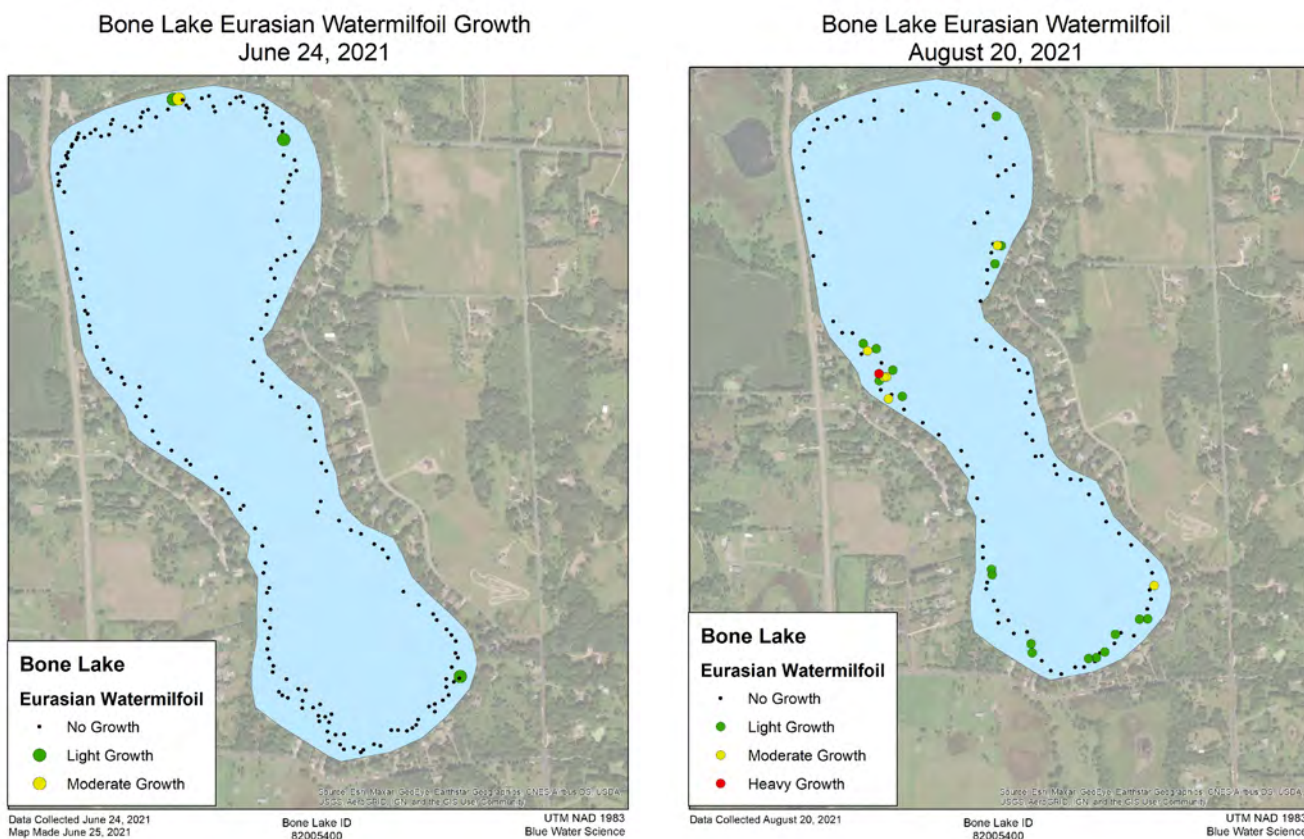
Figure S2. [left] EWM coverage for Bone Lake on June 24, 2021. [right] EWM delineation for Bone Lake on August 20, 2021.

Eurasian Watermilfoil Delineation, Treatment, and Assessment: Eurasian watermilfoil (EWM) was verified in Bone Lake in 2006. In 2021, an initial early EWM check was conducted on April 30, 2021, EWM was found at 13 sites out of 153 sites sampled and only light growth observed. Another EWM delineation was conducted on June 24, 2021 and EWM was found at 4 sites out of the 186 sites sampled again only light growth was observed (Figure S2). No areas were delineated for EWM treatment in 2021.

A follow-up assessment was conducted on August 20, 2021. Eurasian watermilfoil had increased in distribution and was found at 25 sites out of 125 sample locations. EWM density was mostly light in Bone Lake (Figure S2).

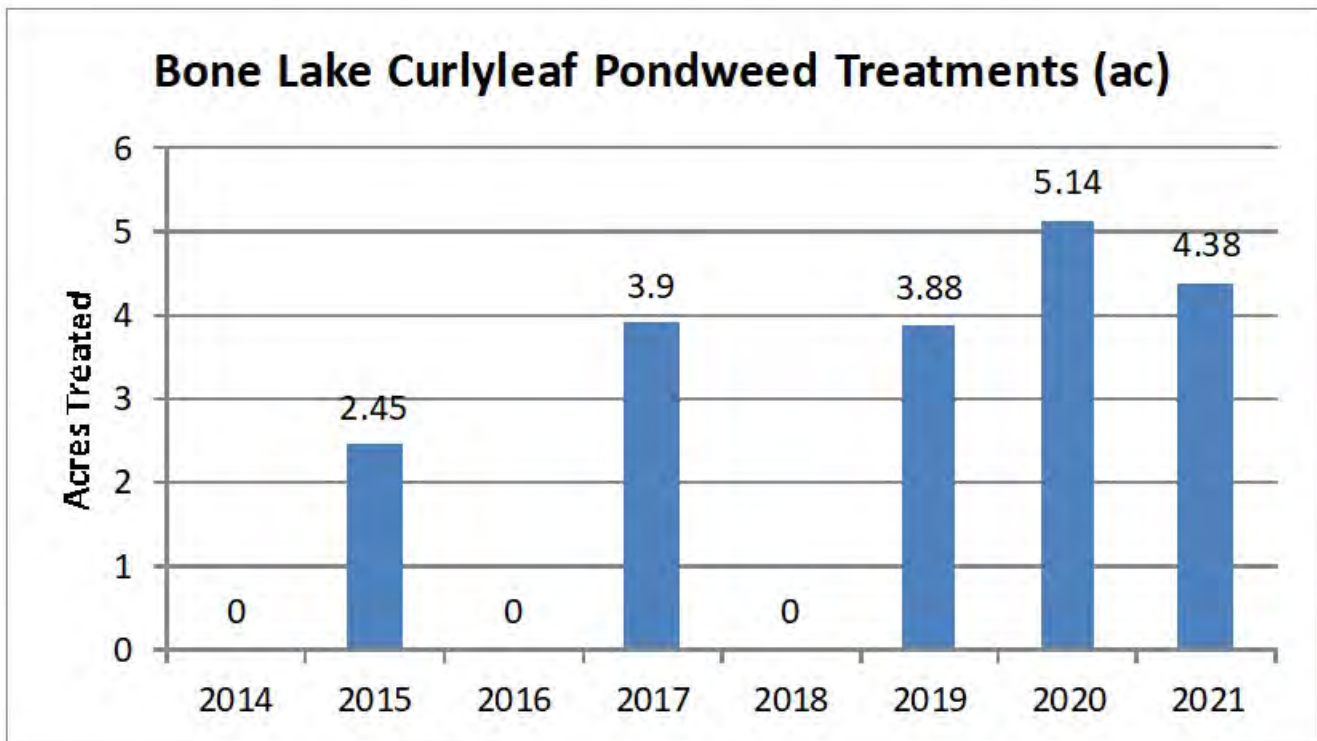
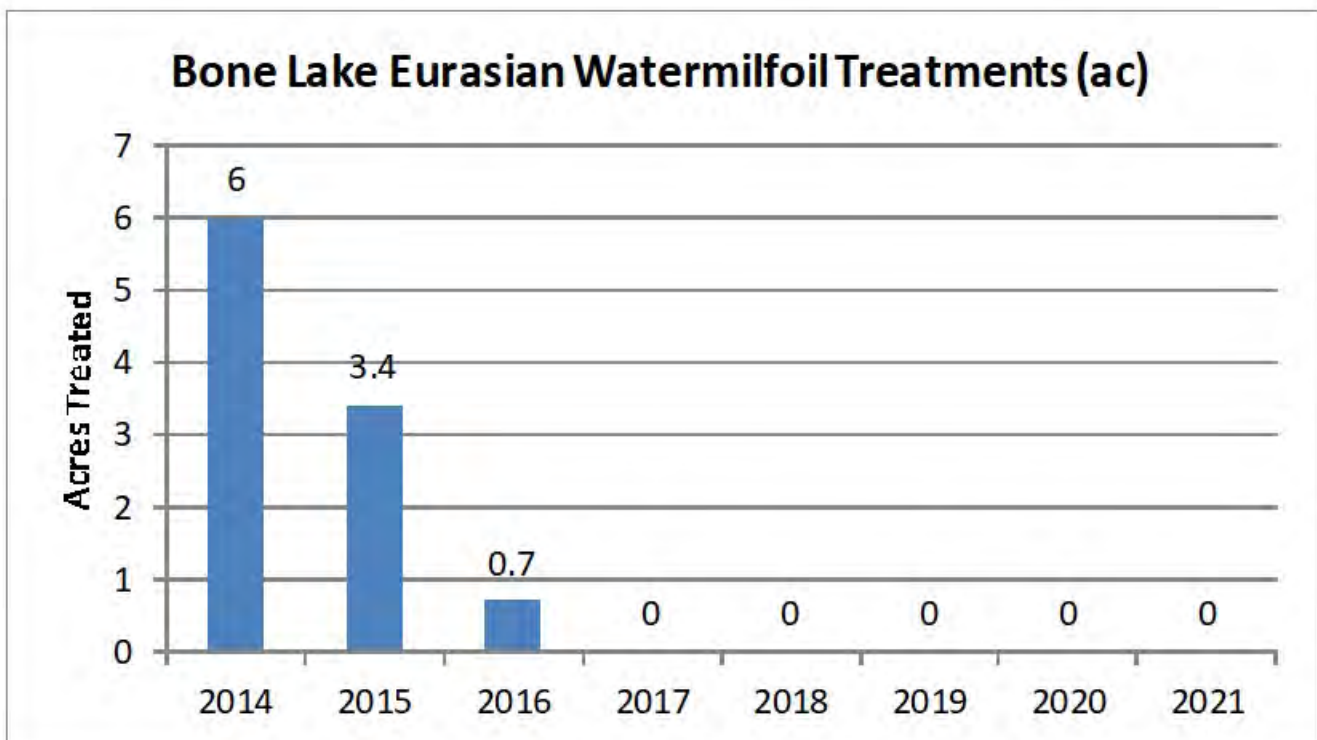
Figure S3. Summary of CLP and EWM treatment acreage for 2014-2021.

Summary of CLP and EWM Bone Lake Treatments: CLP has been treated in 5 out of the last 8 years including the last 3 years. EWM has been treated in 3 out of the last 8 years. However, no EWM has been treated in the last 5 years (Figure S3).

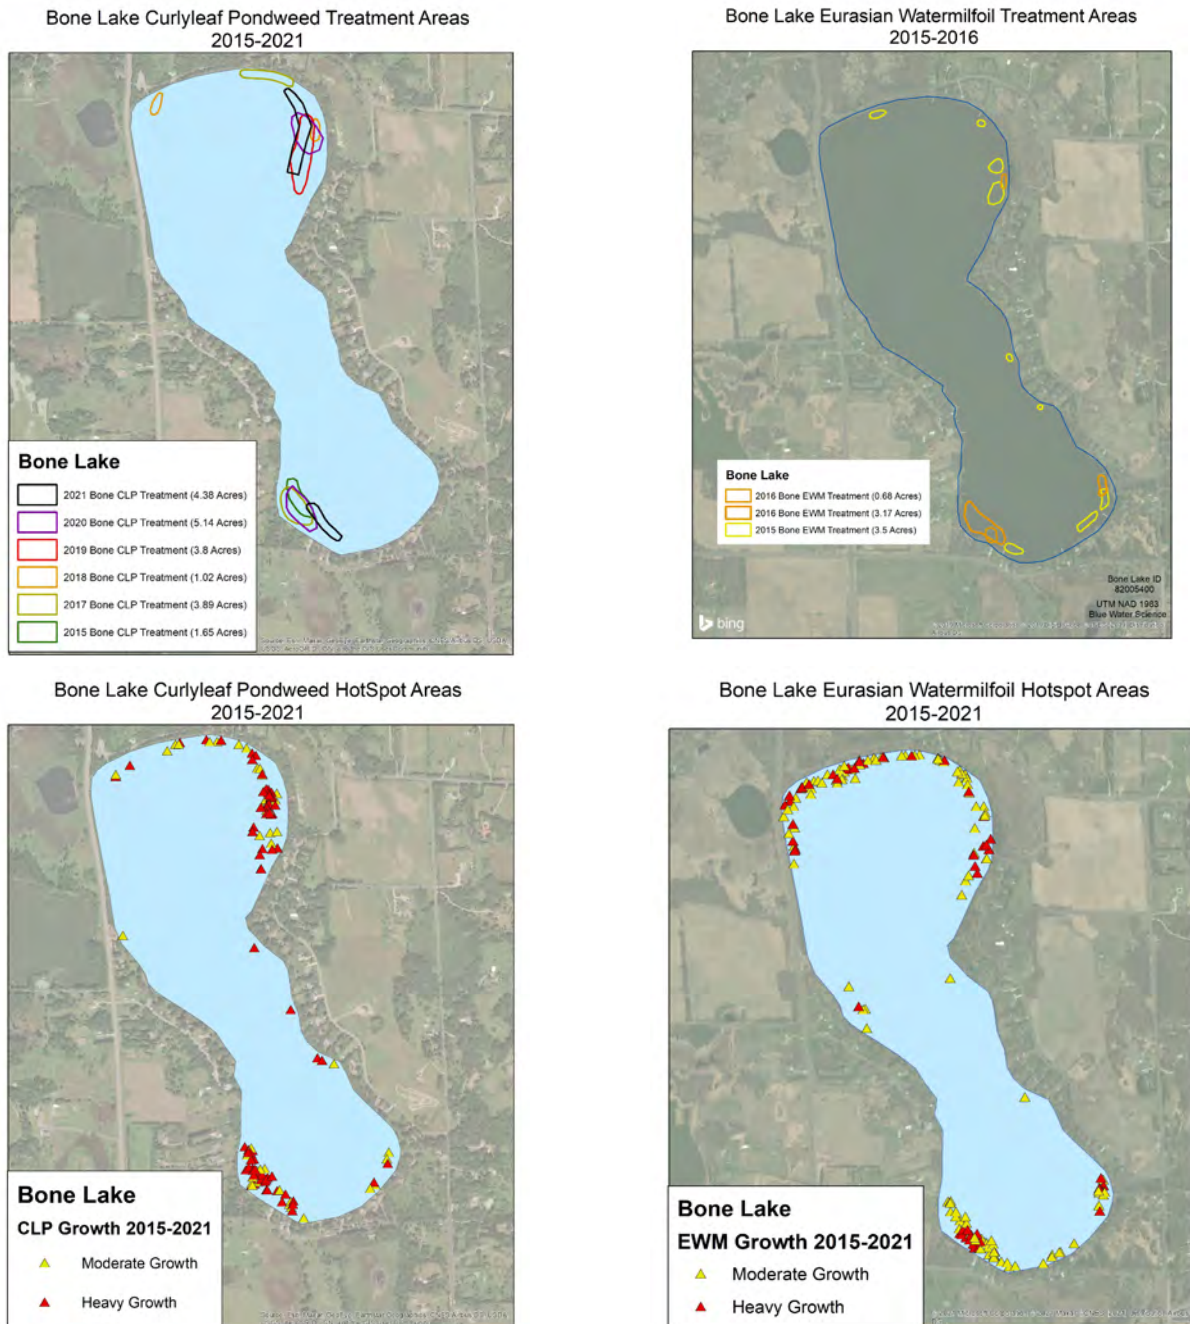
Figure S4. [top-left] Bone Lake CLP treatment map 2015-2021. [top-right] Bone Lake EWM treatment map 2015-2016. [bottom-left] Hotspot map of CLP growth over the years of 2015-2021 placed on a single map. [right] Hotspot map of EWM growth over the years of 2015-2021 placed on a single map
Key: yellow = moderate growth, and red = heavy growth.

Curlyleaf and Milfoil Treatments from 2015-2021: A summary of CLP and EWM treatments from 2015 through 2021 is shown in Figure S4. CLP growth has been variable for the last couple of years. Lake ice, snow cover, and even cloudy days can limit curlyleaf growth. EWM treatment areas have decreased since 2014, but EWM is still present in nearshore areas in Bone Lake.

A hotspot map of sites of EWM moderate and heavy growth for 2015 through 2021 is shown in Figure S4. In the last 5 years EWM growth has been most evident in the northern and southern ends of Bone Lake where growing conditions are conducive to heavy plant growth. EWM has typically grown to a water depth of 6 feet or less.

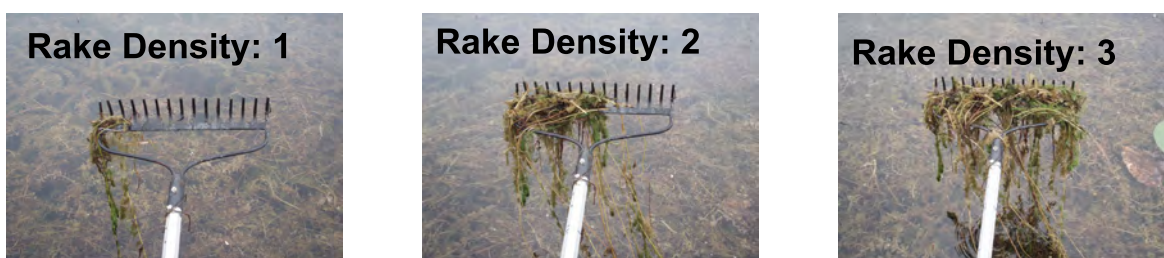
Chart of Aquatic Plant Density Ratings

Figure 2. Aquatic plant density ratings from 1 to 3.

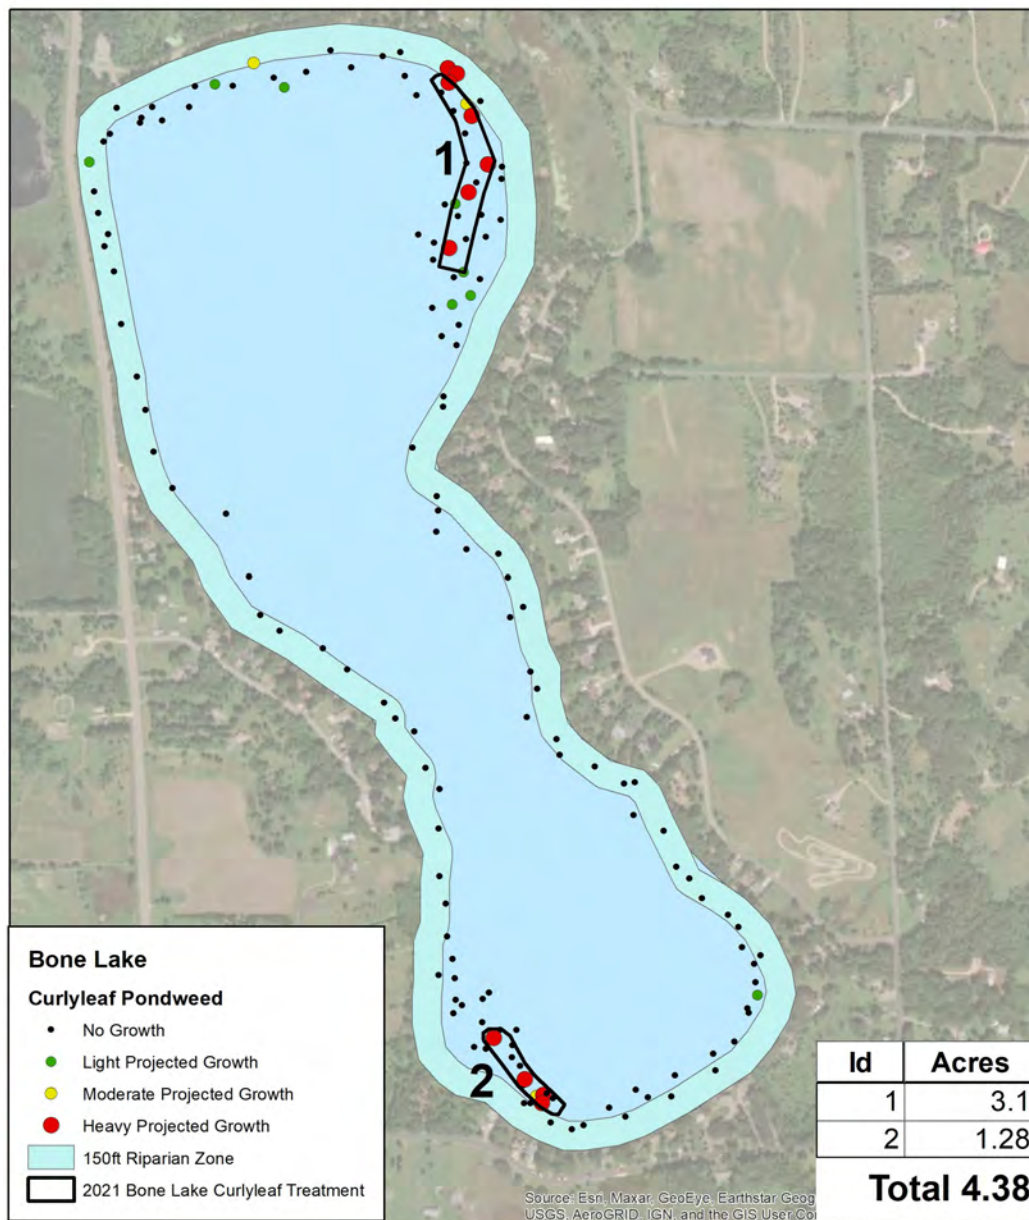
Bone Lake Curlyleaf Pondweed Treatment April 30, 2021

Figure 3. CLP coverage for Bone Lake on April 30, 2021.

Key: green dots = light growth, yellow dots = moderate growth, red dots = heavy growth, black dots = no growth, and blue shading = 150 ft riparian zone.

Results of the delineation conducted on April 30, 2021 found CLP present at 22 sample sites out of a total of 153 sites sampled. Two areas were delineated for CLP treatment (Figure 3). A CLP treatment of 4.38 acres was conducted on May 26, 2021 using Aquathol at 1.25 ppm (3.2 gallons per acre).

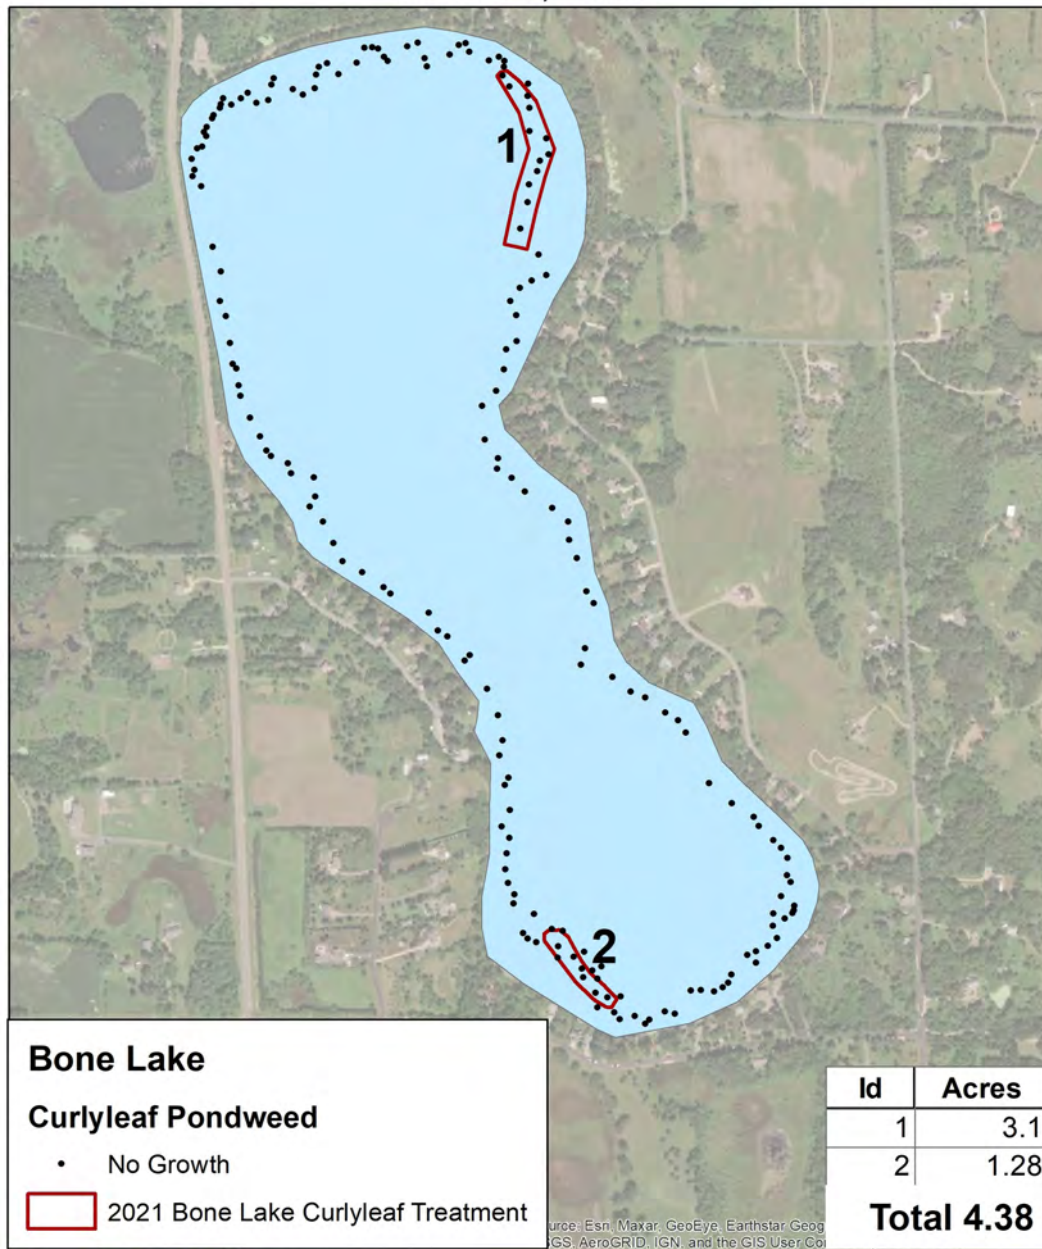
Bone Lake Curlyleaf Pondweed Assessment June 24, 2021

Figure 4. CLP was not found in Bone Lake on June 24, 2021.

Key: black dot = no curlyleaf growth and red outlined areas = 2021 CLP treatment areas.

Results of an assessment conducted on June 24, 2021 found that CLP was not present in the 186 locations sampled. The CLP treatment on May 26, 2021 of 4.38 acres had good control results. Very little CLP was present in lake areas outside of the treatment polygons (Figure 4).

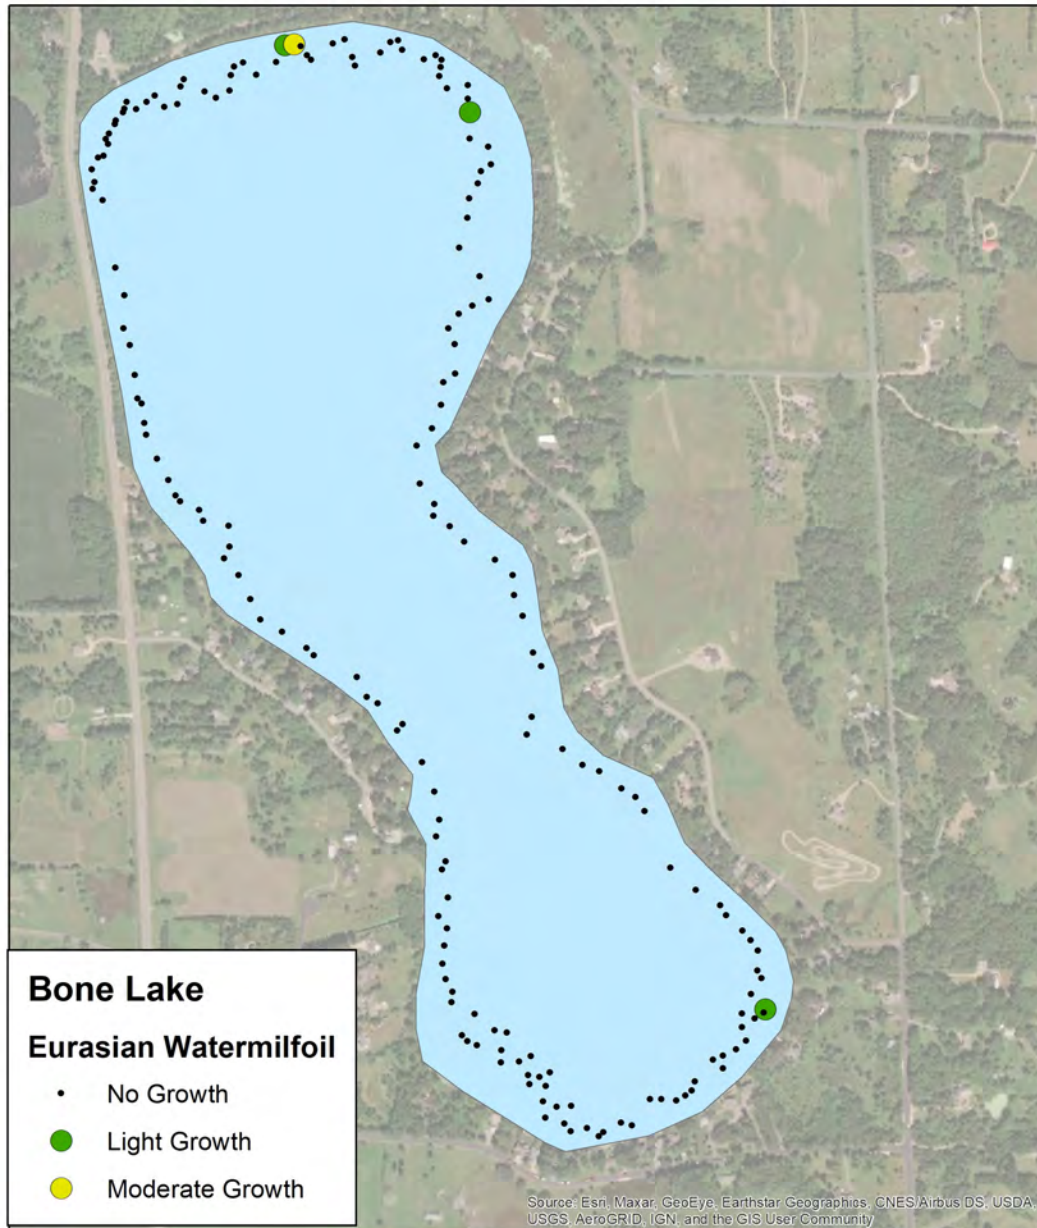
Bone Lake Eurasian Watermilfoil Growth June 24, 2021

Figure 5. EWM coverage for Bone Lake on June 24, 2021.

Key: green dots = light growth, yellow dots = moderate growth, and black dots = no growth.

An EWM delineation was conducted on June 24, 2021. EWM was found at 4 sites out of 186 sites sampled (Figure 5). No areas were delineated for treatment (Figure 5).

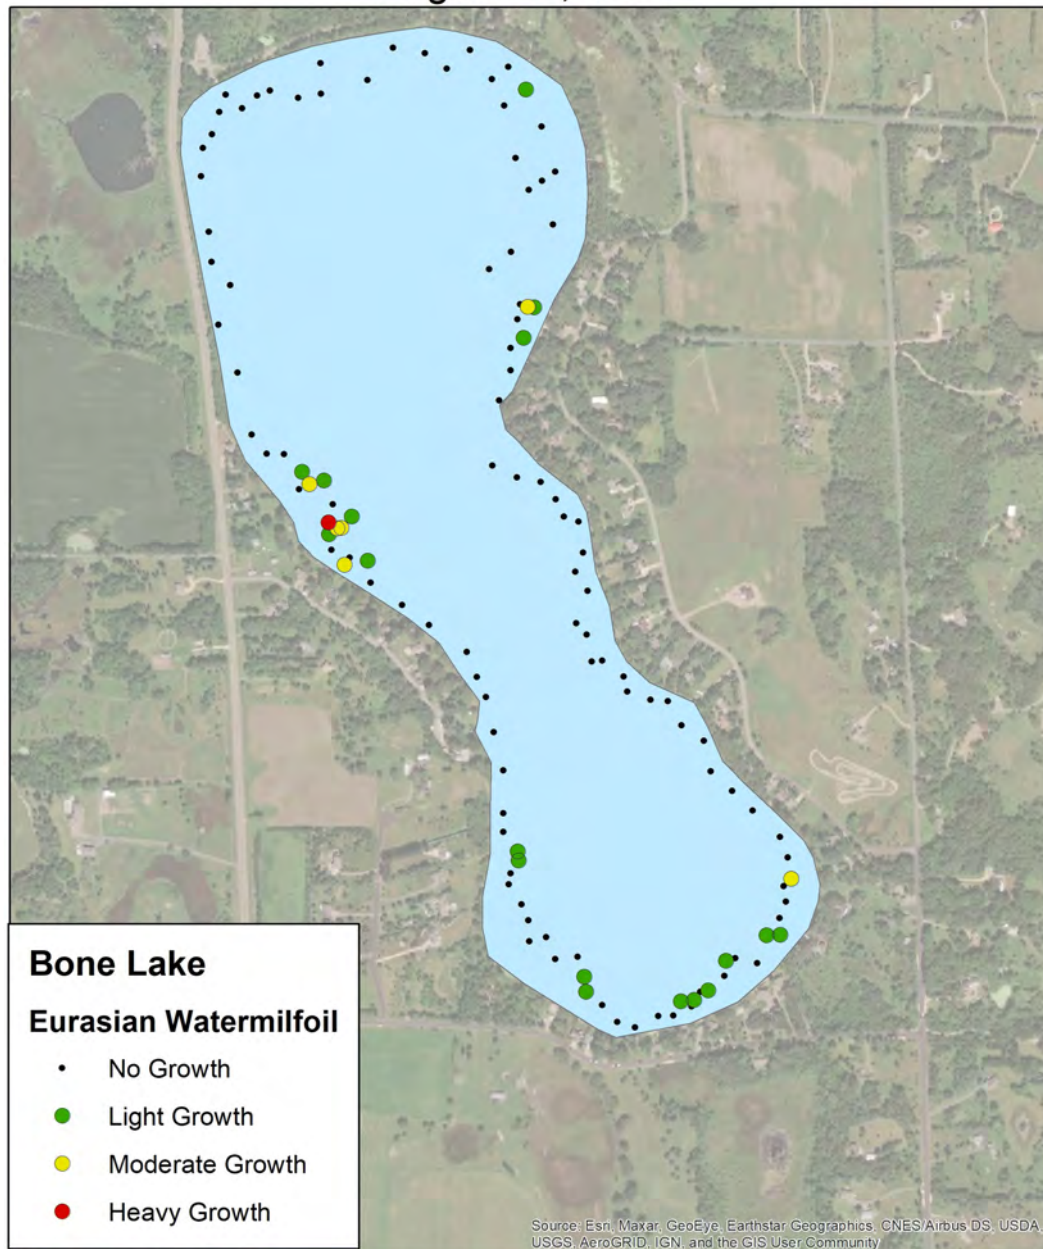
Bone Lake Eurasian Watermilfoil August 20, 2021

Figure 6. EWM coverage for Bone Lake on August 20, 2021.

Key: green dots = light growth, yellow dots = moderate growth, red dots = heavy growth, and black dots = no growth.

EWM growth was assessed on August 24, 2021 and 25 occurrences of EWM were observed in Bone Lake (Figure 6). No large scale treatment (greater than 1 acre) of EWM was conducted in 2021.

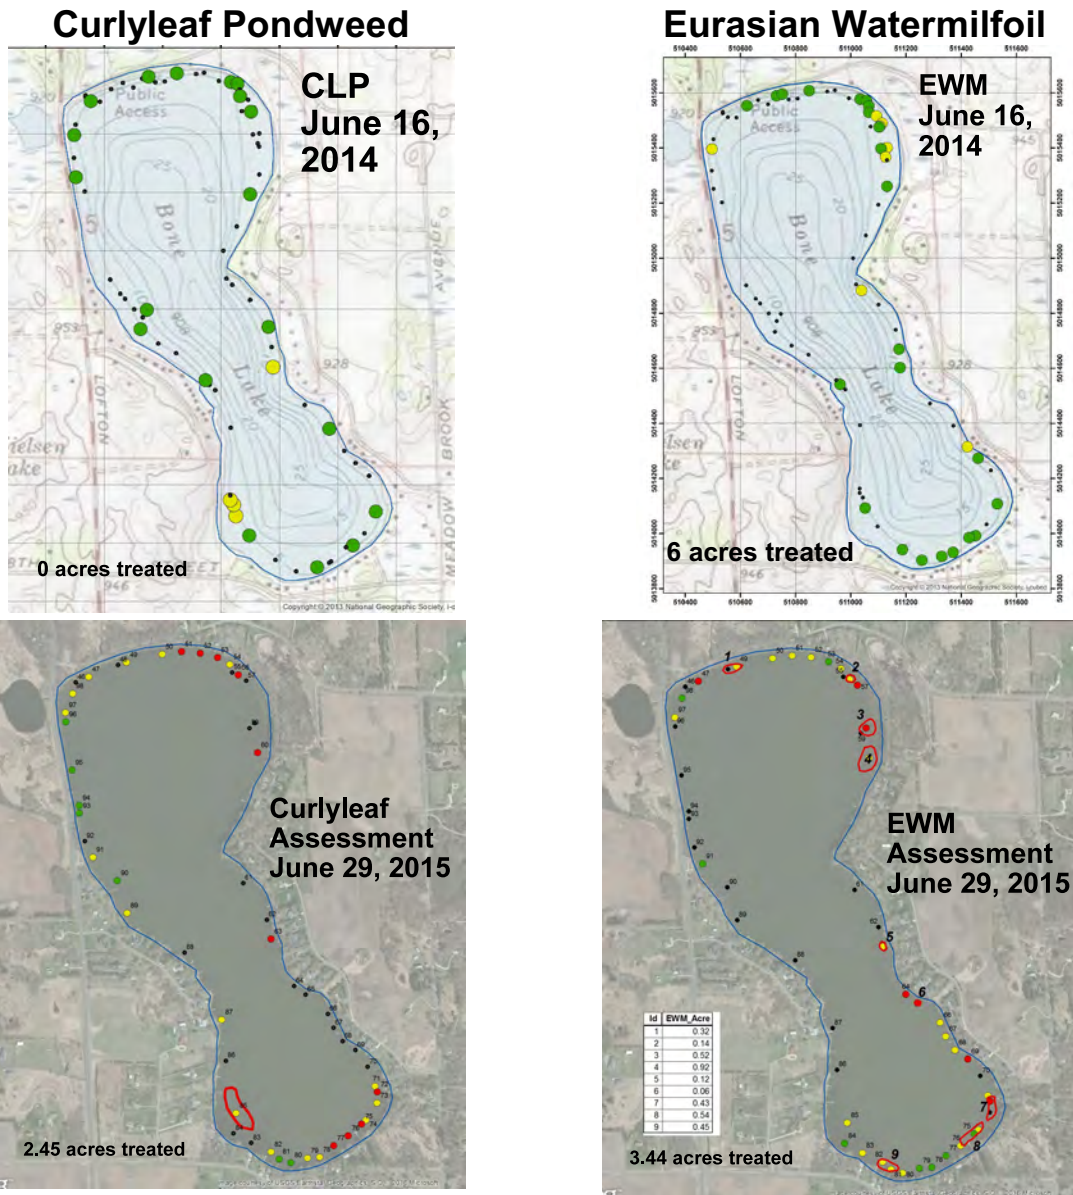
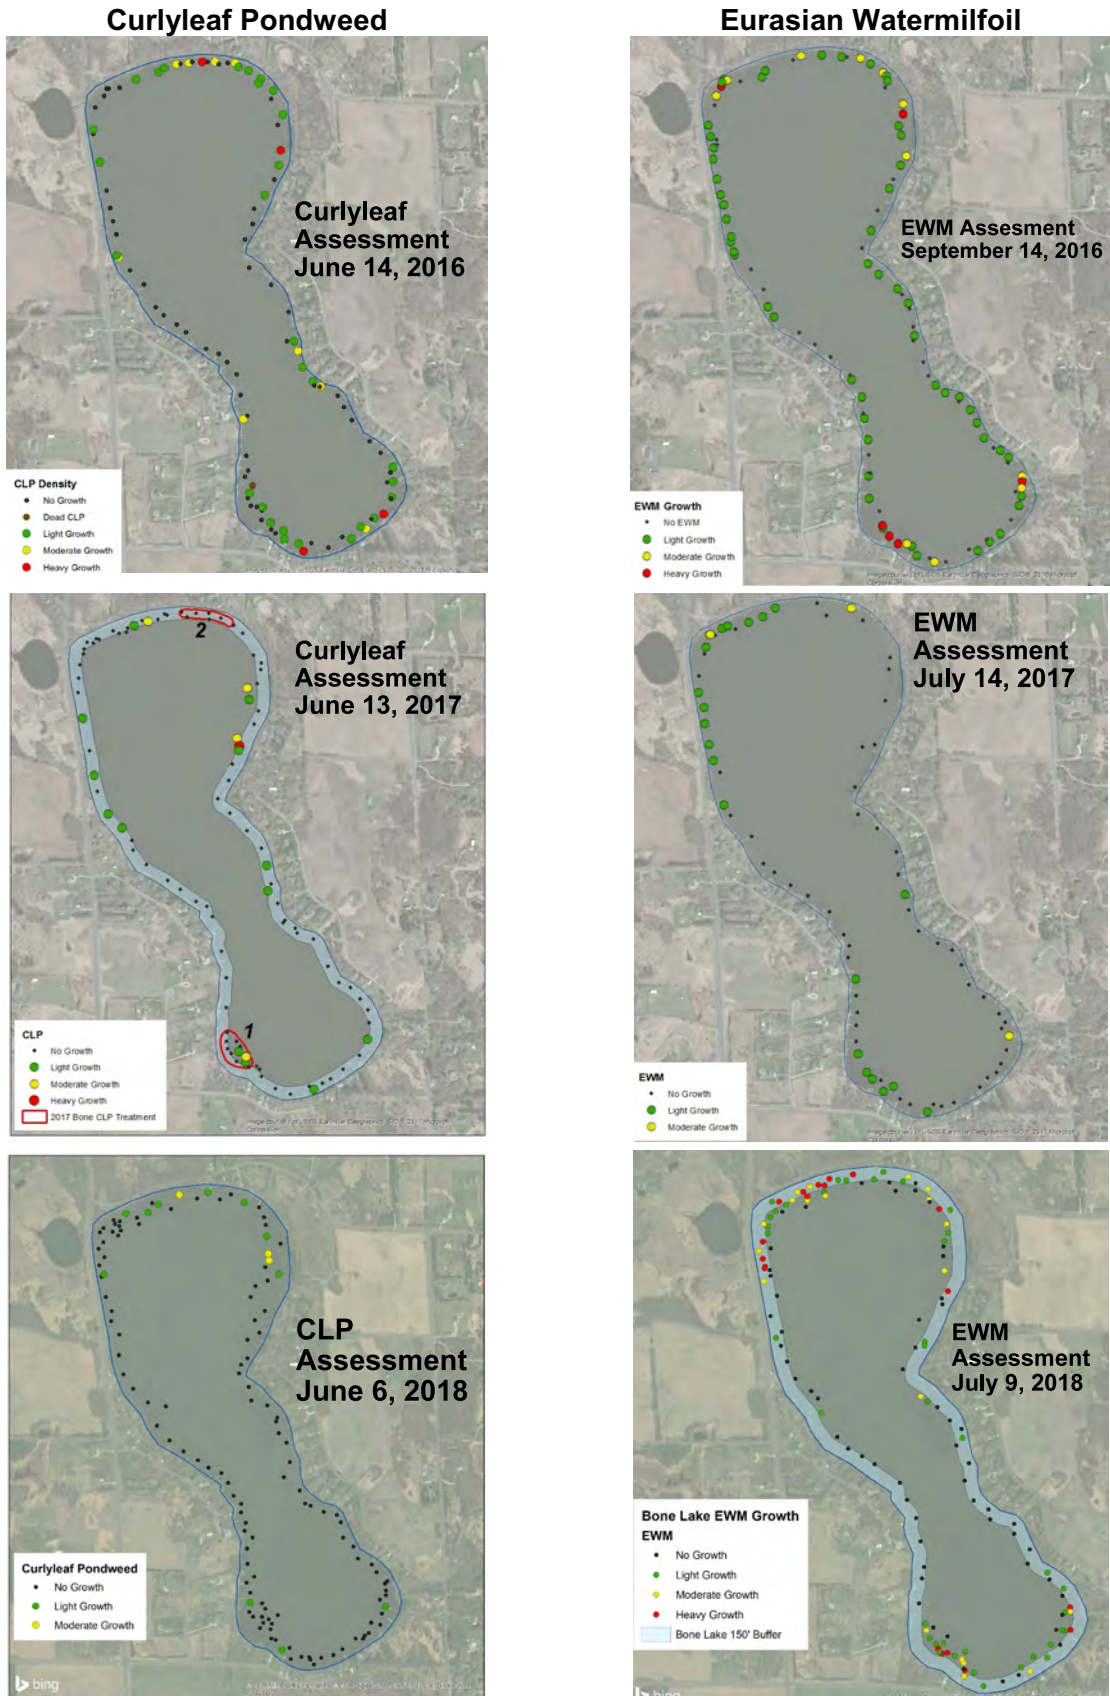
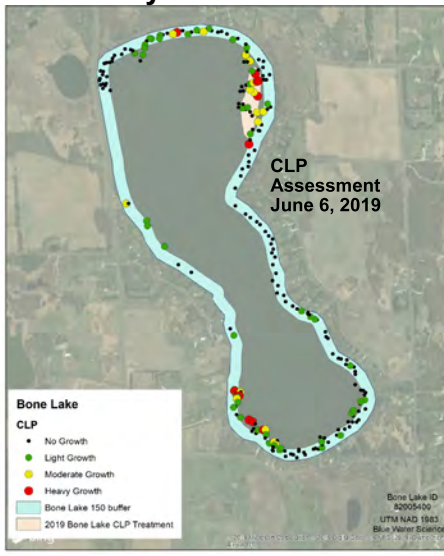
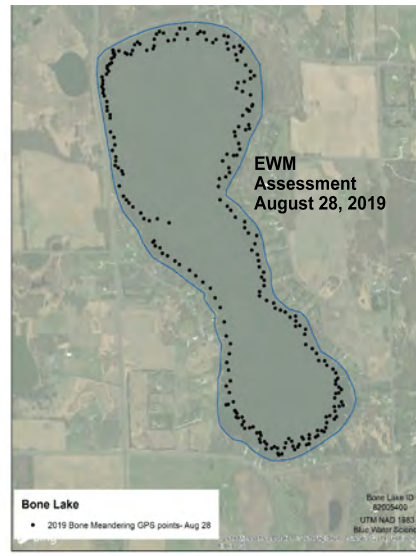
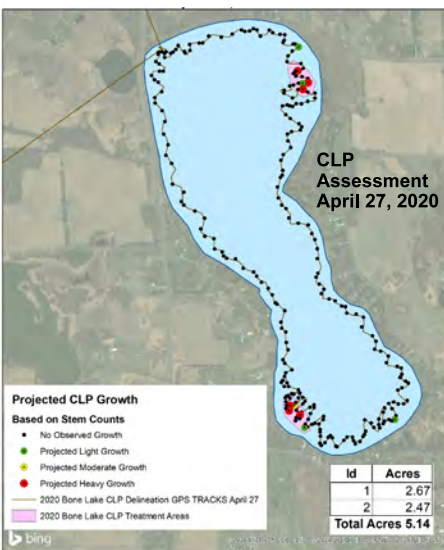
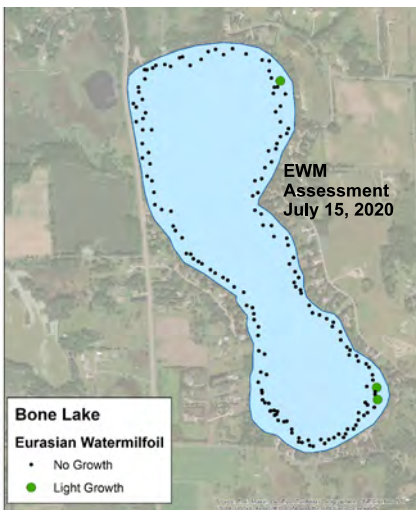
Figure 7. CLP and EWM maps for 2014 through 2020 (continued on the next 2 pages).

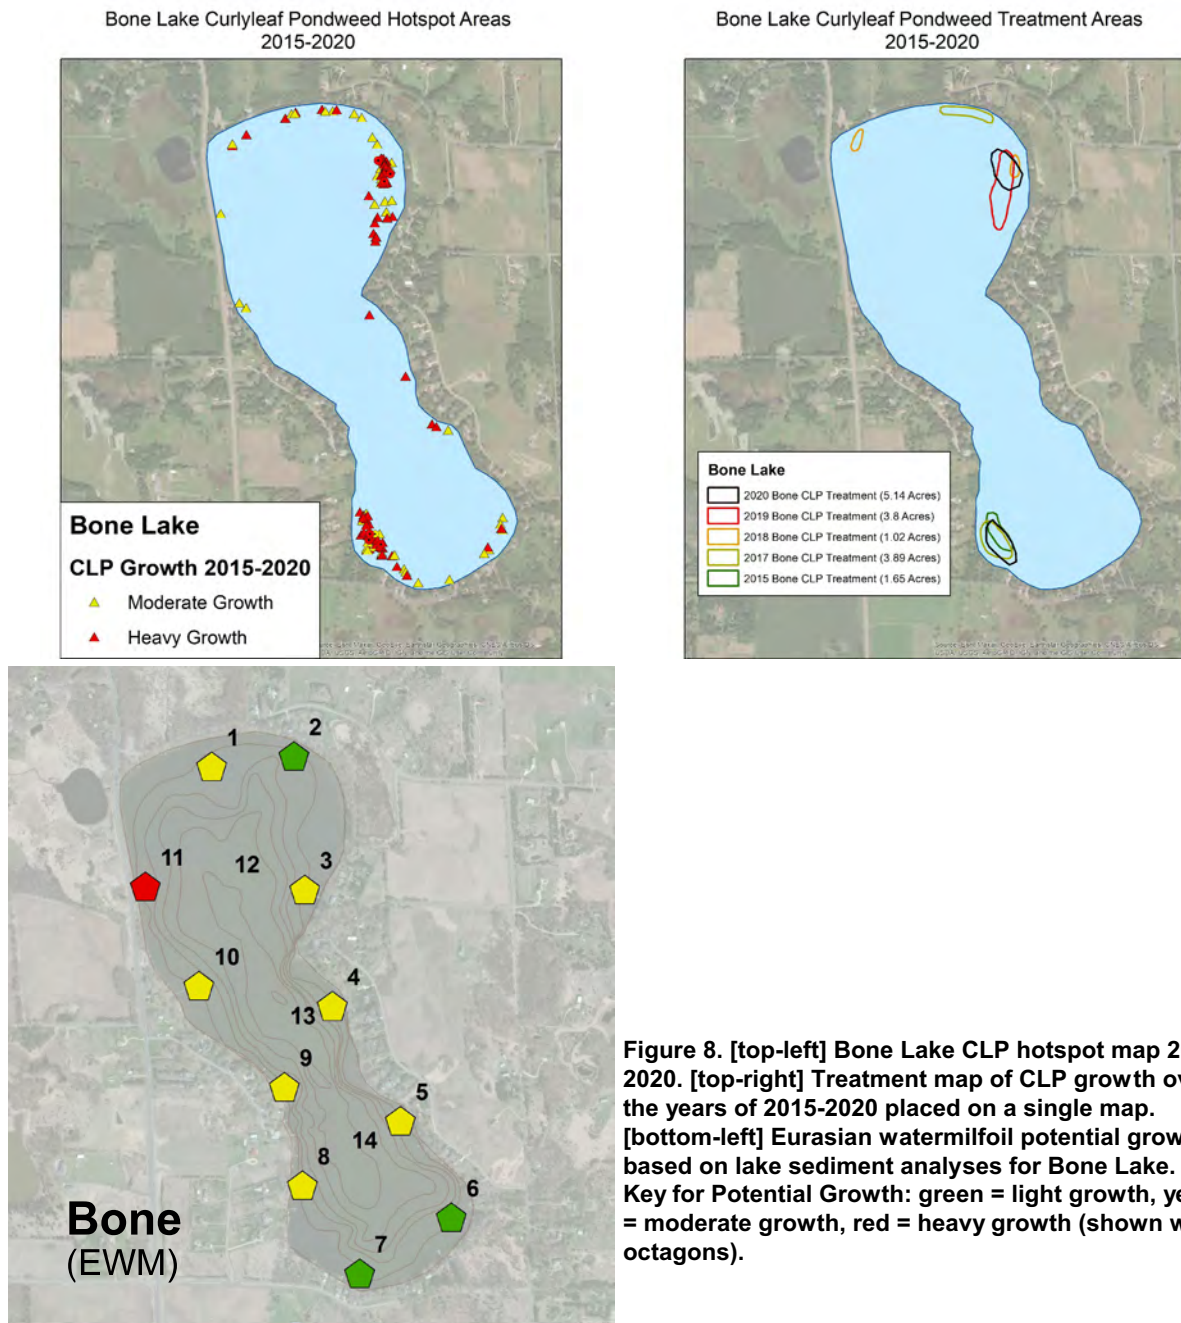
Figure 8. [top-left] Bone Lake CLP hotspot map 2015-2020. [top-right] Treatment map of CLP growth over the years of 2015-2020 placed on a single map. [bottom-left] Eurasian watermilfoil potential growth based on lake sediment analyses for Bone Lake. Key for Potential Growth: green = light growth, yellow = moderate growth, red = heavy growth (shown with octagons).

A summary of CLP treatments from 2015 through 2020 is shown in Figure 8. CLP growth has been variable for the last couple of years. Lake ice, snow cover, and even cloudy days can limit curlyleaf growth. A hotspot map of sites of CLP moderate and heavy growth for 2015 through 2020 is shown in Figure 8. In the last 5 years CLP growth has been most evident in the northern and southern ends of Bone Lake where growing conditions are conducive to heavy plant growth. CLP has typically grown to a water depth of 6 feet or less.

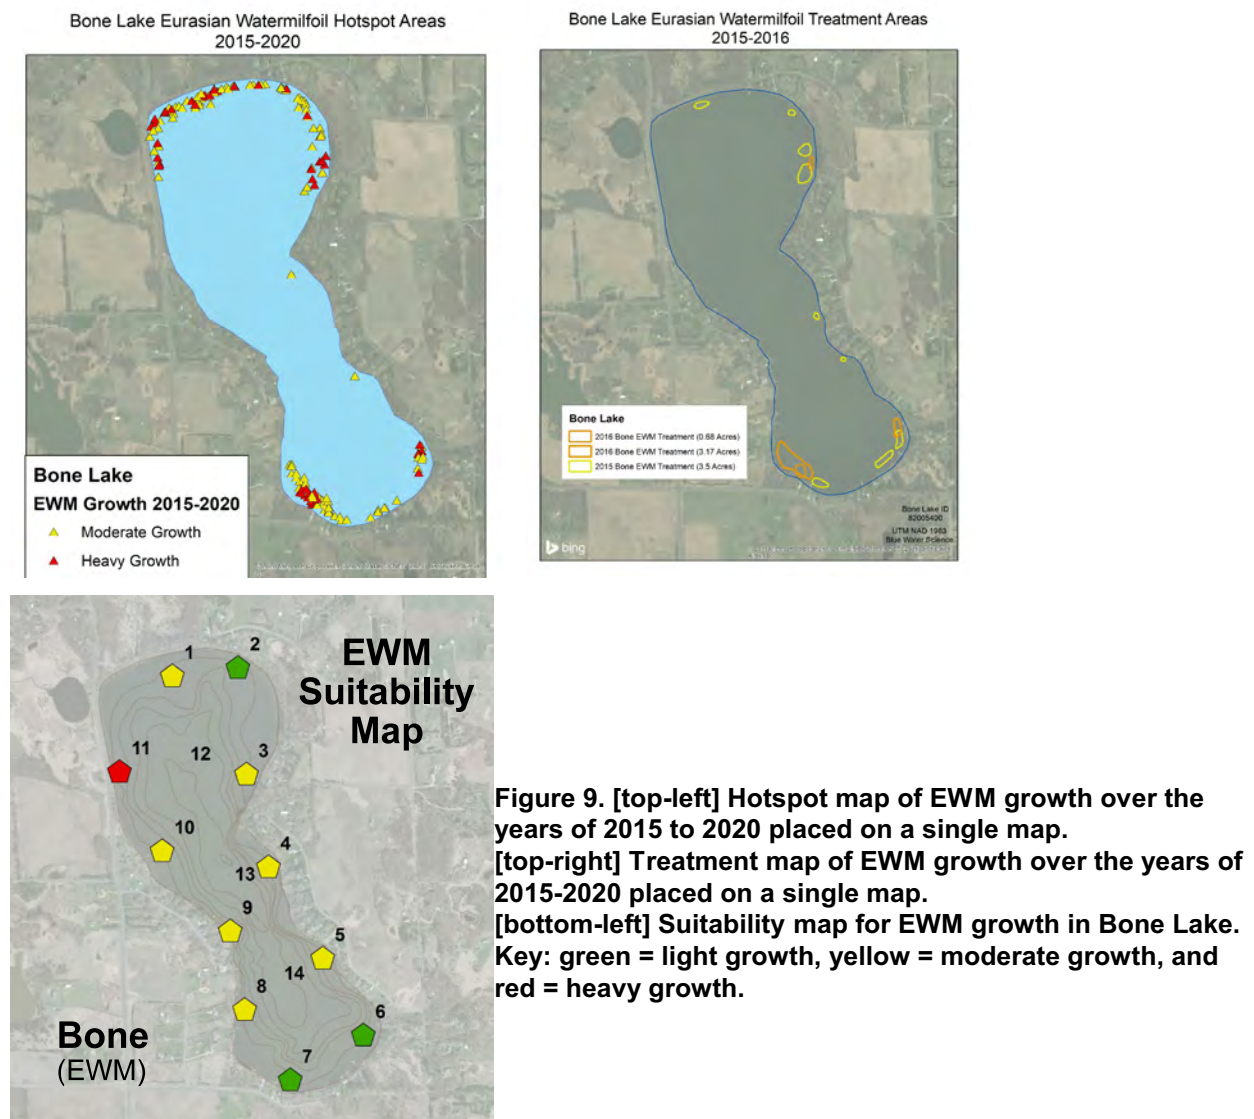
EWM has been in Bone Lake since 2006. Although control of EWM has been ongoing since 2006, EWM continued to expand around the lake. A map showing the occurrence of moderate to heavy growth of EWM in Bone Lake from 2015 through 2020 is shown in Figure 9. Some nearshore areas in the north and south ends of Bone Lake support consistently significant growth. These “hotspot” areas are shown in Figure 9.

Heavy milfoil growth has been correlated with high sediment nitrogen conditions and from a soils survey conducted in 2014, Bone Lake has at least 1 area with high lake sediment nitrogen conditions. The potential for long term milfoil growth, based on lake sediment sampling, predicts mostly moderate growth with the potential for annual heavy growth limited to the northwest side of Bone Lake.

For Bone Lake, it is estimated the plants have the potential to grow down to at least 7 feet of water depth based on low Secchi transparencies, restricting milfoil growth to nearshore areas. Results of the sediment survey indicate growth would be primarily light on a long term basis.
