## Curlyleaf Pondweed and Eurasian Watermilfoil Delineation, Treatment, and Assessment for Comfort Lake, Chisago County, 2017

**Prepared for:**  
Comfort Lake/Forest Lake  
Watershed District  
Forest Lake, Minnesota

**Prepared by:**  
Steve McComas  
Jo Stuckert  
Blue Water Science

**March 20, 2018**

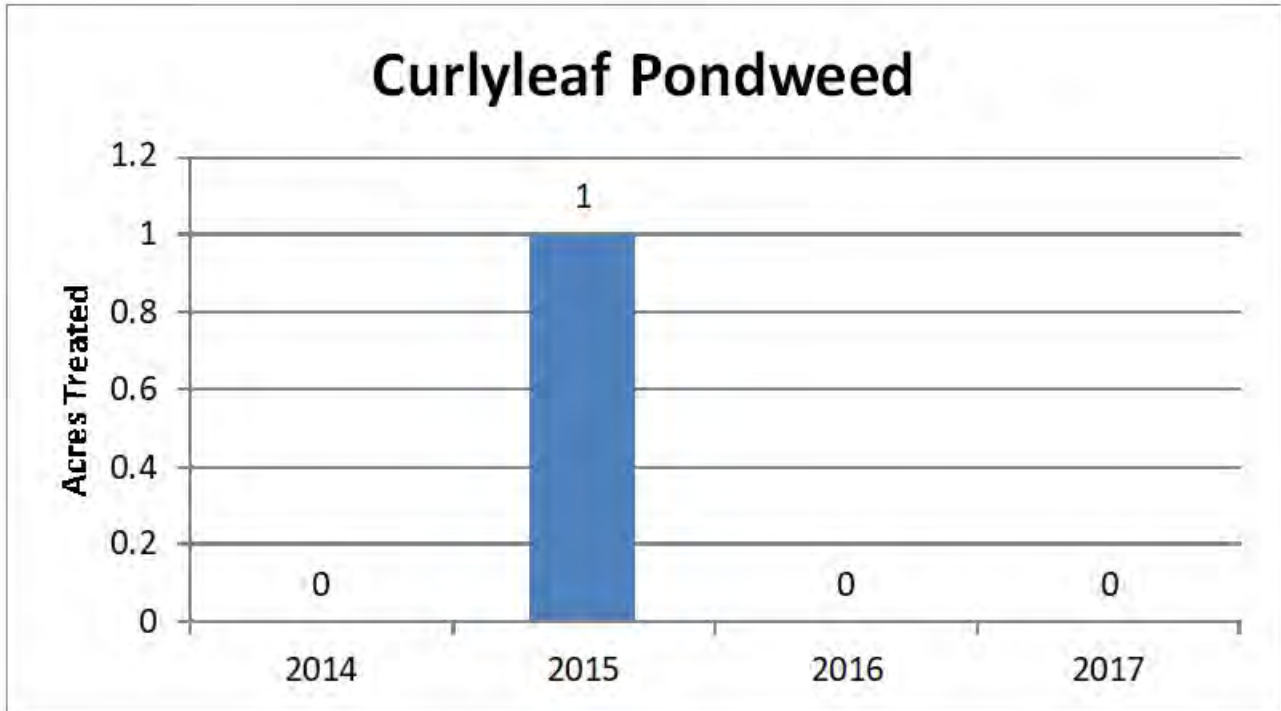
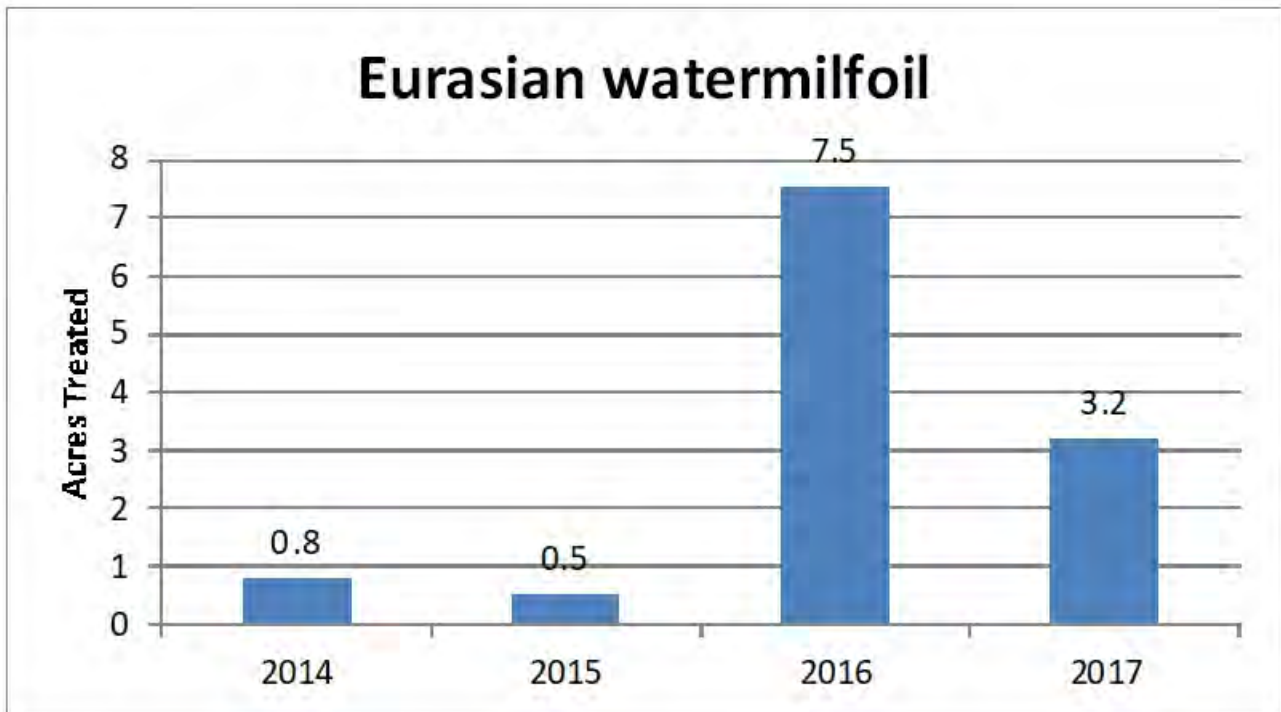
Figure S3. [top] Curlyleaf pondweed treated in 2014-2017. [bottom] Eurasian watermilfoil treated in 2014-2017.

**Curlyleaf Pondweed and Eurasian Watermilfoil Treatments from 2014 Through 2017:** A summary of curlyleaf pondweed and milfoil treatments from 2014-2017 is shown in Figure S3. Curlyleaf was only treated at 1 acre in 2015. Curlyleaf has been sparse in Comfort Lake. EWM was first observed in 2014 and it has spread around the lake in the last 3 years. A total of 7.5 acres was treated in 2016 and although 3.2 acres were treated in 2017, several acres were delineated but not treated. EWM is still new in Comfort Lake and may expand further in the next few years.

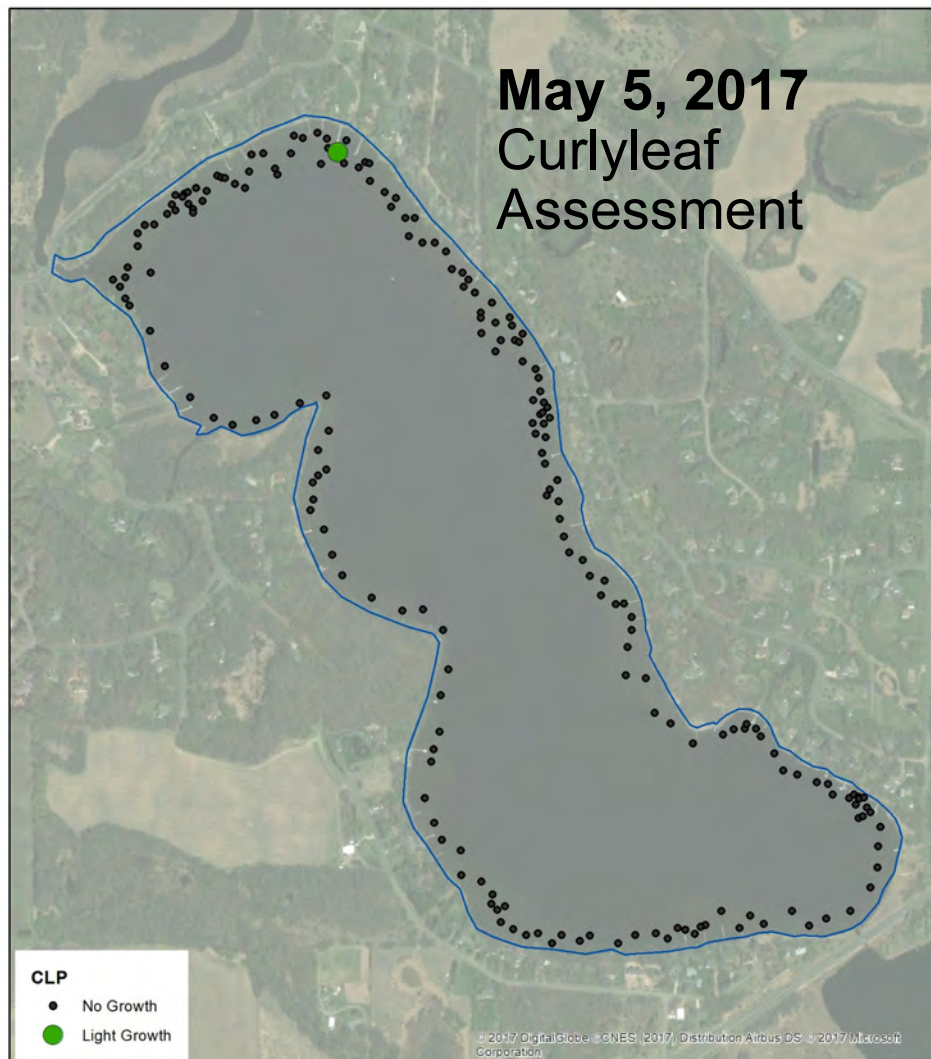
A CLP assessment was conducted on May 5, 2017 and a total of 200 sites were assessed with rake sampling. Curlyleaf was found at 1 sample site with light growth out of the 200 sites that were monitored (Figure 2). No CLP treatment occurred in 2017 and no significant CLP growth occurred in the spring.

**Figure 2. Map of curlyleaf distribution in Comfort Lake on May 5, 2017.  
Key: black dots = sample locations and green dots = light growth.**

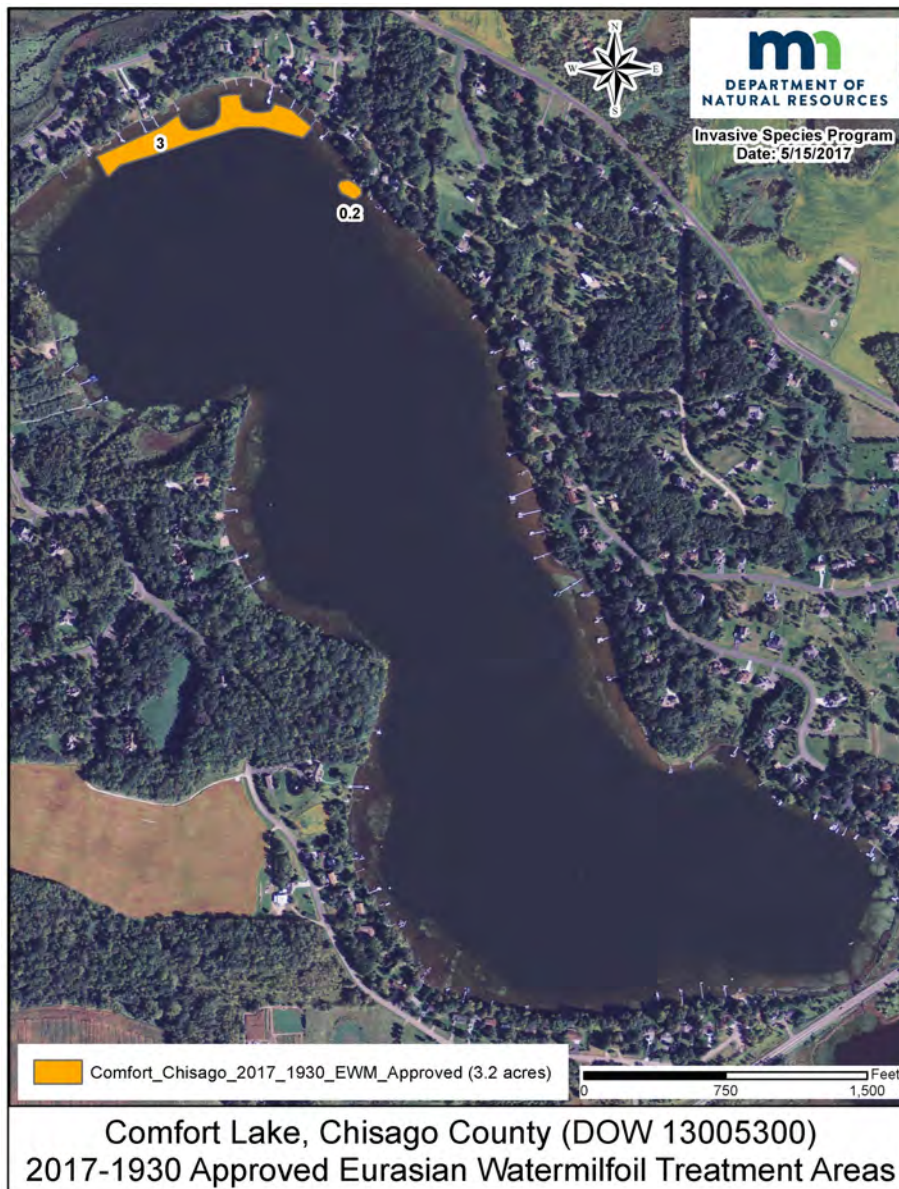
However once the MnDNR inspected the proposed treatment areas it was determined that the lily growth may be impacted by the herbicides and the treatment areas were reduced to 2 sites totaling 3.2 acres (Figure 5). The 2 areas were treated with a 2,4-D herbicide (trade name: DMA-4) with 17.04 gallons applied in the 3 acre area and 1.14 gallons in the 0.2 acre area.

Figure 5. MnDNR approved treatment map of 3.2 acres of EWM were treated on May 24, 2017.

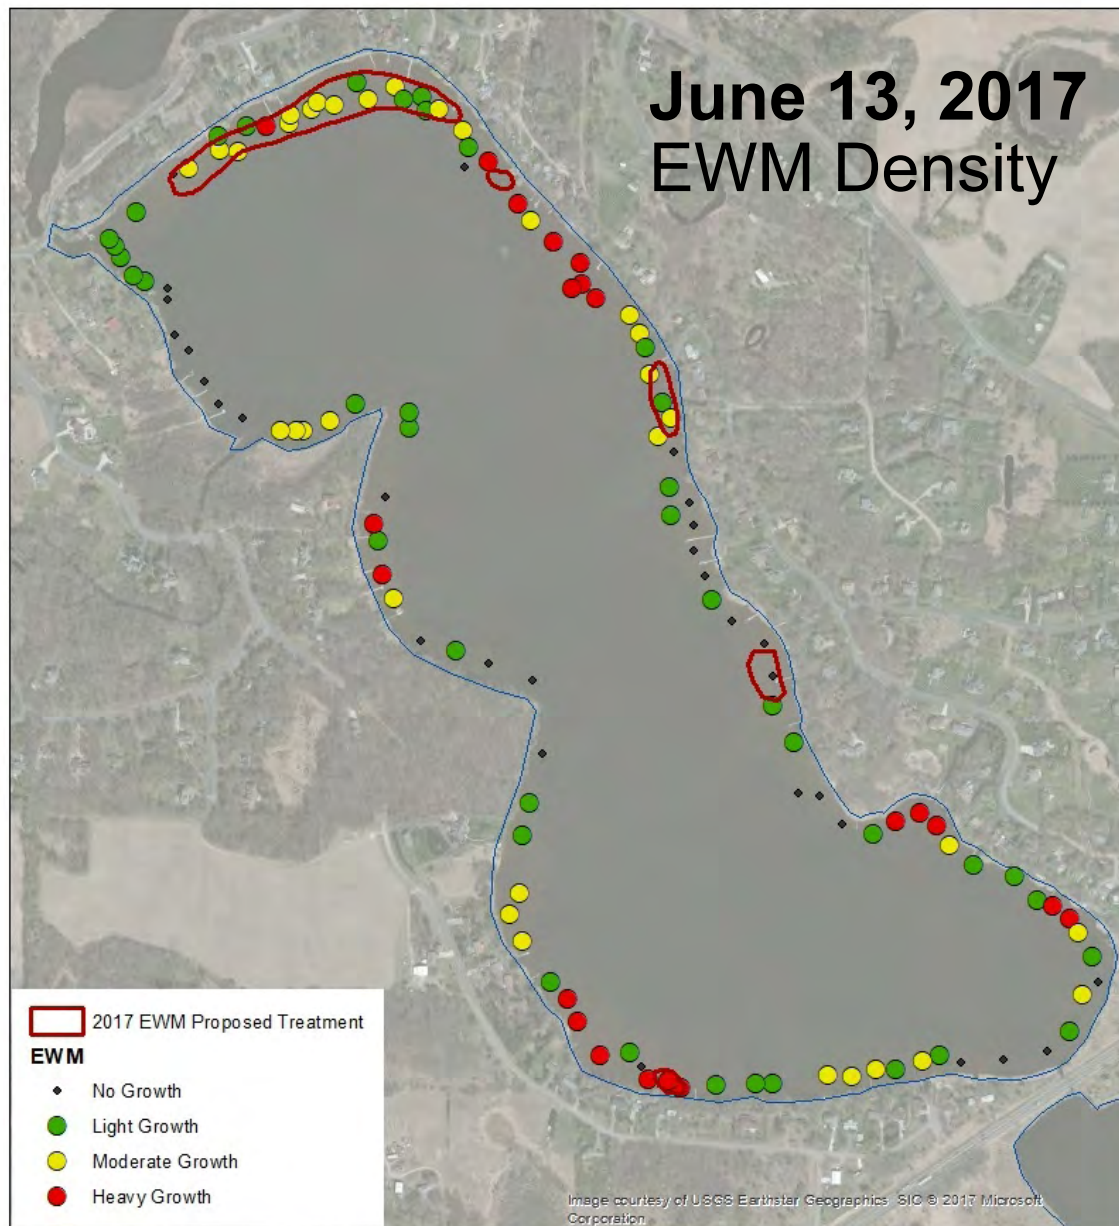
After treating 3.2 acres of EWM on May 24, an EWM assessment consisting of 124 points was conducted using rake sampling on June 13, 2017 (Figure 6). The treatment effectiveness in the 2 areas totaling 3.2 acres was fair, with light to moderate EWM growth still observed within the treatment area on the north end of Comfort Lake (Figure 6). Outside of the treatment areas, heavy EWM growth was found on the NE side and the southern end of Comfort Lake. Eurasian watermilfoil was found at 94 out of the 124 sample sites on June 13, 2017.

Figure 6. ASSESSMENT: Map of EWM sites for June 13, 2017.

Key: black dot = no EWM, green dot = light growth, yellow dot = moderate growth, and red dot = heavy growth.

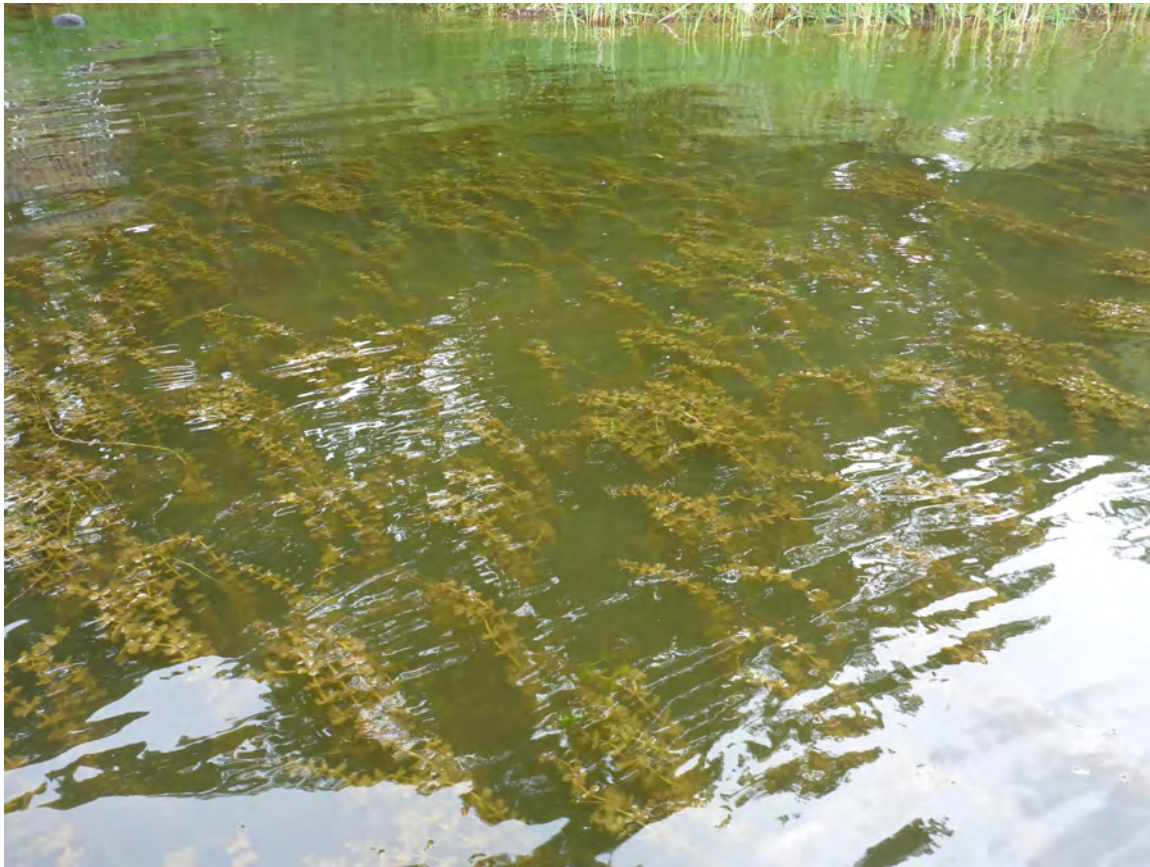
Curlyleaf pondweed growth has been light from 2014 through 2017. Only 1 acre of CLP has been treated in the last 4 years. EWM growth was heavier in 2017 compared previous years even though less acreage was treated in 2017 compared to 2016 (Figures 7 and 8).

**Figure 7. EWM in Comfort Lake in June 2017.**

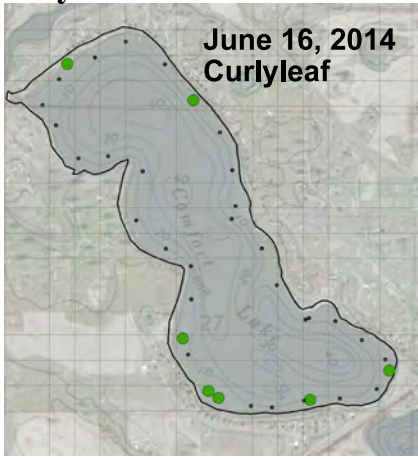
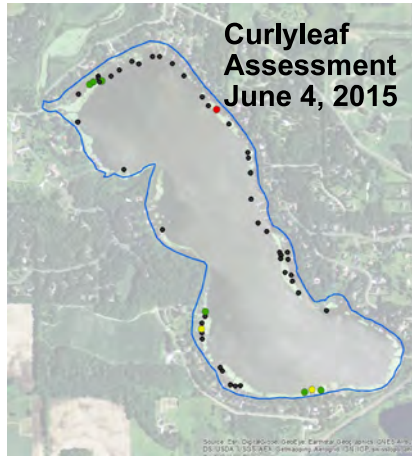
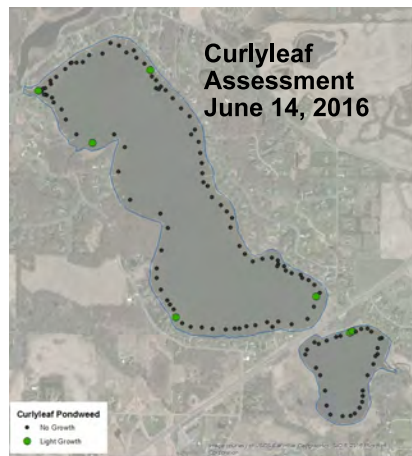
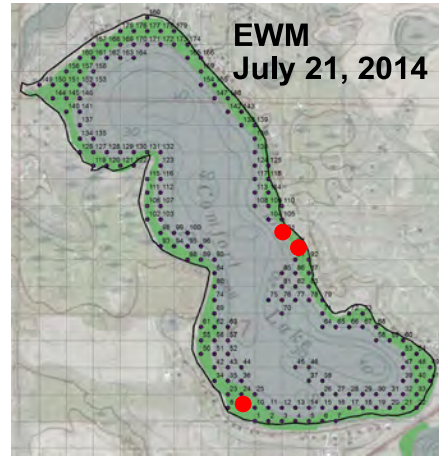
Figure 8. Curlyleaf pondweed and Eurasian watermilfoil maps for 2014, 2015, 2016, and 2017.

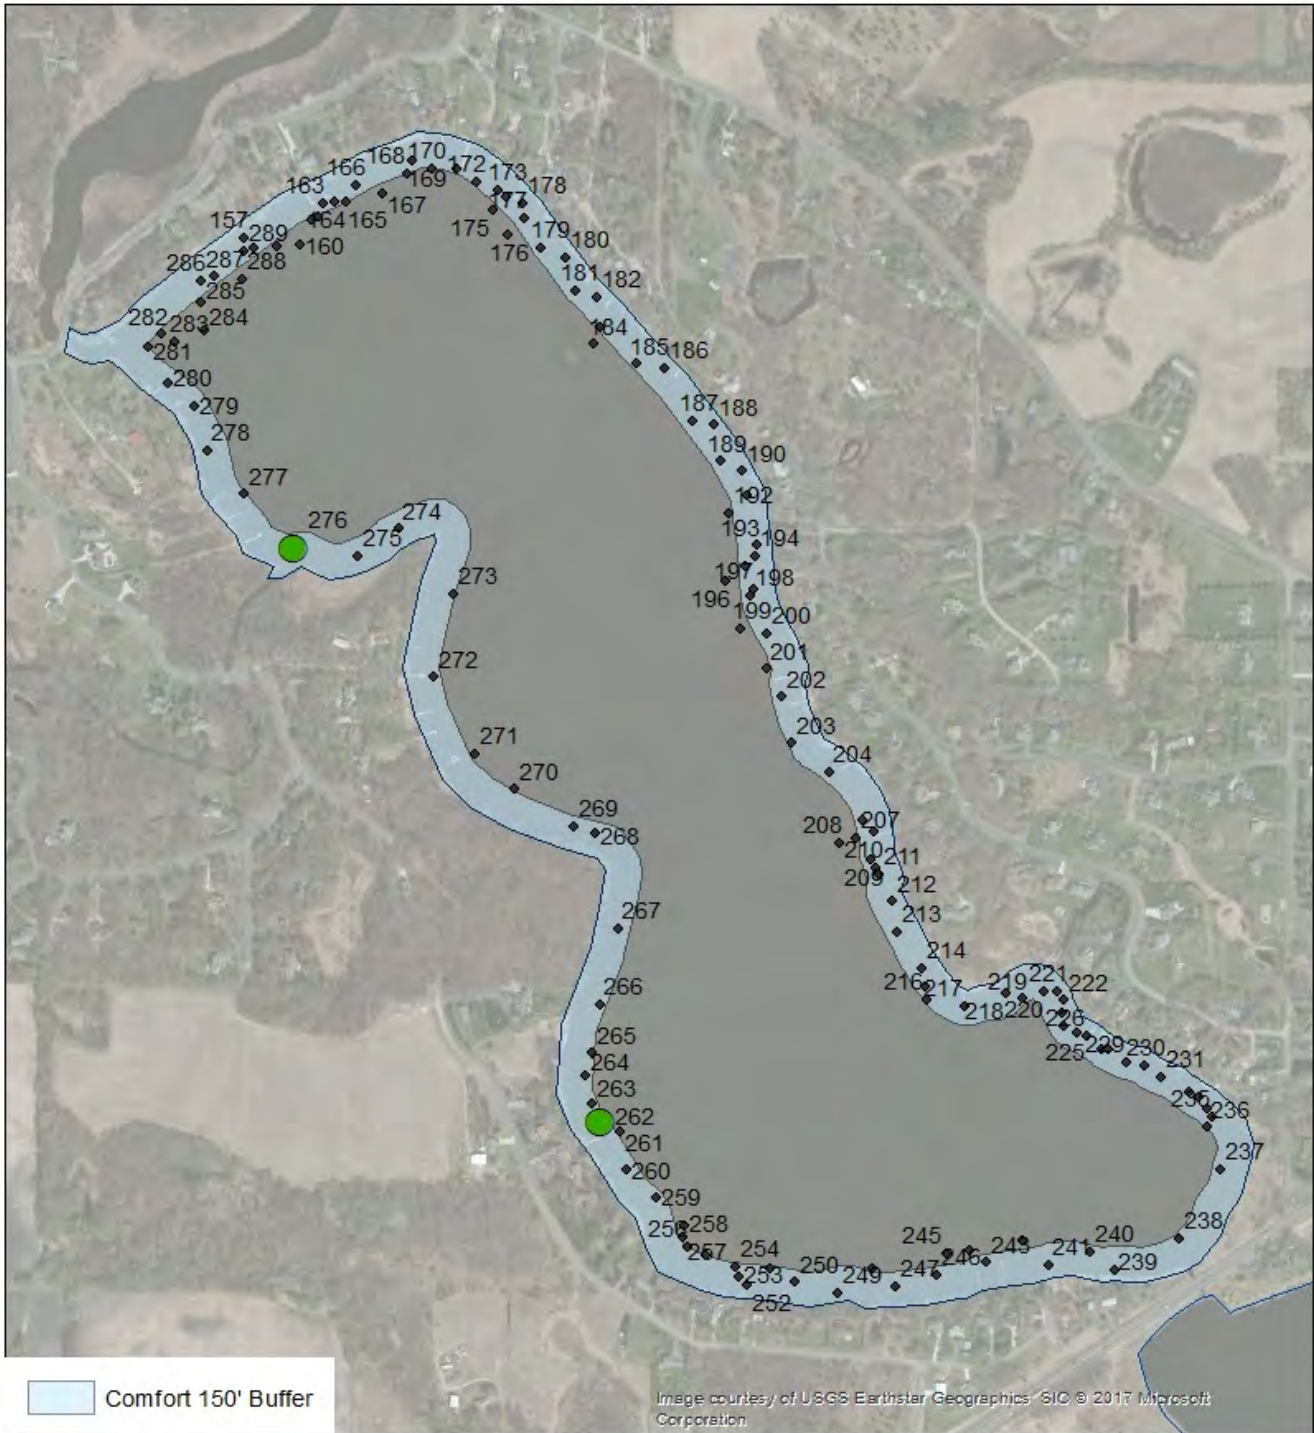
# Comfort Lake CLP

April 21, 2017

A CLP delineation was conducted using rake sampling on April 21, 2017, 133 sites were examined. At this time of the year curlyleaf was found at 2 sample sites in Comfort Lake (Figure 1). No CLP treatment was conducted in 2017.

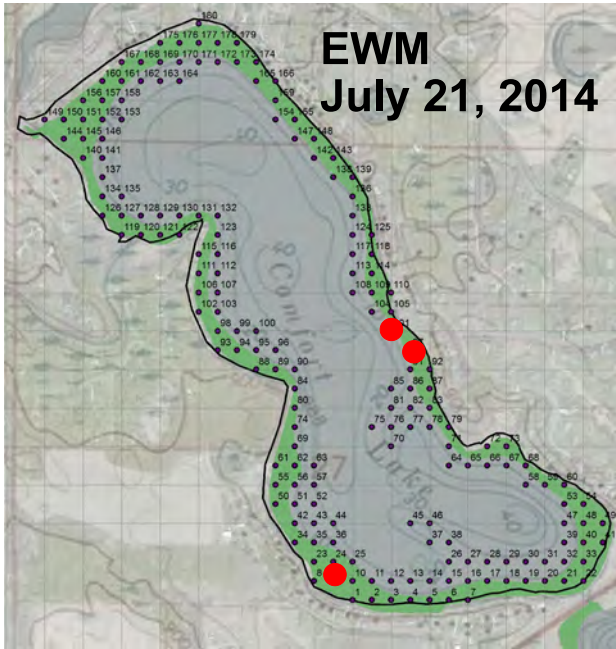
During the point-intercept survey on July 21, 2014, Eurasian watermilfoil (EWM) was identified at three sites (Figure 7a). EWM was verified by the MnDNR on August 6, 2014 at 13 sites (Figure 7b). Due to the lateness of the season, only the EWM area at the public access was treated (Figure 7c). EWM will be monitored in the next few years to characterize distribution and abundance.

**EWM locations (red dots) on the July 21, 2014 point-intercept survey.**

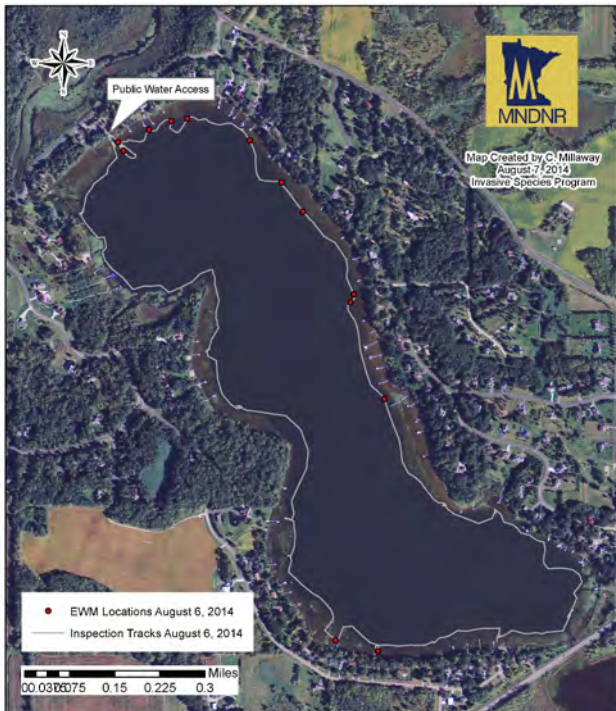
Comfort Lake, Chisago County (13005300)  
Eurasian watermilfoil Inspection: August 6, 2014  
Invasive Species Program

**EWM delineation by MnDNR.**

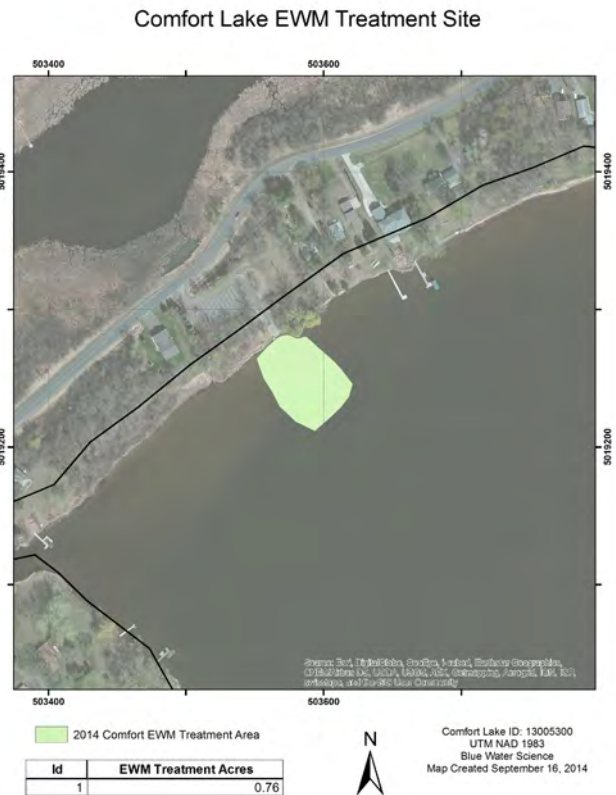
**EWM treatment area in front of the public access.**
