Flowering Rush Delineation, Control, and Assessment for Forest Lake, Washington County, Minnesota, 2016

Delineation: July 14 and 15, 2016
Herbicide Treatments on 36 acres: August 3 and 31, 2016
Assessment: September 21, 2016

Prepared for:
Washington County and
Comfort Lake/Forest Lake
Watershed District

Prepared by:
Steve McComas
Blue Water Science

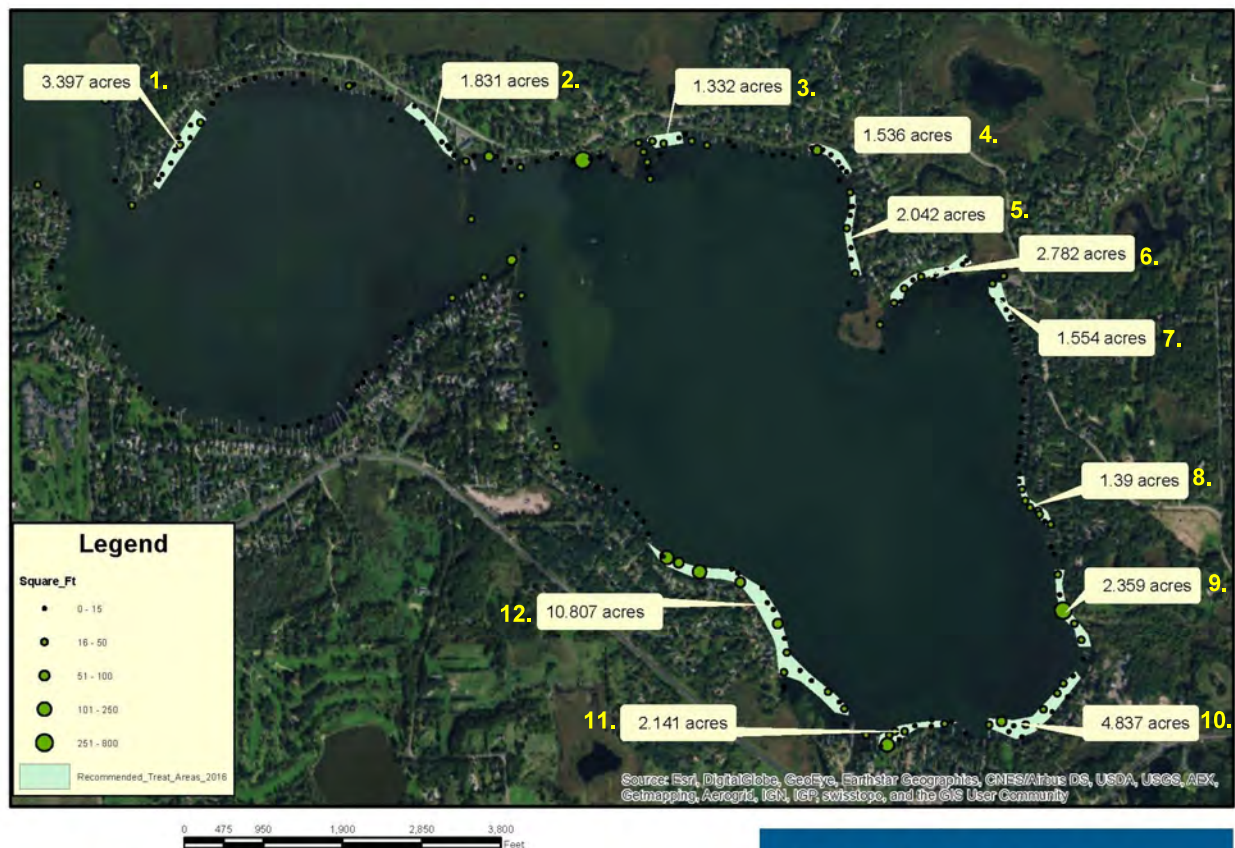
Figure S2. Flowering rush treatment areas for August 3, and 31, 2016.

A total of 36 acres of flowering rush in 12 treatment areas was treated with diquat on two occasions on August 3 and August 31, 2016. Although the area of flowering rush did not total 36 acres, previous treatment research in the Detroit Lakes area found treating large areas was more effective than treating small, individual patches. The applicator delineated the large areas to be treated. A number of small patches were treated as well.

**2016 Flowering Rush Treatment
Forest Lake Lake, Washington County
Acres: 36**

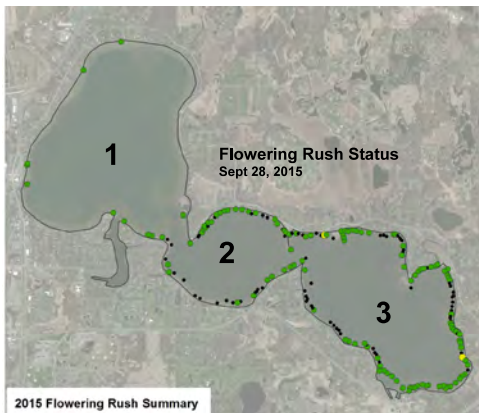
Figure 4b. Flowering rush sites and relative abundance in 2015. Black dots = no flowering rush, green dots = 10-500 sf, yellow dots = 500-2,000 sf, and red dots = 3,000 to 50,000 sf. Estimated flowering rush area in September 2015: 4,411 sf.

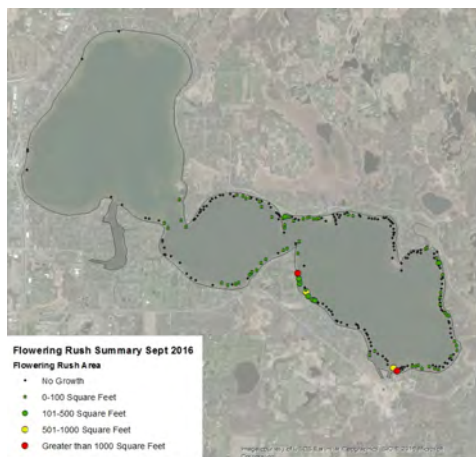
Figure 4c Flowering rush sites and relative abundance in 2016. Black dots = no flowering rush, green dots = 10-500 sf, yellow dots = 500-2,000 sf, and red dots = 3,000 to 50,000 sf. Estimated flowering rush area in September 2016: 9,183 sf.

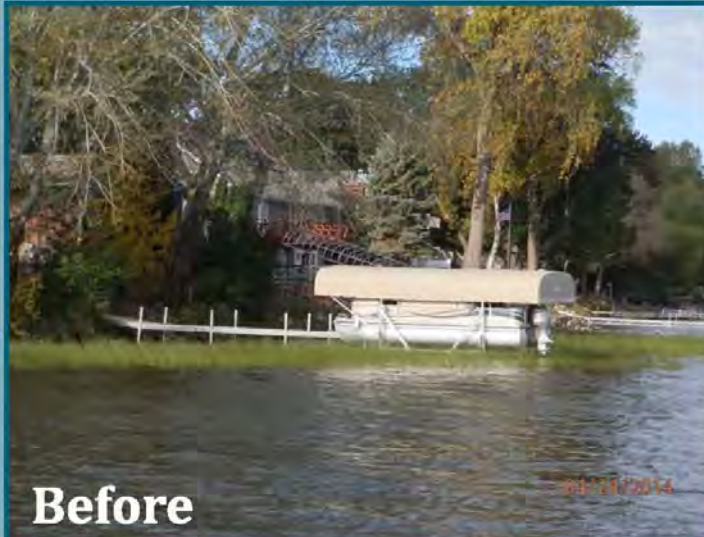
Photo right: Flowering rush growing in large dense patches on the south side of Forest Lake east basin (3rd Lake). Photo was taken in April 2014.

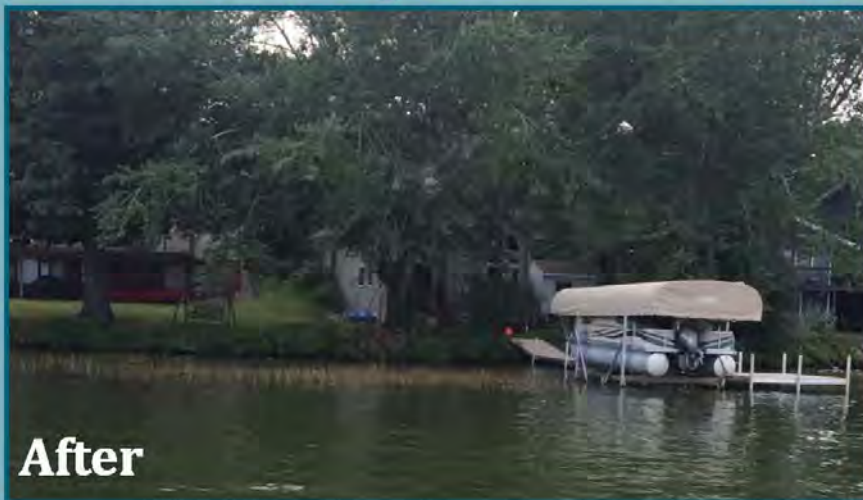
Photo left: Patch of flowering rush on 3rd Lake after herbicide treatment. Photo was taken in August 2015.

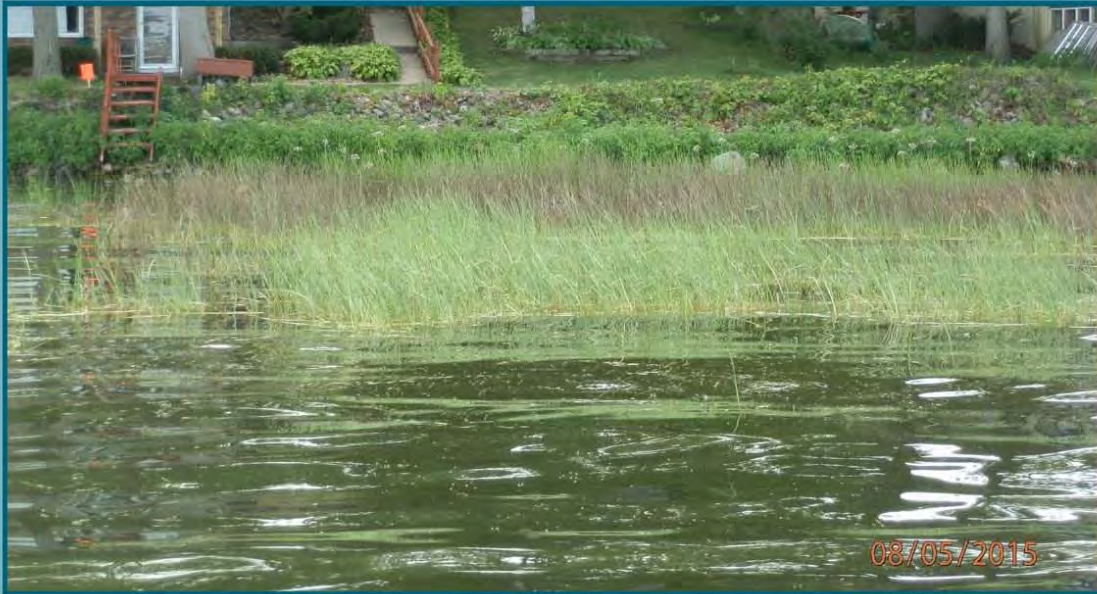
Photo top: Flowering rush 2 days after herbicide treatment, some portions starting to turn brown and die.

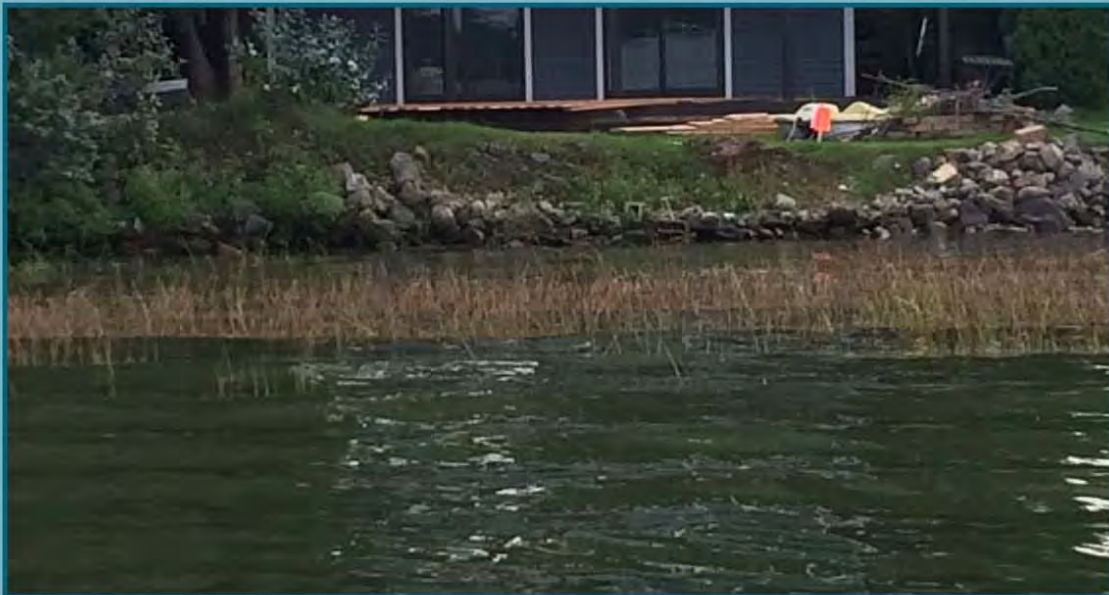
Photo bottom: Flowering rush 10 days after herbicide treatment. Entire patch is brown, withering and dying or already dead.

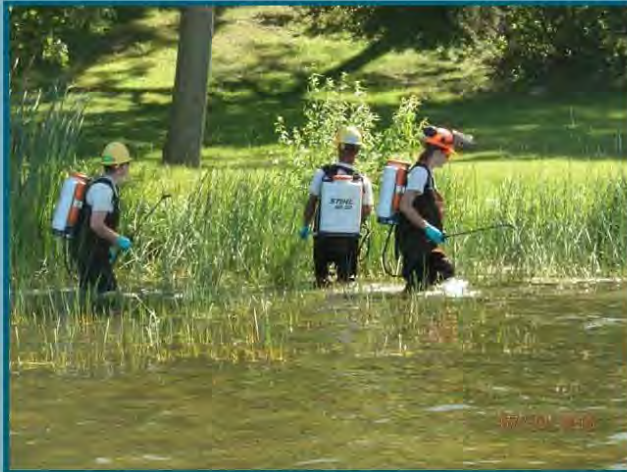
Photo right: MCC crew spraying small patches along the shoreline using backpack sprayers.

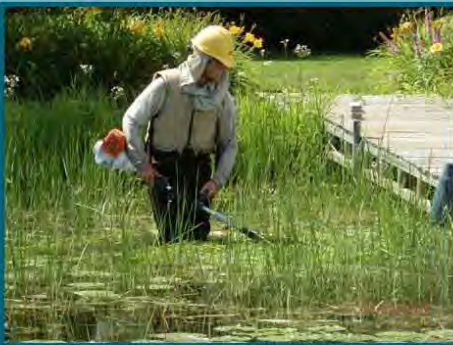
Photo bottom: MCC crew member using mechanical cutting device to manually cut flowering rush stems. Cutting the stems just below the water line cuts off the plant's access to oxygen, eventually causing it to die.

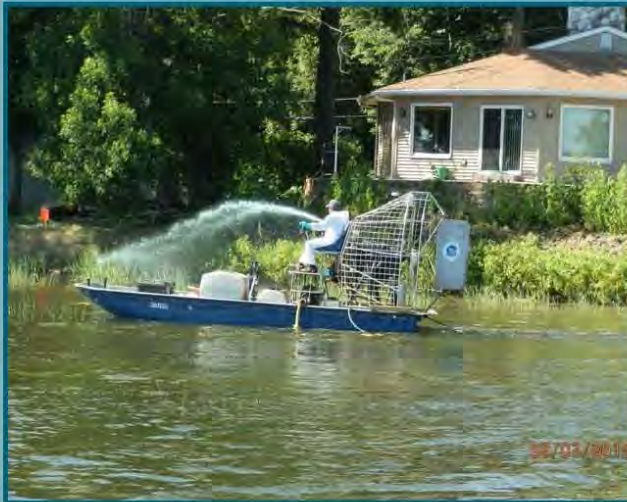
Photo right: Herbicide treatment of large patches. The herbicide that was used is called Tribune and the active ingredient is Diquat. During the first round, large patches were treated with herbicide. During the second round, entire shorelines on 3rd Lake were treated. This change was recommended by the herbicide applicator based on his recent experiences treating other lakes.

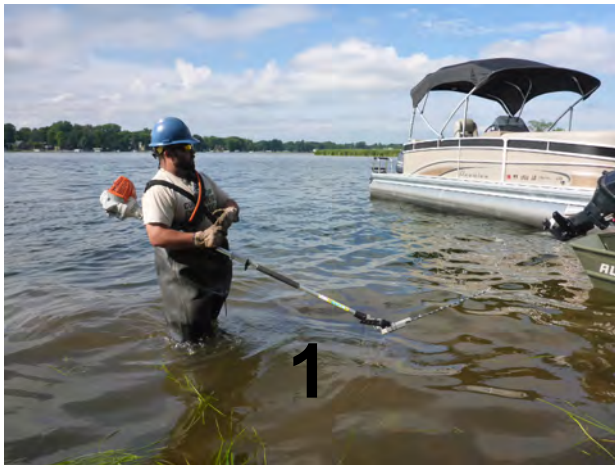
[top-left] A hand held brush cutter was the primary cutting tool.

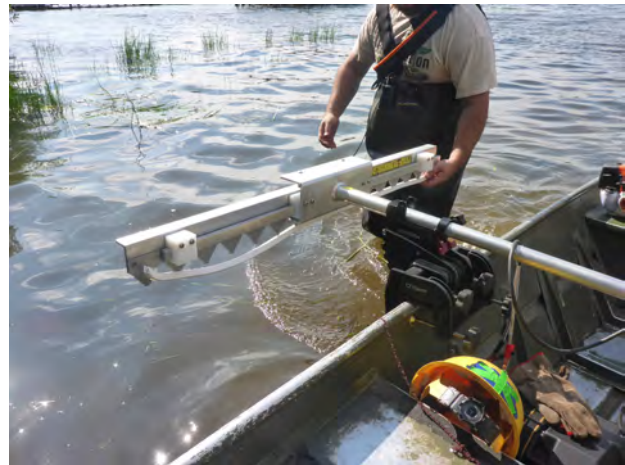
[top-right] A boat mounted aquatic plant cutter was also used in water 3 feet and deeper.

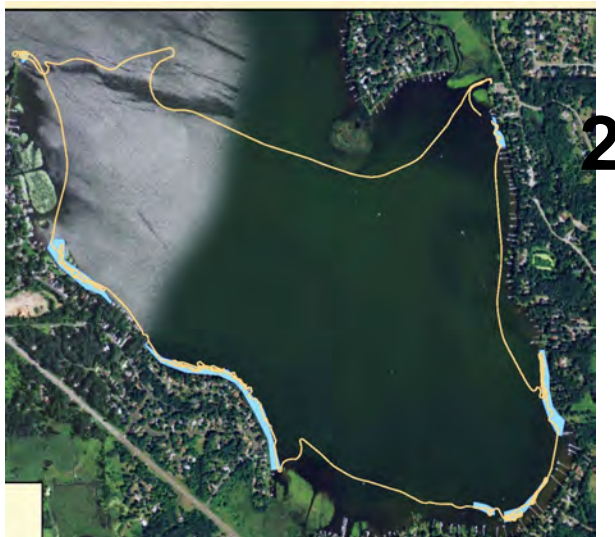
[bottom-left] The second herbicide treatment areas on August 26, 2015 covered 13.17 acres.

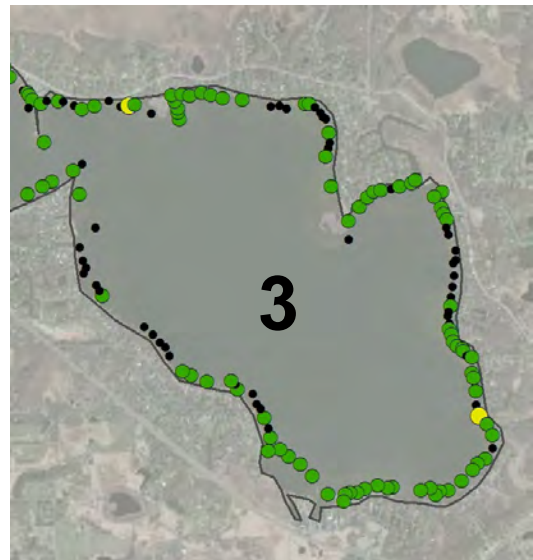
[bottom-right] Herbicide treatment was effective with small scattered patches of flowering rush remaining after the treatments. Approximately 98% of the flowering rush was controlled.
