## **Curlyleaf Pondweed Delineation and Assessment And a Point Intercept Survey for Moody Lake, Chisago County, Minnesota, 2015**

**Comfort Lake/Forest Lake  
Watershed District  
Forest Lake, Minnesota**

**Steve McComas  
Jo Stuckert  
Blue Water Science**

**January 26, 2016**

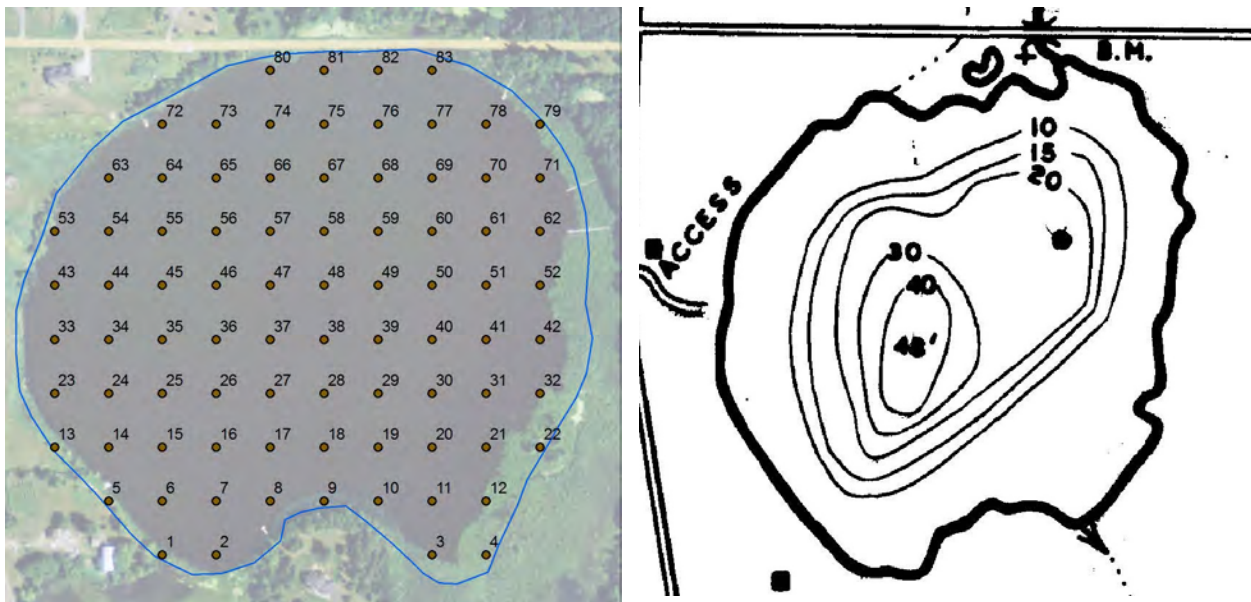
Figure 3. [left] Point locations for the aquatic plant surveys. Lake map with UTM coordinates using the NAD1983 datum. [right] MnDNR contour map.

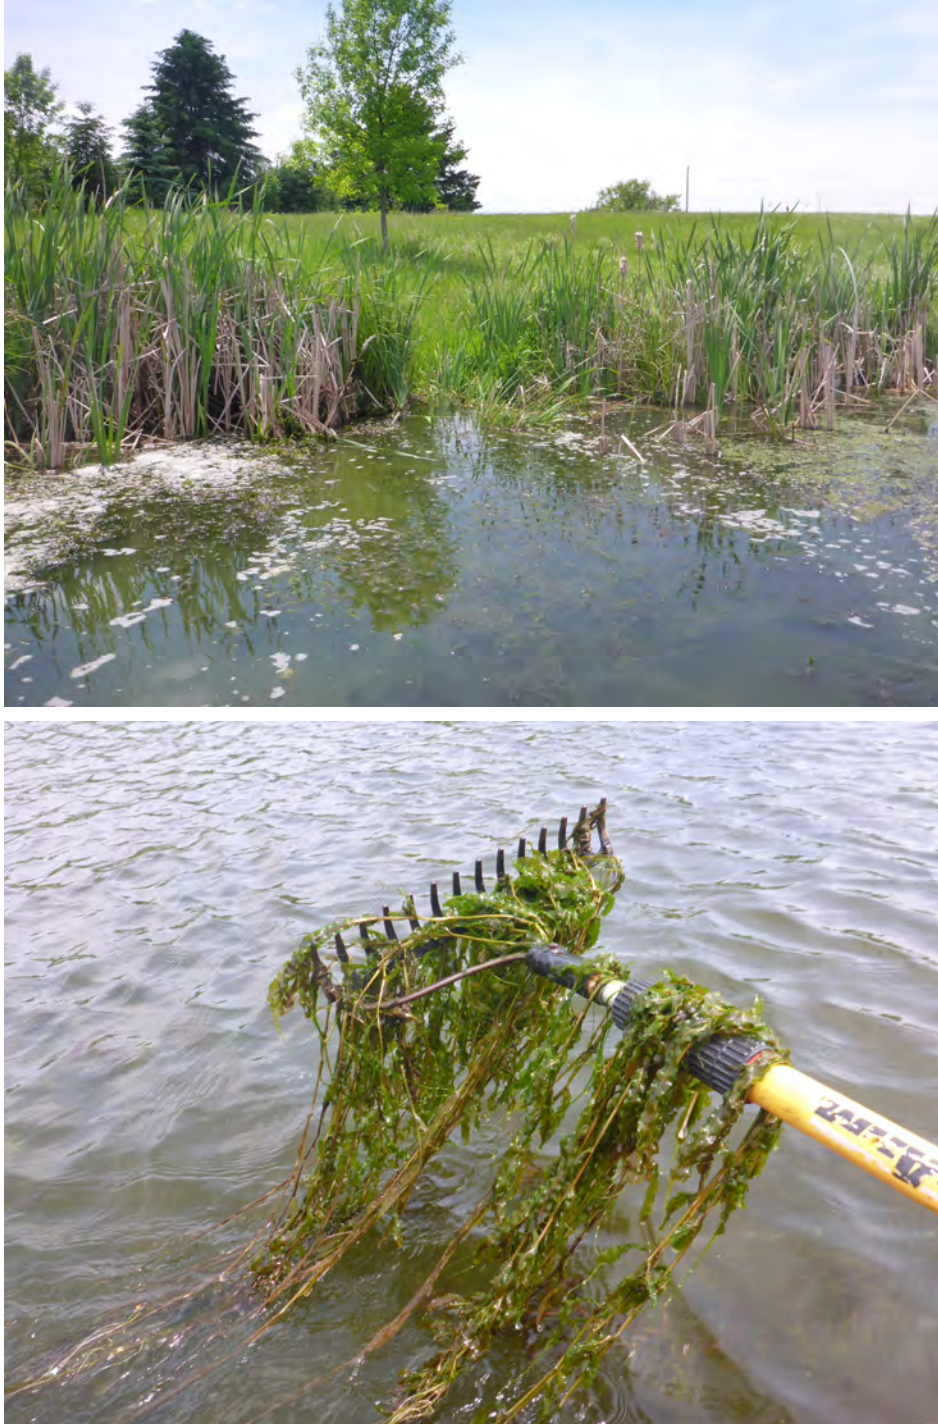
Curlyleaf pondweed was distributed around the perimeter of Moody Lake and covers much of the nearshore area. In June of 2015, curlyleaf was found to grow at a moderate to heavy densities (Figure 6). In a few areas, curlyleaf was found at light densities.

**Figure 6. (top) Curlyleaf pondweed in Moody Lake was reaching the surface in a few locations close to shore on June 2, 2015.  
(bottom) Curlyleaf pondweed was still growing in June 2015.**

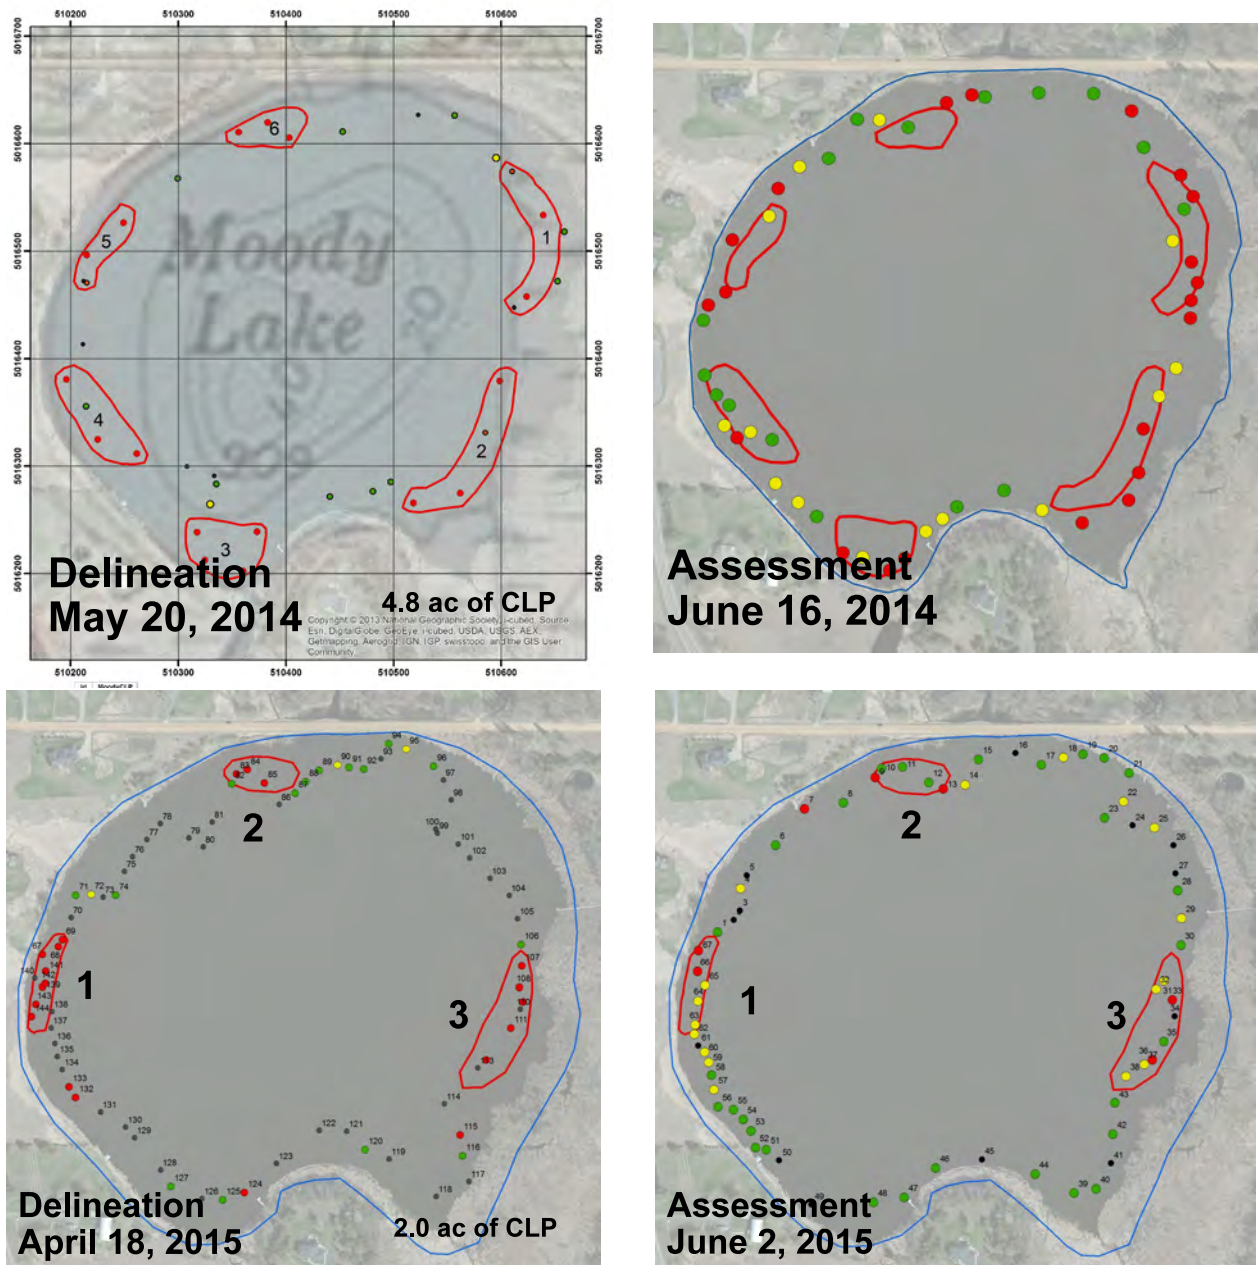
Figure 7. [top-left] Curlyleaf pondweed potential treatment areas Moody Lake that were delineated on May 20, 2014. In the delineation, red outlined areas are potential treatment sites totaling 4.8 acres.

[top-right] Curlyleaf pondweed coverage for Moody Lake on June 12, 2014. The May delineation predicted areas of heavy growth in June.

[bottom-left] Curlyleaf pondweed potential treatment areas Moody Lake that were delineated on April 18, 2015. In the delineation, red outlined areas are potential treatment sites of 2.0 acres.

[bottom-right] Curlyleaf pondweed coverage for Moody Lake on June 2, 2015. The April delineation predicted areas of heavy growth in June.

Key: green dots = light growth, yellow dots = moderate growth, red dots = heavy growth, and black dots = no growth.

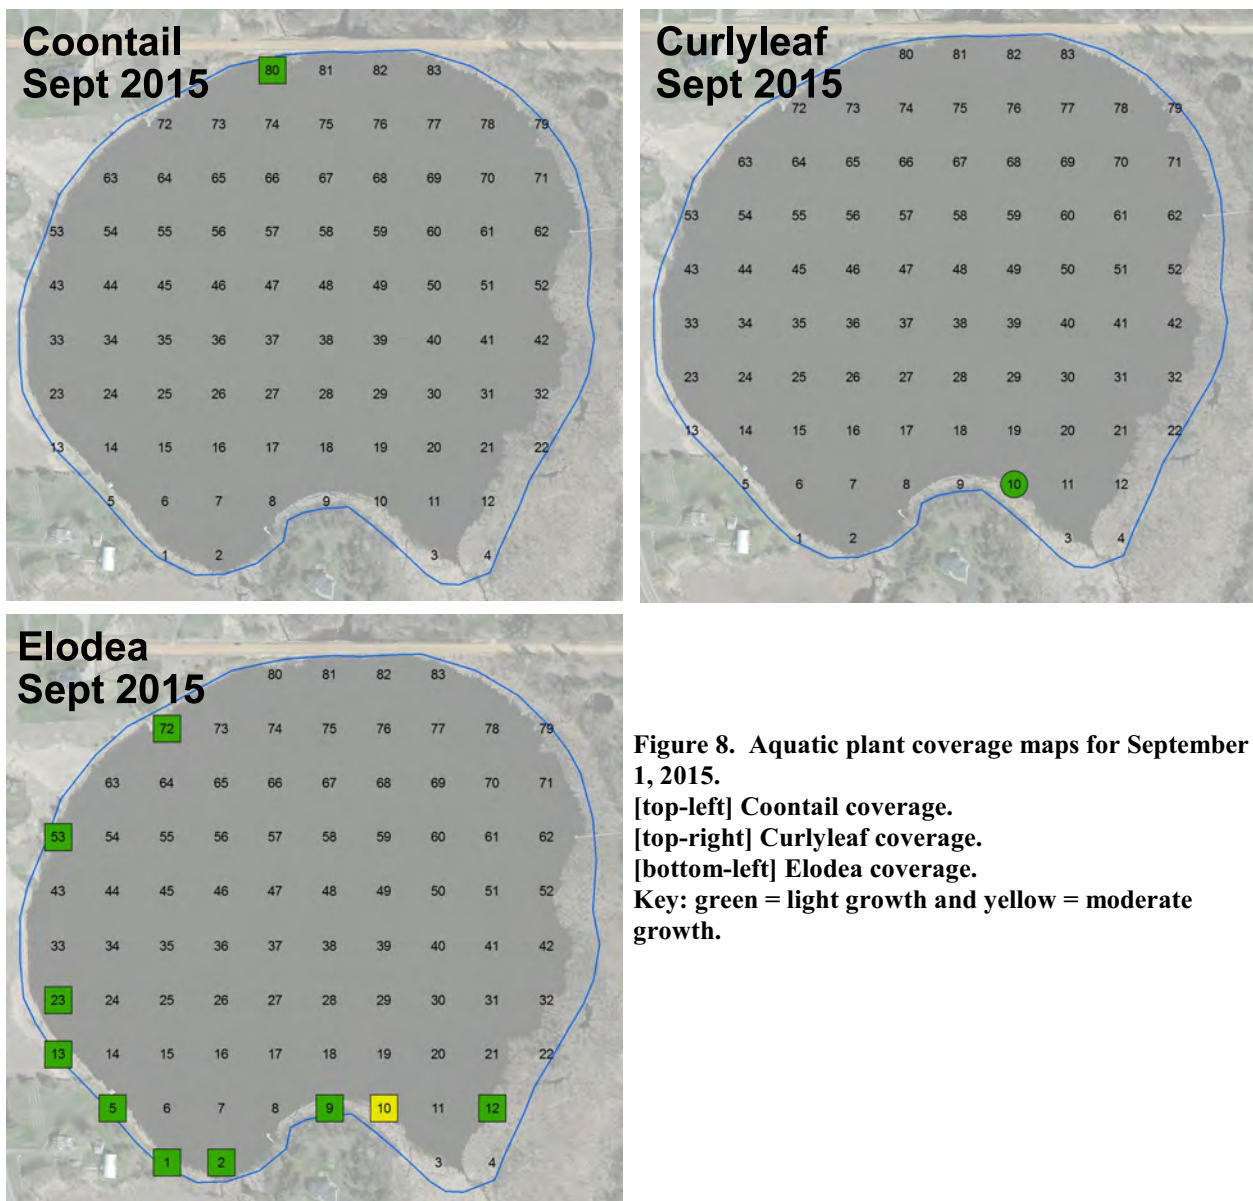
The most abundant plant on the September 1, 2015 point-intercept plant survey for Moody Lake was elodea, found at 10 out of 83 sites (12%) but at light growth (Figure 8 and Table 5). The other submerged plants observed were coontail and curlyleaf pondweed, each found at 1 site at light growth (Figure 8).

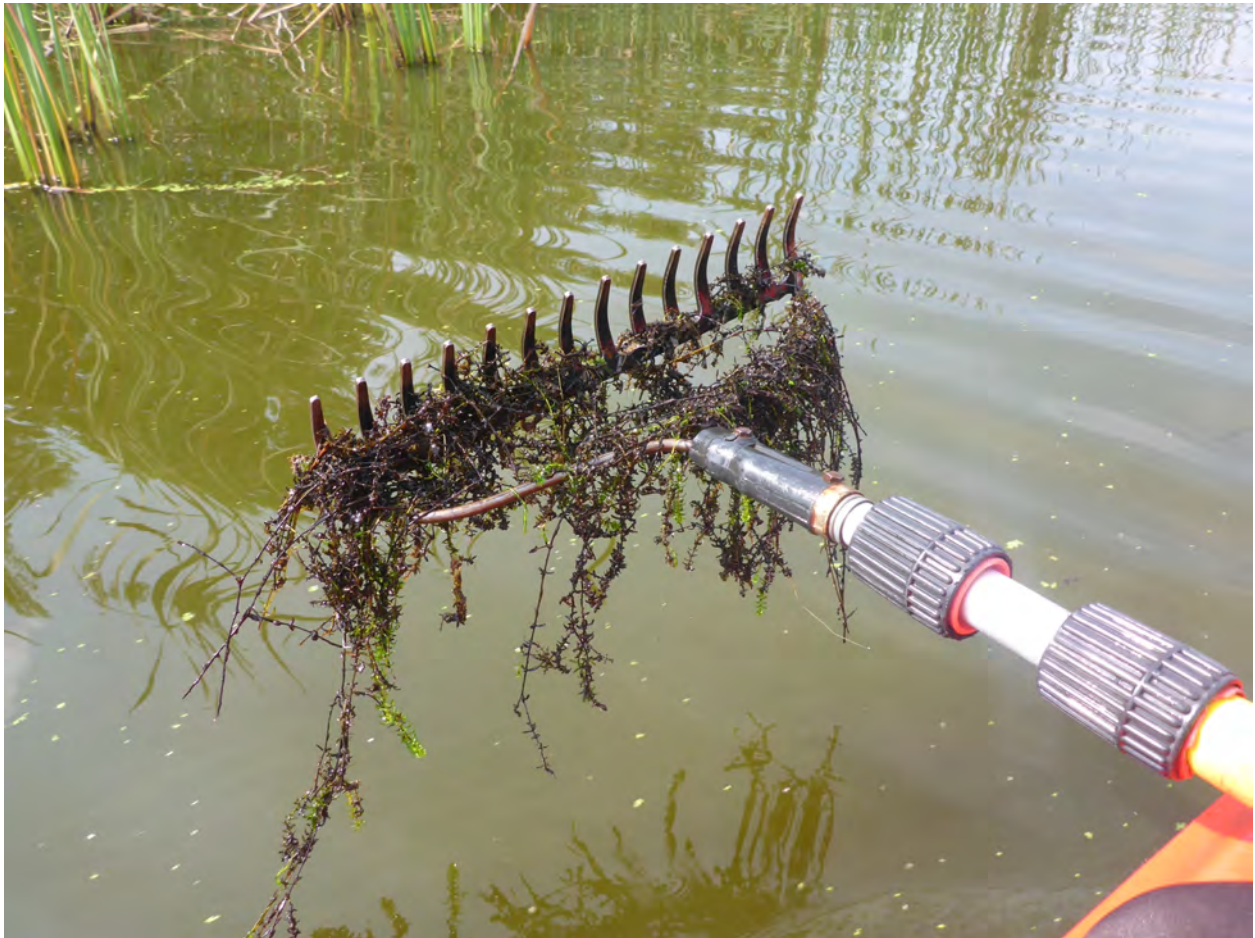
**Figure 9. Elodea was most common submerged aquatic plant found on September 1, 2015.**

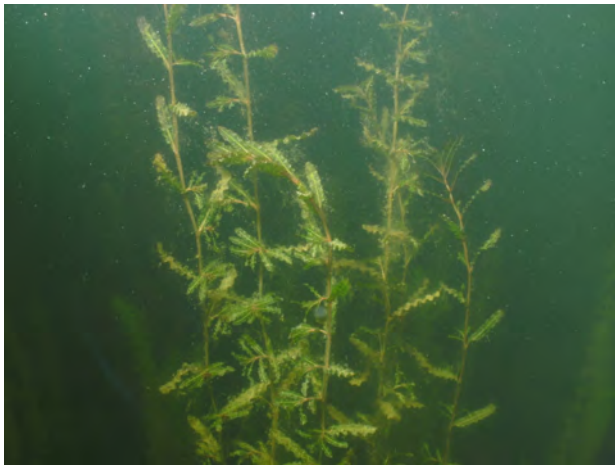
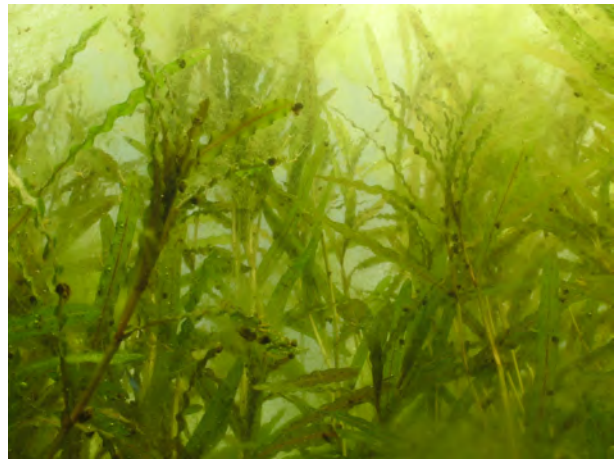
Underwater views of curlyleaf pondweed. Light growth (left) and moderate growth (right).

Lake sediment sampling results from 2014 have been used to predict lake bottom areas that have the potential to support heavy curlyleaf pondweed plant growth. Various types of curlyleaf growth patterns are shown in Figures 5 and 6. Based on the key sediment parameters of pH, sediment bulk density, organic matter, and the Fe:Mn ratio (McComas, unpublished), the predicted growth characteristics of curlyleaf pondweed in Moody Lake are shown in below.

Curlyleaf pondweed growth is predicted to produce heavy growth (where plants top out in a solid canopy) at Site 5 in Moody Lake. Otherwise, for the rest of the lake, curlyleaf pondweed is expected to exhibit mostly moderate growth with occasional heavy growth.

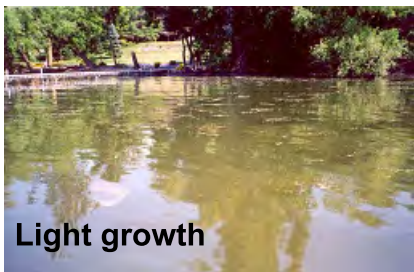
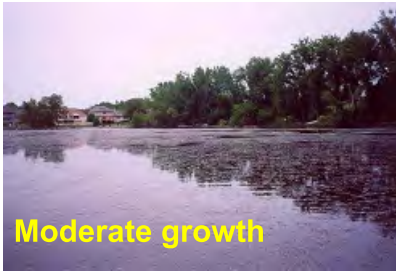
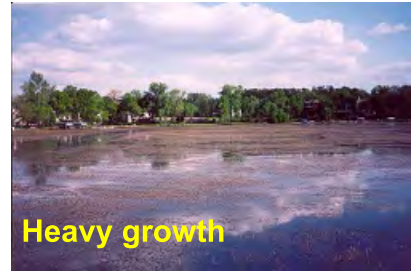
Light growth (left) refers to non-nuisance growth that is mostly below the surface and is not a recreational or ecological problem. Moderate growth (middle) refers to growth that is just below the water surface. Heavy growth (right) refers to nuisance matting curlyleaf pondweed. This is the kind of nuisance growth predicted by high sediment pH and a sediment bulk density less than 0.51.

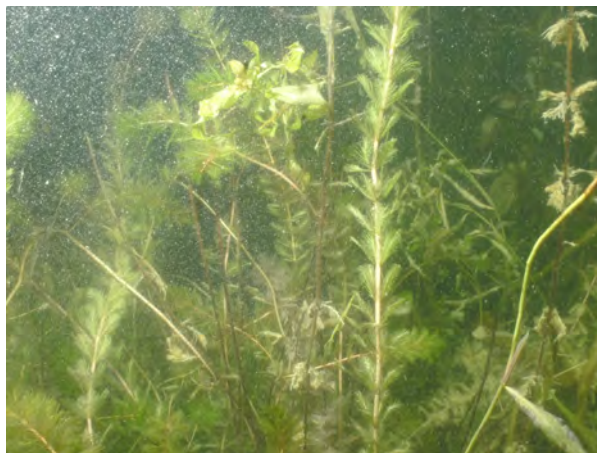
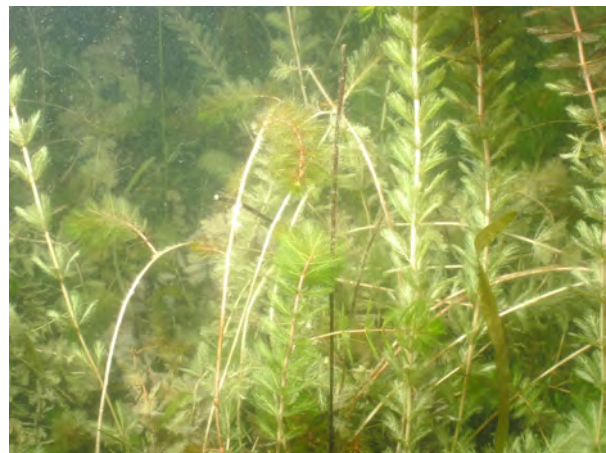
Underwater views of Eurasian watermilfoil.

Lake sediment sampling results from 2014 have been used to predict lake areas that have the potential to support heavy Eurasian watermilfoil growth. Examples of milfoil growth characteristics are shown below. Based on the key sediment parameters of  $\text{NH}_4$  and organic matter (McComas, unpublished), a table and map were prepared that predict the type of growth that could be expected in the future if milfoil becomes established in Moody Lake.

In Moody Lake a majority of sites had low to moderate nitrogen but higher than optimal organic matter and these areas are predicted to have the potential to produce mostly light growth of milfoil on an annual basis unless water clarity is limiting.

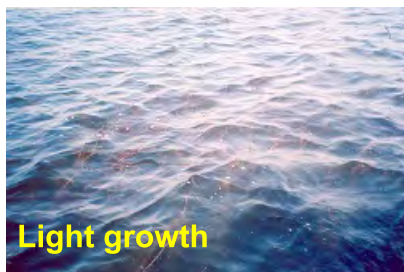
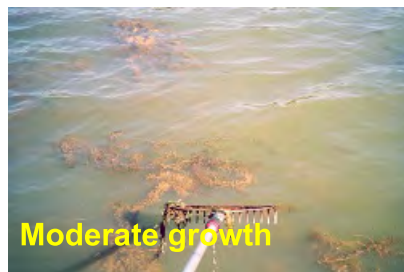
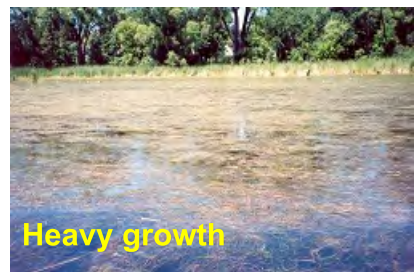
Light growth (left) refers to non-nuisance growth that is mostly below the surface and is not a recreational or ecological problem. Heavy growth (right) refers to nuisance matting Eurasian watermilfoil. This is the kind of nuisance growth predicted by high sediment nitrogen values and a sediment organic matter content less than 20%.
