Flowering Rush Delineation, Treatment, and Assessment for Forest Lake, Washington County, Minnesota, 2022

Prepared for:
Washington County and
Comfort Lake - Forest Lake
Watershed District

Prepared by:
Steve McComas
Blue Water Science

December 7, 2022

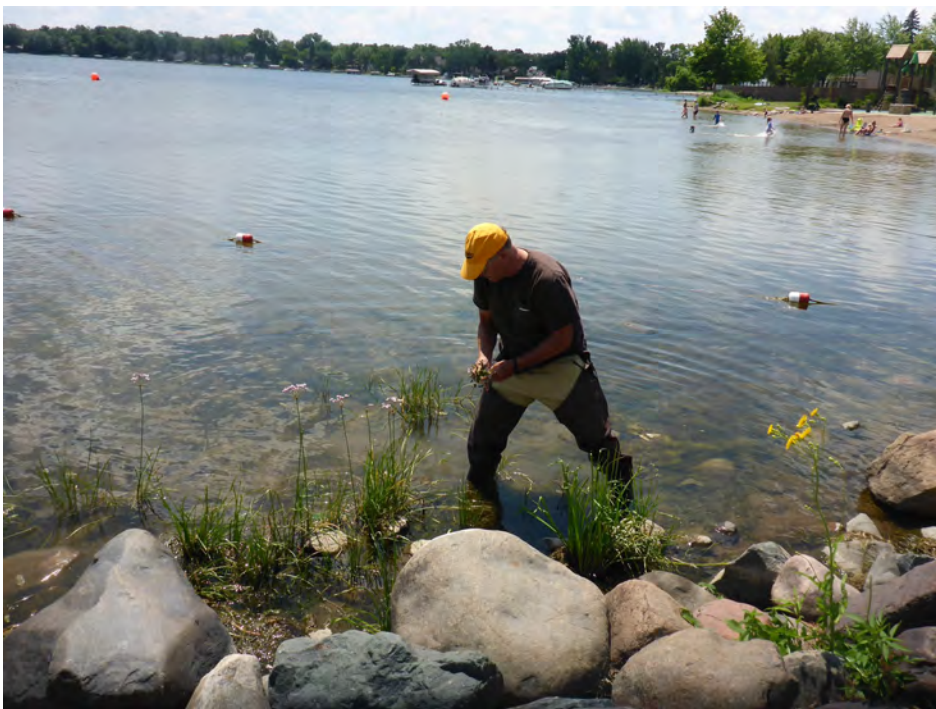
Several patches of flowering rush with seedheads were found close to the swimming beach on July 12, 2022.

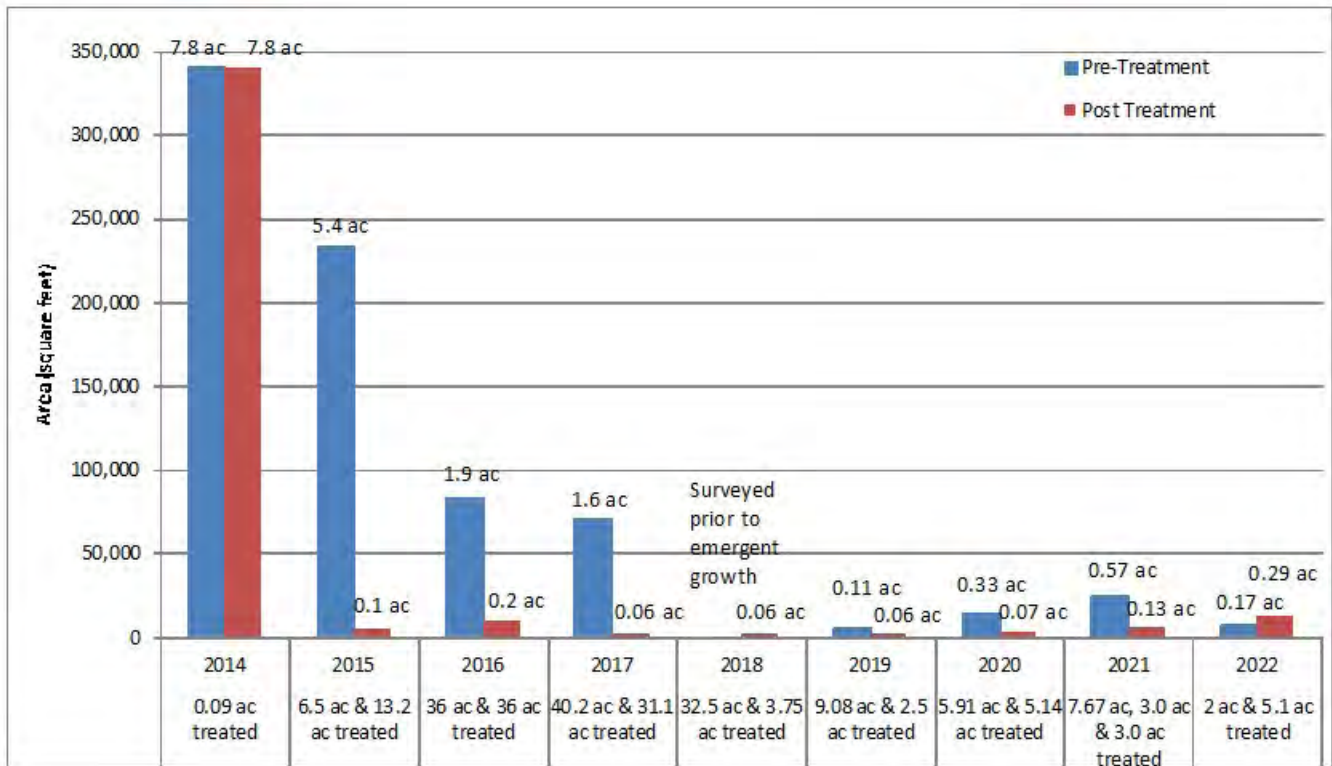
Figure S1. Flowering rush areas from 2014 through 2022 for pre-treatment and post treatment conditions.

In Forest Lake, the total area of flowering rush has decreased from 7.8 acres in 2014 to 0.29 acres in October of 2022 indicating the flowering rush control program is reducing the distribution and density of flowering rush (Figure S1). Although the estimated total area of flowering rush was around 0.29 acres in October of 2022, flowering rush regrowth is expected in 2023. Continuing to control areas of flowering rush should reduce abundant regrowth but it appears eradication will be a challenge.

A summary of flowering rush treatments and results over the previous 9 years are shown in Table S1. Flowering rush has decreased from 7.8 acres in 2014 to 0.29 acres on October 18, 2022 roughly, a decrease of about 96% from 2014. Regrowth in 2022 occurred at a number of persistent areas located in 2nd and 3rd lakes and 62 new sites of colonization were recorded.

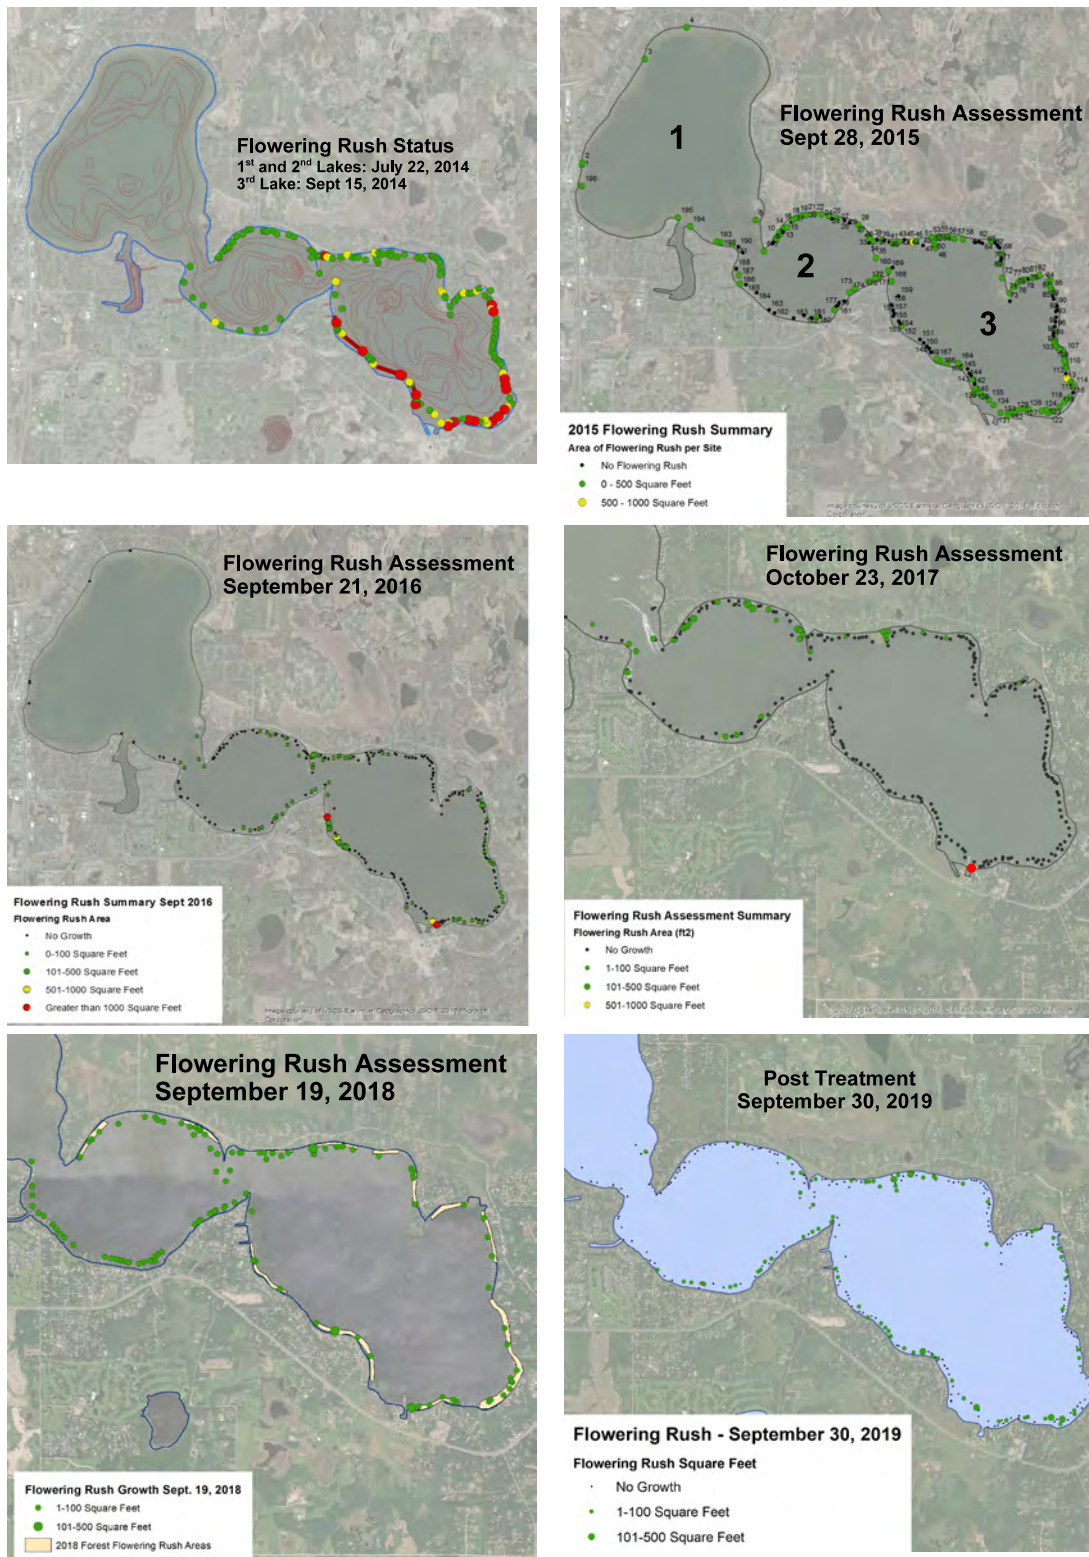
Figure S2. Estimated flowering rush coverage. [top-left] Sept 2014: 340,125 square feet (sf)(only 0.09 acres were treated). [top-right] Sept 2015: 4,411 sf. [middle-left] Sept 2016: 9,183 sf. [middle-right] October 2017: 2,655 sf. [bottom-left] Sept 2018: 2,726 sf. [bottom-right] Sept 2019: 2,790 sf.

At the middle of October 2022, the area of flowering rush was about 99% less compared to 2014. The number of sites, usually less than 88 square feet per site, also declined slightly compared to 2014. Maps of flowering rush assessments for 2014-2022 are shown in Figure S2.
