# Curlyleaf Pondweed Delineation and Assessment Surveys for Moody Lake, Chisago County, Minnesota, 2022

Curlyleaf Pondweed Delineation: April 21, 2022

Curlyleaf Pondweed Assessment: June 7, 2022

Prepared for:  
Comfort Lake/Forest Lake  
Watershed District  
Forest Lake, Minnesota

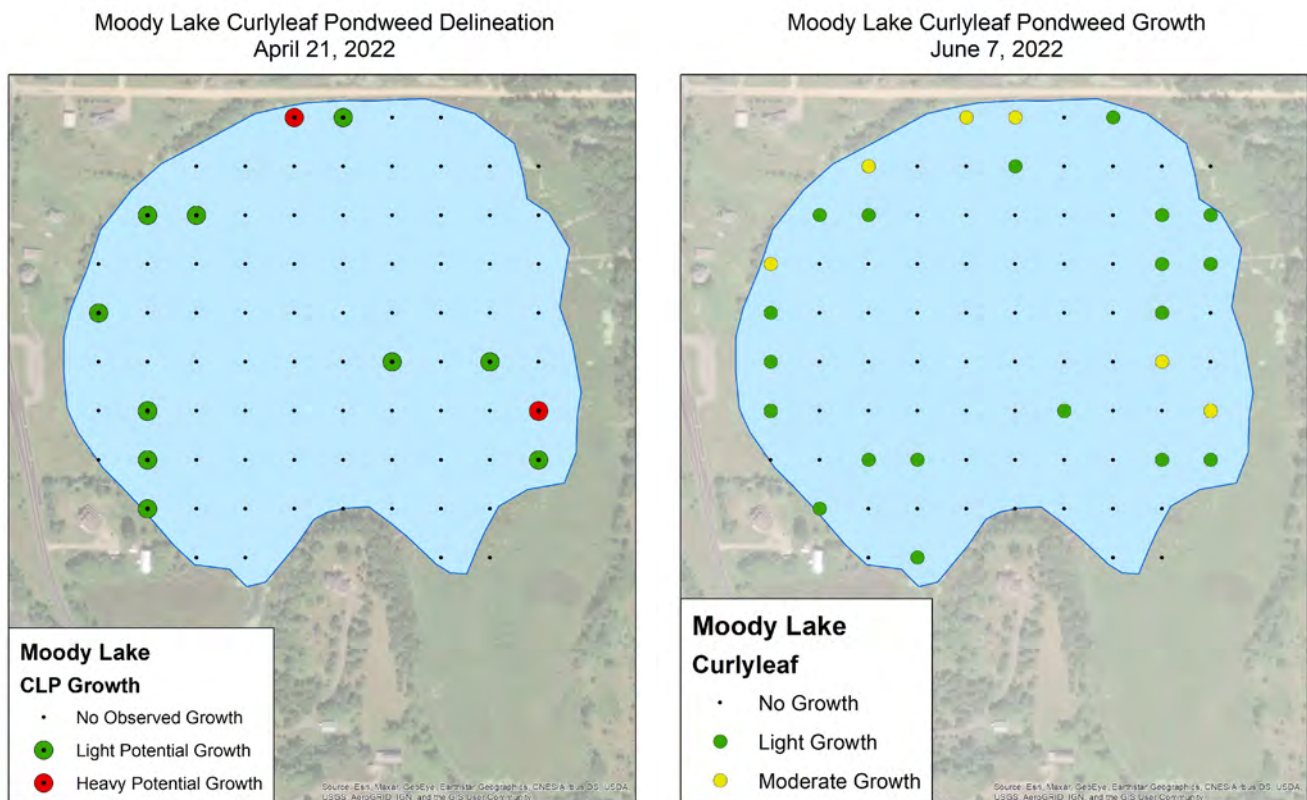
Figure S1. [left] Curlyleaf pondweed treatment areas Moody Lake that were delineated on April 21, 2022. [right] Curlyleaf pondweed coverage for Moody Lake on June 7, 2022.

Key: green dots = light growth, yellow dots = moderate growth, red dots = heavy growth, and black dots = sample site without plants.

**Curlyleaf Pondweed Delineation:** Moody Lake (MnDNR ID #13-0023) is a 45 acre lake located in Chisago County, Minnesota. Water clarity has a summer average of 8.7 feet in 2021 (source: CLFLWD). A full point intercept survey were conducted on April 21, 2022 by Blue Water Science. Data from the point intercept survey was used to determine areas for curlyleaf pondweed treatment and to look for Eurasian watermilfoil. Results of the curlyleaf delineation found curlyleaf pondweed was only found in a few sample sites and were in the nearshore area of Moody Lake (Figure S1). No treatment for curlyleaf pondweed was conducted in 2022.

**Curlyleaf Pondweed Assessment:** A point intercept survey was used for the curlyleaf pondweed assessment and was conducted on June 7, 2022 by Blue Water Science (Figure S1). Results of the curlyleaf pondweed assessment found curlyleaf pondweed in Moody Lake was growing at light to moderate densities. Also, in June, Moody Lake had a low diversity of submerged aquatic plants, with coontail, elodea, and stringy pondweed the only other submerged aquatic plant species observed.

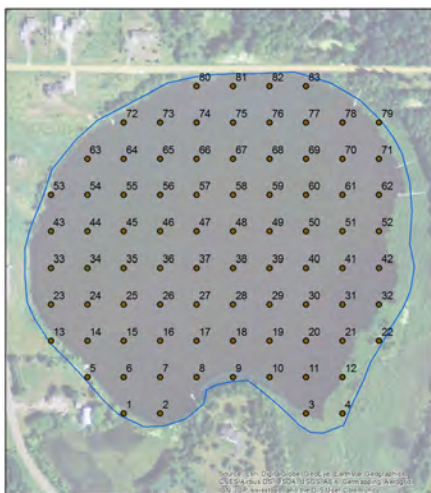
and June 7, 2022. Grid spacing was 50 meters. The plant species were recorded and the density of each species was assigned. Densities were based on the coverage on the teeth of the rake. Density ratings were from 1 to 3 with 1 being sparse and 3 being a nuisance. Based on these sample sites, plant distribution maps were constructed.

Figure 1. Point intercept site map for Moody Lake.

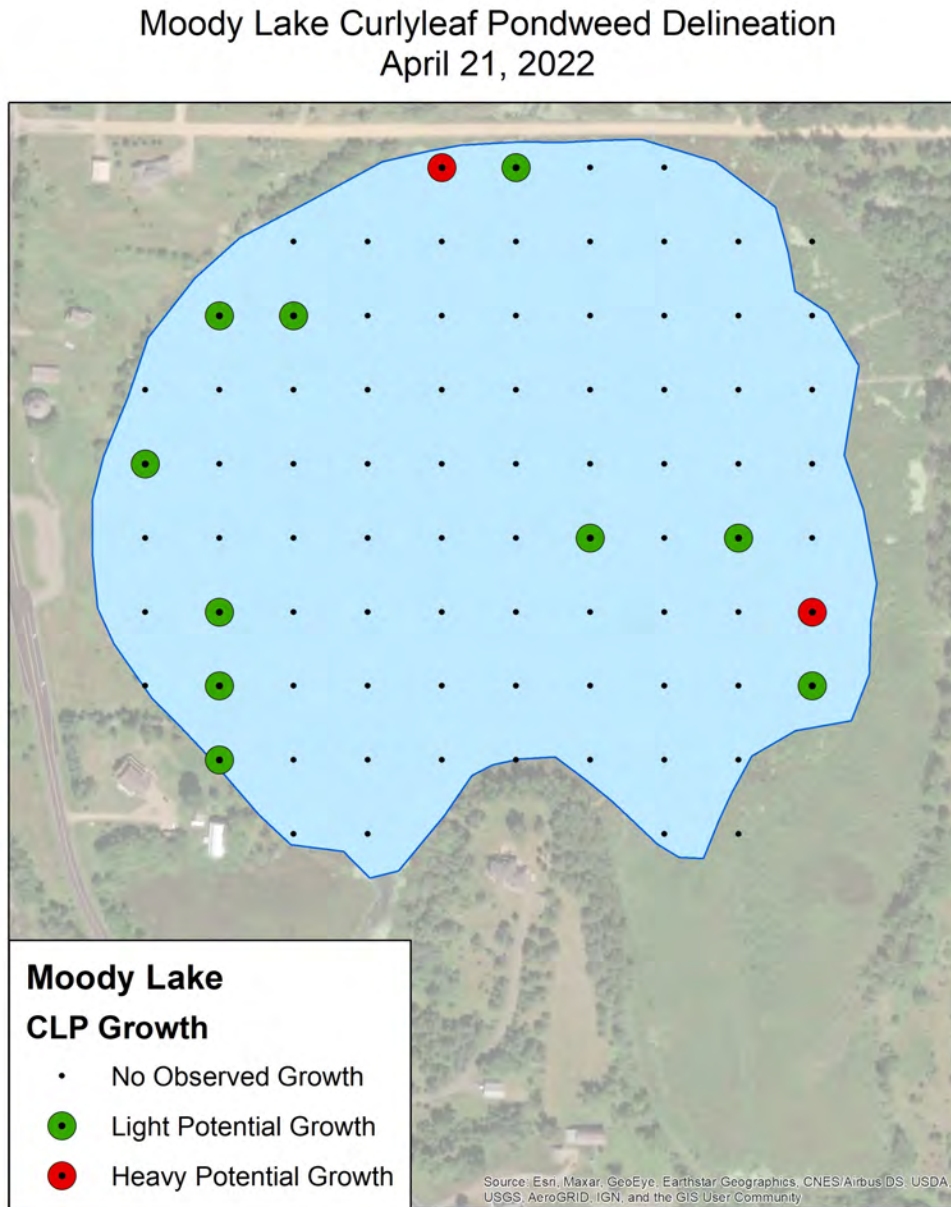
A point intercept survey was conducted to delineate CLP on April 21, 2022 (Figure 2). Results from the survey found that CLP stem densities were not predicted to produce heavy growth of CLP abundance in June therefore no areas were delineated for treatment. No treatment occurred in 2022. Coontail and elodea was the only other submerged plant species observed (Tables 1 and 2).

**Figure 2. Curlyleaf pondweed from the point intercept survey conducted on April 21, 2022.  
Key: Green dots = light growth, red dots = heavy growth, and black dot = sample site, no plants.**

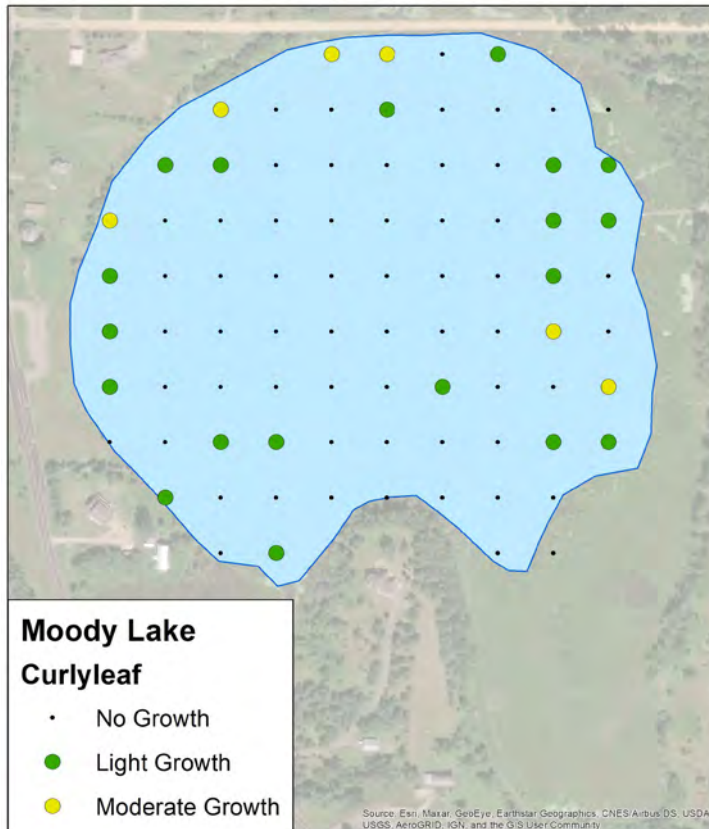
Moody Lake Curlyleaf Pondweed Growth  
June 7, 2022

Results of the June 7, 2022 assessment using a point intercept survey found there were 4 submerged plant species, coontail, curlyleaf pondweed, elodea, and stringy pondweed with elodea being the dominant plant (Tables 3 and 4). No CLP treatment occurred in 2022 and CLP abundance at peak growing conditions was mostly light to moderate (Table 3 and Figure 3). Results from the assessment found native plants growing out to a depth of 11 feet (Table 4).

**Figure 3. Curlyleaf pondweed coverage for Moody Lake on June 16, 2021. Key: black dots = no growth, green dot = light growth and yellow dots = moderate growth.**

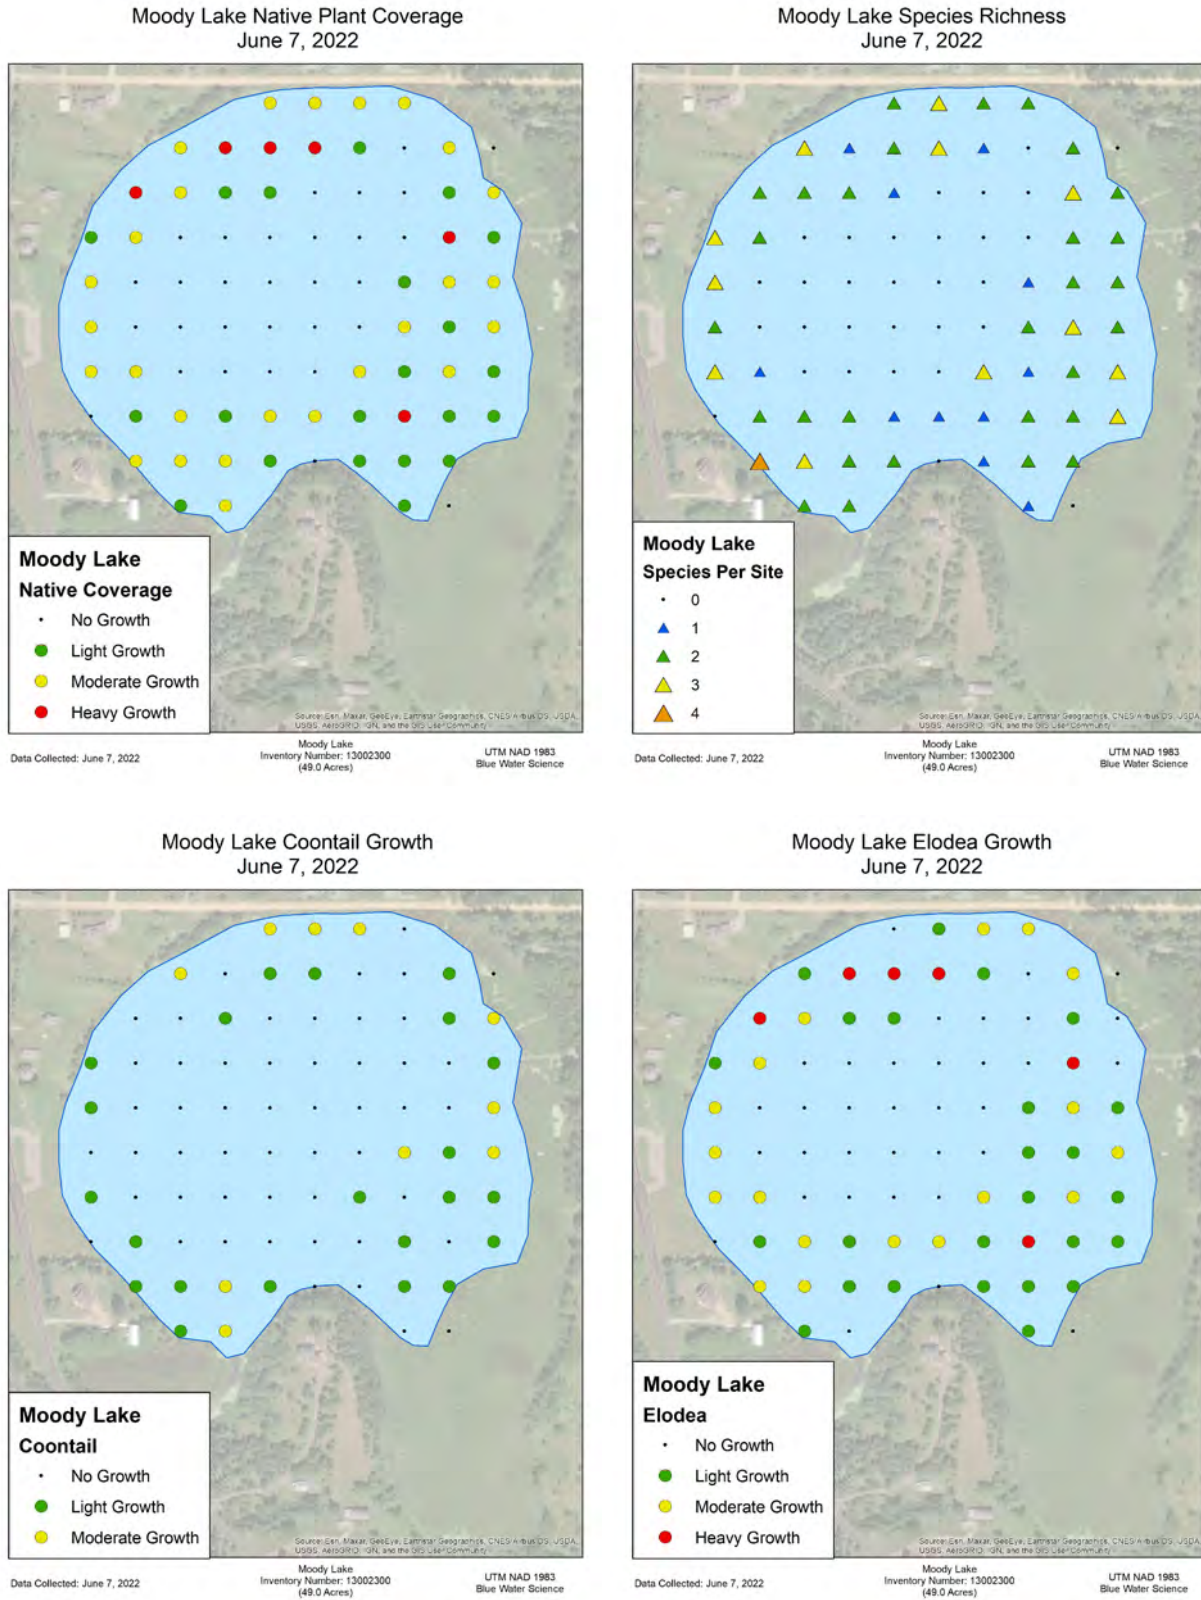
Figure 4. Aquatic plant conditions on June 7, 2022.
