# Curlyleaf Pondweed Delineation and Assessment Surveys for Moody Lake, Chisago County, Minnesota, 2023

Curlyleaf Pondweed Delineation: April 25, 2023

Curlyleaf Pondweed Assessment: June 1, 2023

Prepared for:  
Comfort Lake/Forest Lake  
Watershed District  
Forest Lake, Minnesota

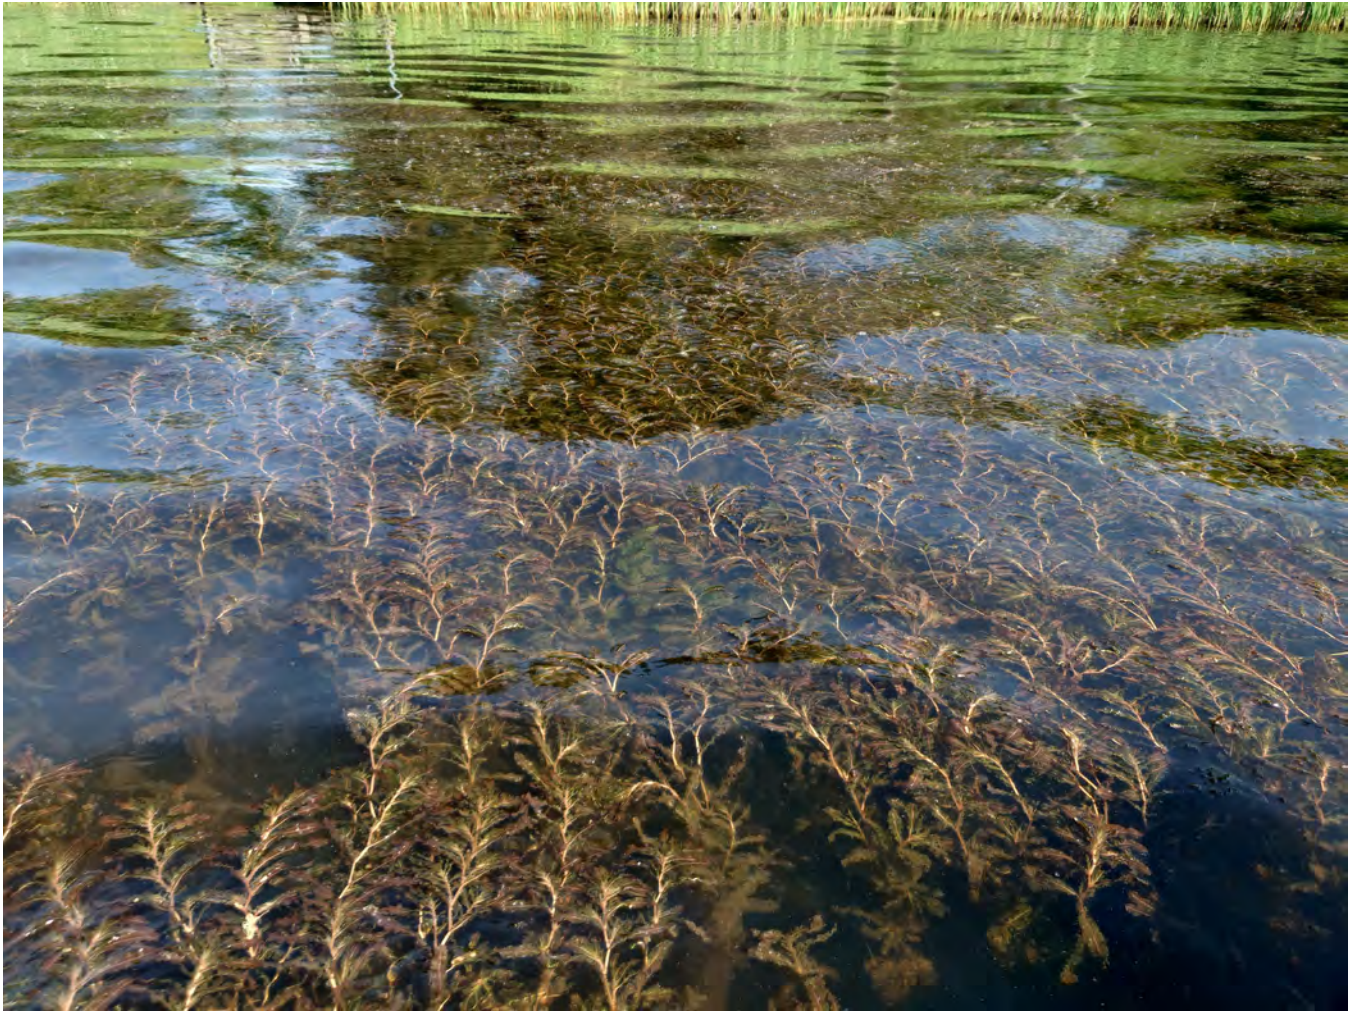
Bed of Curlyleaf Pondweed, Moody Lake, Chisago County, Minnesota, June 1, 2023

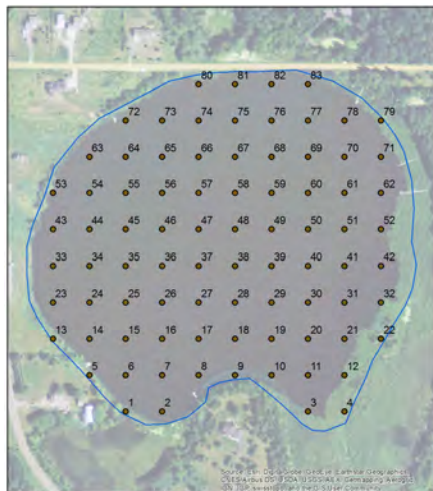
and June 1, 2023. Grid spacing was 50 meters. The plant species were recorded and the density of each species was assigned. Densities were based on the coverage on the teeth of the rake. Density ratings were from 1 to 3 with 1 being sparse and 3 being a nuisance. Based on these sample sites, plant distribution maps were constructed.

**Figure 2. Point intercept site map for Moody Lake.**

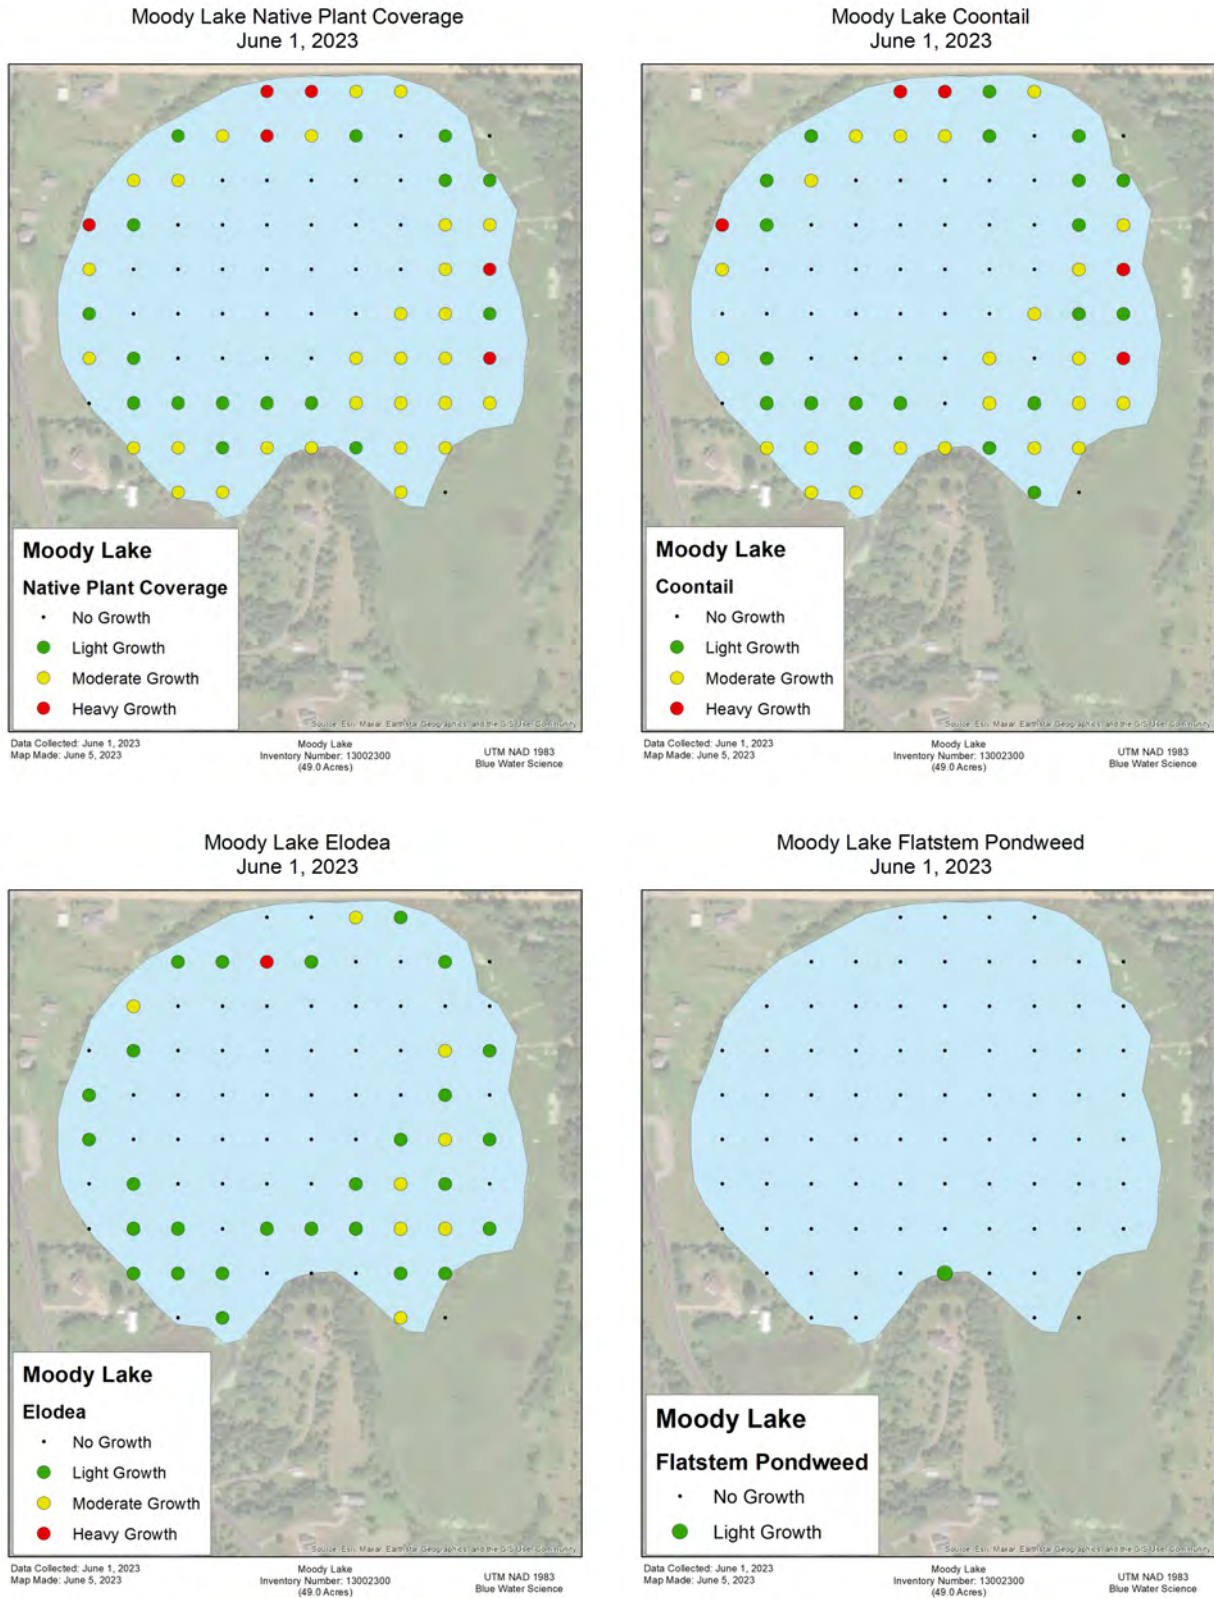
Figure 5. Aquatic plant conditions on June 1, 2023.
