Shoreland Inventory of Comfort Lake, Chisago County, Minnesota in 2014

Date of Inventory: July 21, 2014

Prepared for:
Comfort Lake/Forest Lake
Watershed District

Prepared by:
Steve McComas
Jo Stuckert
Blue Water Science

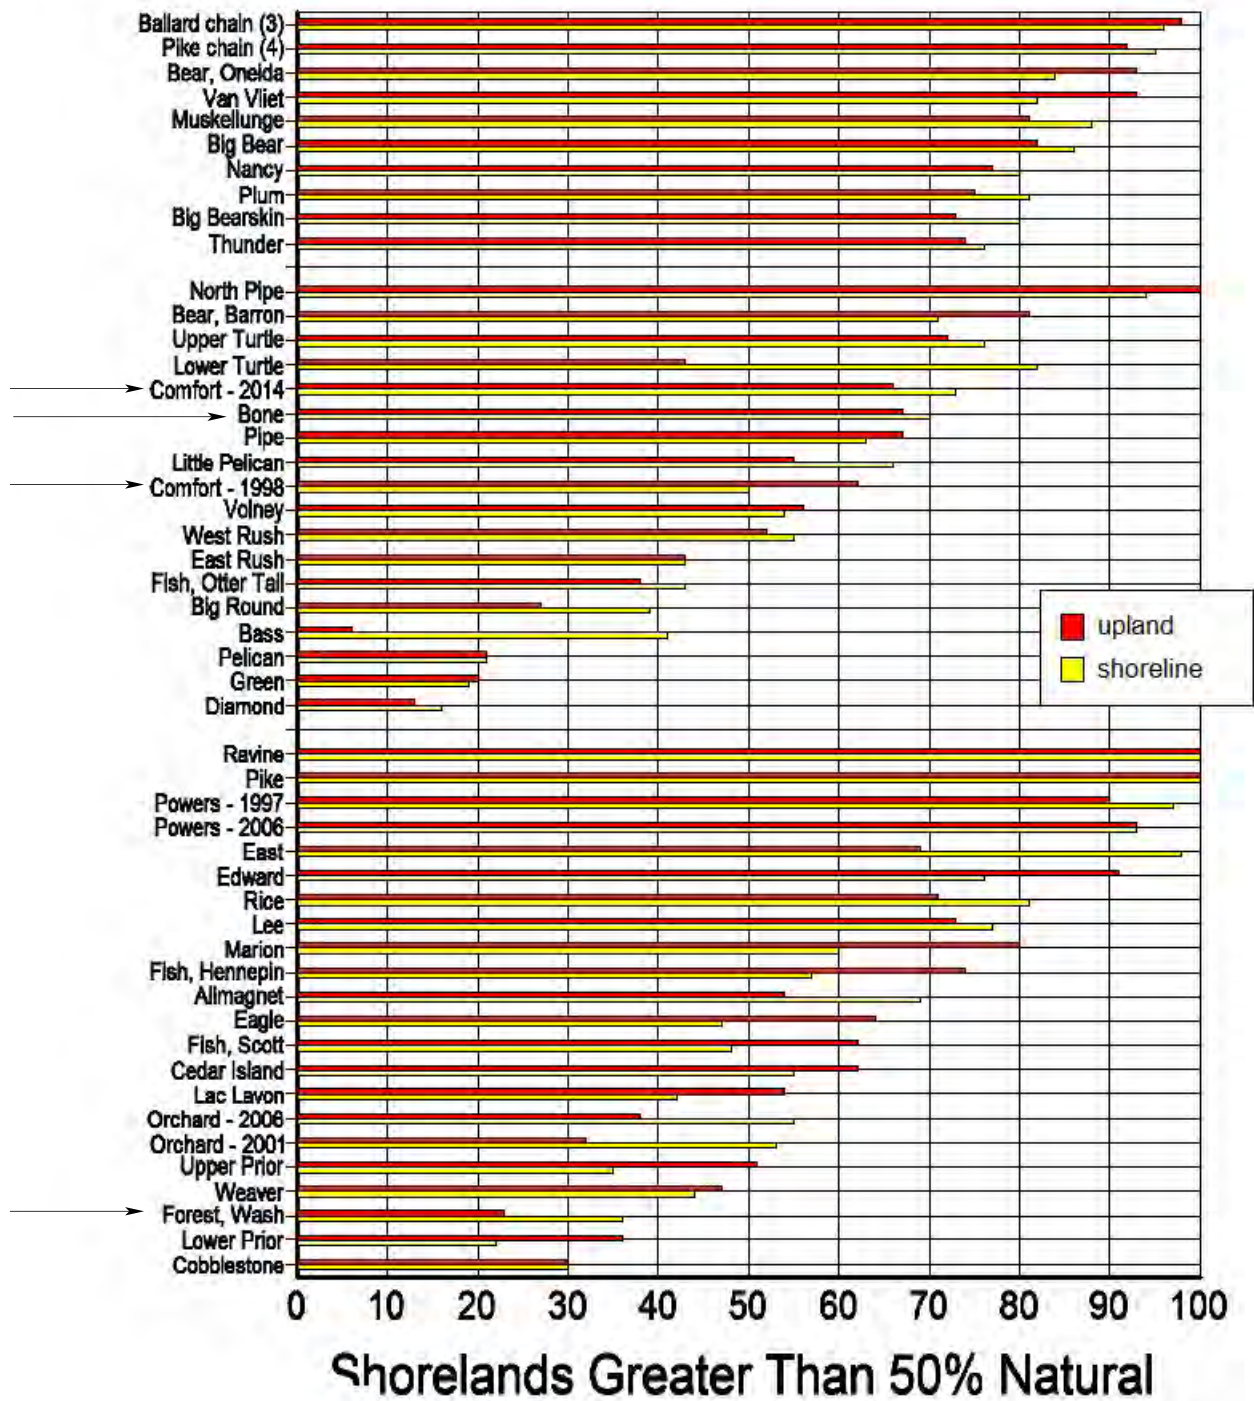
Figure 2. A summary of shoreland inventory results for lakes using an evaluation based on shoreland photographs. For each lake the percentage of shoreline and upland conditions with greater than 50% natural conditions is shown. The first tier of lakes are located in northern Wisconsin which are 4 to 5 hours from a major metropolitan area. The middle tier of lakes are about an hour's drive from the Twin Cities, and are considered to be "country" lakes. The lower tier of lakes are in the Twin City Metropolitan area and are categorized as urban lakes. Several lakes of the "urban" lakes have most of their shoreland owned by the city and there is a high percentage of natural conditions.

Comfort Lake is considered a country lake for this inventory. Natural shoreland conditions for Comfort Lake are average compared to the other country lakes.

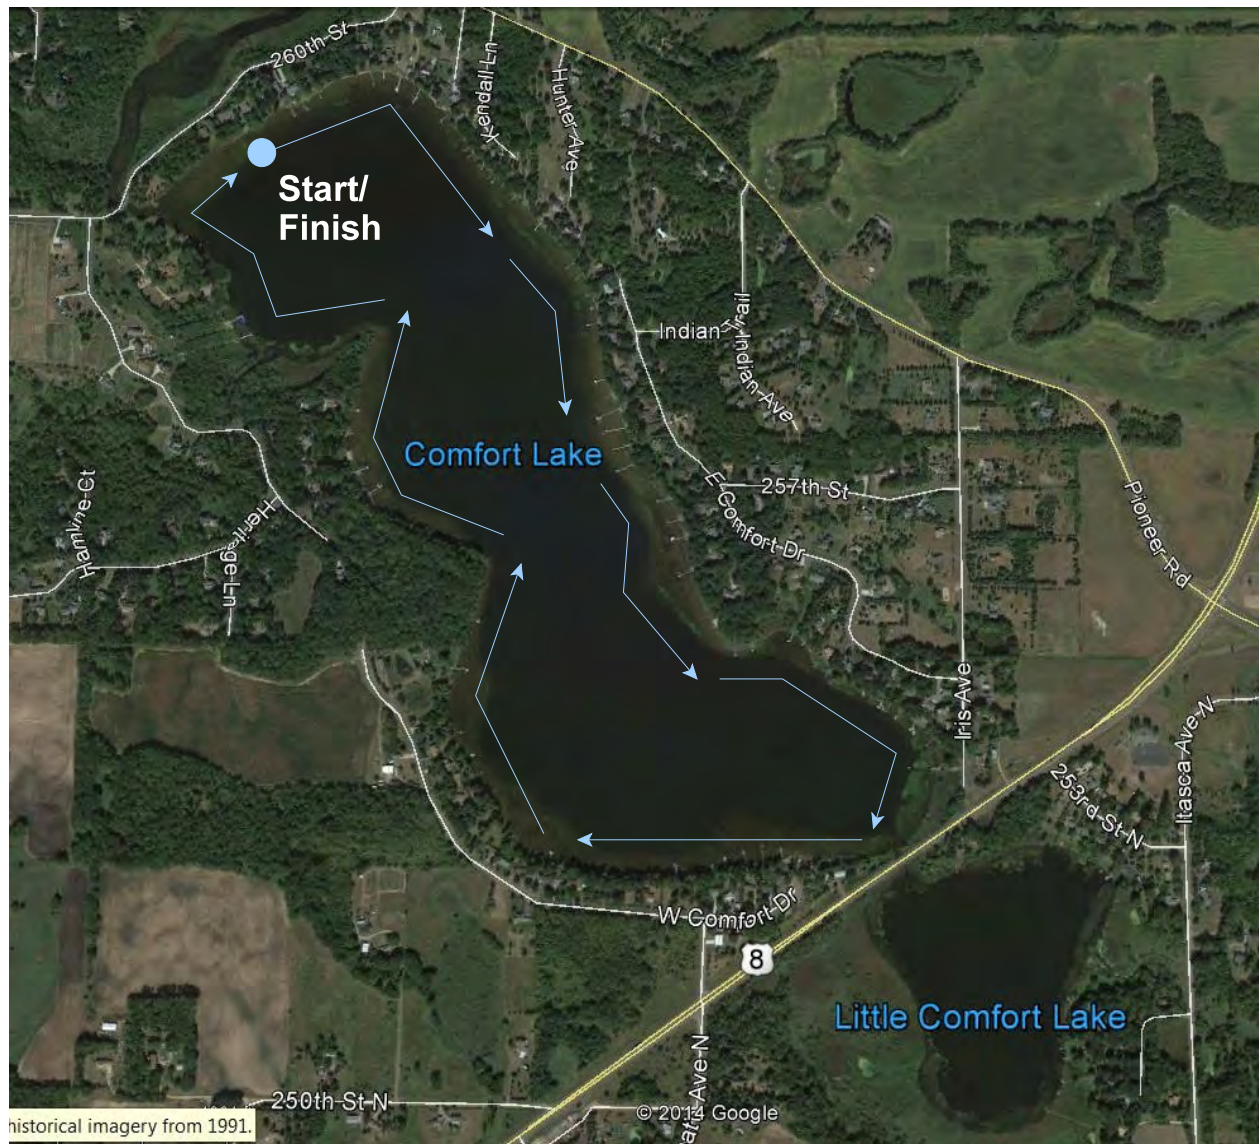
Figure 3. Key to shoreland photo parcels for Comfort Lake, July, 2014.
