# BECK RESIDENCE—Shoreline Restoration

## PROJECT SPECS

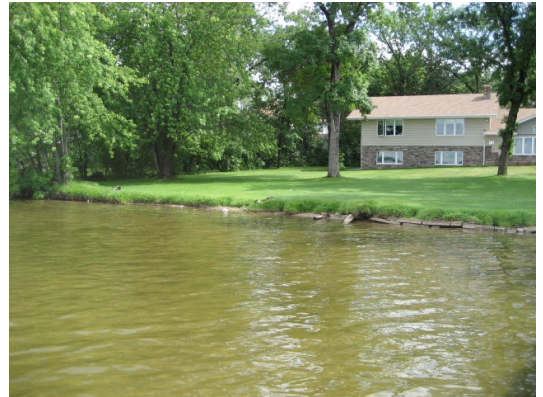
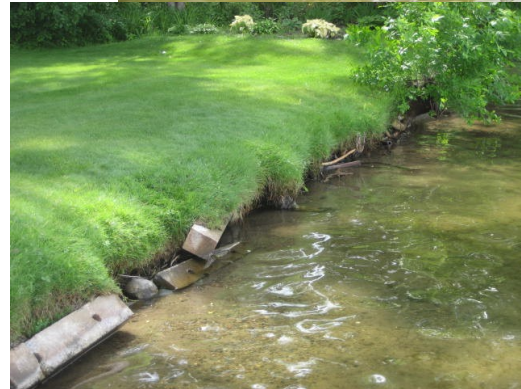
**Before  
Summer 2011**

The Beck property lies on the south shore of Forest Lake (lake 1). The site was dominated by mown turf grass, reed canary grass, and had a significant shoreline erosion.. As a result, there was:

- Active shoreline erosion due to limited root structure to withstand wave/ice action
- Direct conveyance of nutrients and pollution from the property into the lake, increasing algae and unwanted vegetation blooms.
- Limited plant diversity
- Limited wildlife habitat

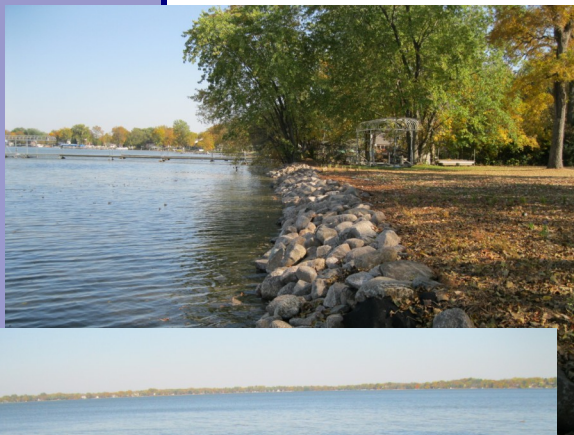
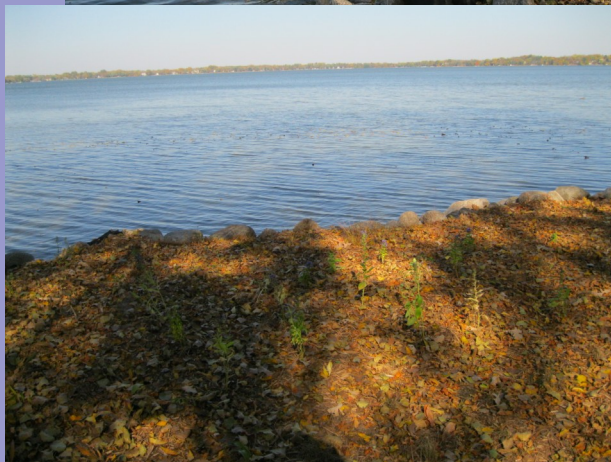
**October,  
2011**

Shoreline erosion was stabilized with rock-rap designed for the site taking into account wave height and ice action. Mown turf grass and invasive plants were replaced with a variety of native plantings along the lakeshore. Approximately 875 native grasses, flowers, shrubs, and aquatic plants were planted. The native plantings, hardwood mulch, and riprap provide many benefits, including;

- Stopping soil from washing into the lake
- Stormwater is slowed and retained as it flows toward the lake increasing infiltration and decreasing input of nutrients and pollutants to Forest Lake
- Plant diversity is dramatically increased and the increase in root structure protects the shoreline from erosion due to runoff and wave/ice action.
- Fish and wildlife habitat is increased
