Hosanna Lutheran Church Rain-garden/water quality project

PROJECT SPECS

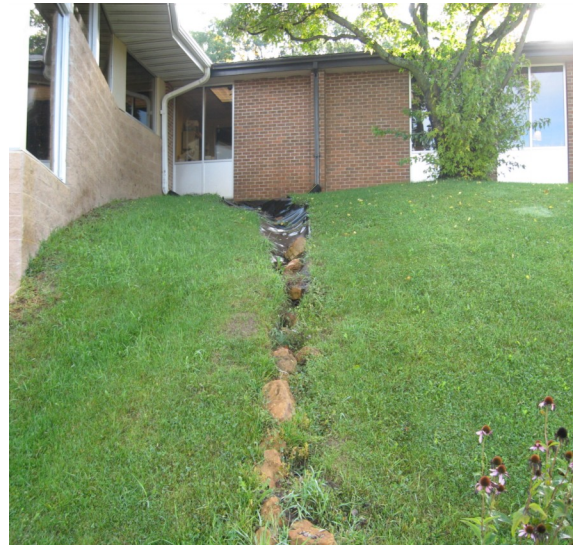
**Before
Fall of 2011**

The Hosanna Lutheran Church property located on Highway 97 drains to Forest Lake. In addition to an eroding hillside, the site was dominated by rooftop and turf grass. As a result, there was:

- Active erosion occurring on a steep slope adjacent to the building. During rain storms the eroded soil would flow across the parking lot and into a wetland and then into Forest Lake.
- The untreated water runoff also conveyed nutrients and pollution from the property into the lake, increasing algae and unwanted vegetation blooms.

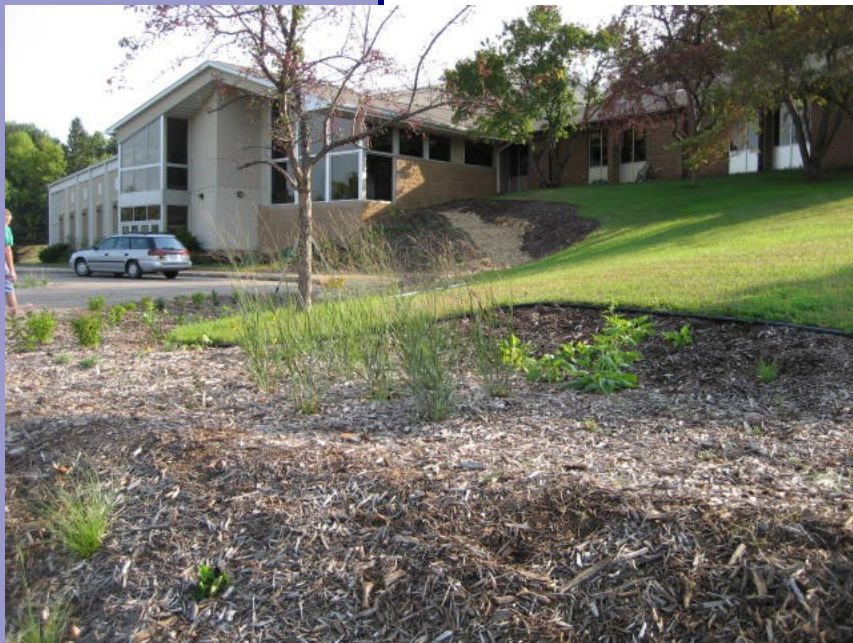
**After
September, 2012**

The steep slope and eroded channel was stabilized with native plantings and mulch, a rock swale, and a rain-garden. Combined the practices are able move water safely from the top of the hill to the bottom of the hill where it goes into a rain-garden and soaks into the ground preventing the polluted water from getting into Forest Lake.

Approximately 585 native grasses and flowers were planted. The native plantings, rock swale and rain-garden provide multiple benefits, including;

- Stopping soil from washing into the lake.
- Stormwater is slowed and retained as it flows toward the lake increasing infiltration and decreasing input of nutrients and pollutants to Forest Lake.
- Plant diversity and wildlife habitat is increased.
