Comfort Lake-Forest Lake Watershed District

**Date:** August 17, 2026  
**To:** CLFLWD Board of Managers  
**From:** Mike Kinney, District Administrator  
**Subject:** Bone Lake South Nature Area Management and Restoration Plan

# Natural Resource Management Plan

## Bone Lake South Nature Area

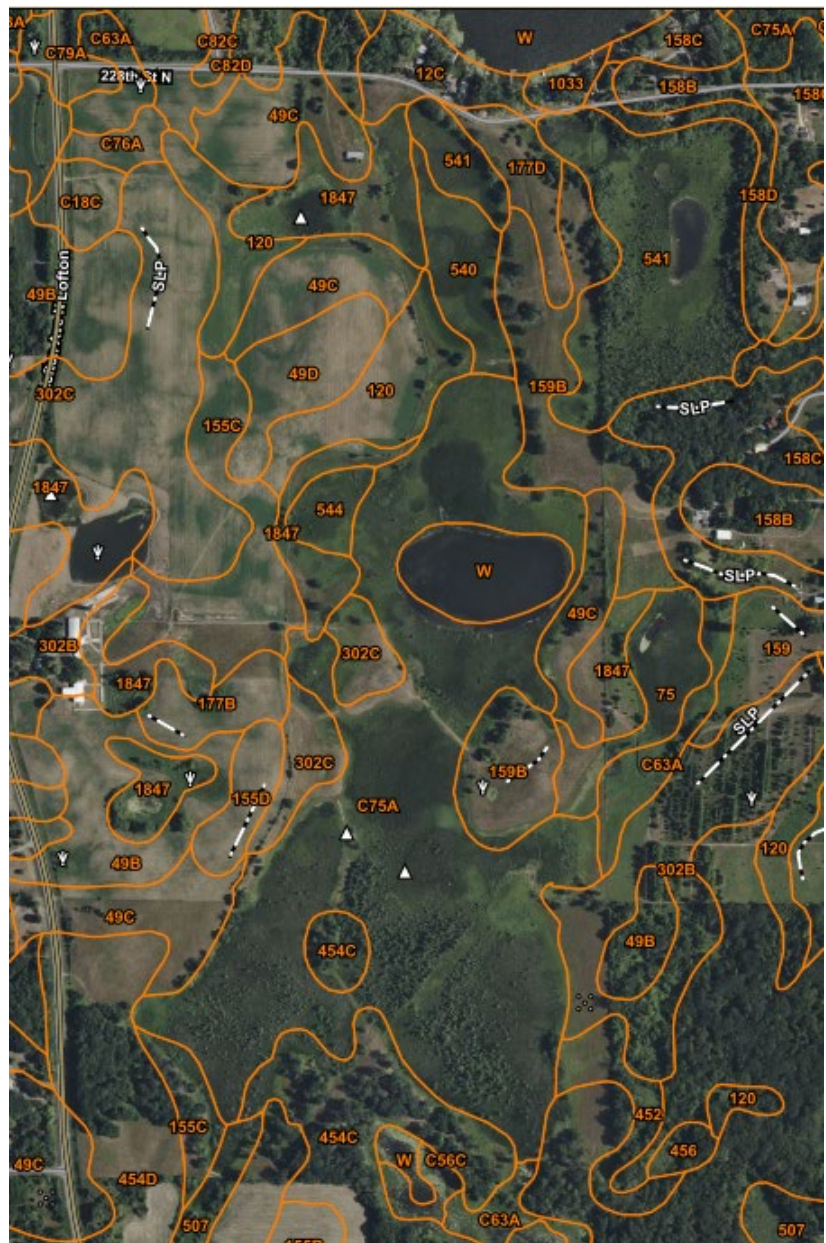
Figure 1- Soil map for the BLSNA. List of abbreviations associated with Figure 1 can be found on page 45.

Over 20 different soil types can be found on the landscape (USDA 2025). The most abundance soil types include: **Seelyeville very poorly drained muck**, **Brill moderately well drained silt loam**, **Antigo well drained silt loam**, and **Barronett poorly drained silt loam**. A complete list of soils can be viewed in Figure 1, as well as in FIGURES section near the end of this document. In general, the property wetland/low lying areas (~60% of the property acreage) are considered poorly drained while uplands (silt/loam soils) are considered well drained. This conditions were likely formed by the glacial processes that shaped these landscapes.

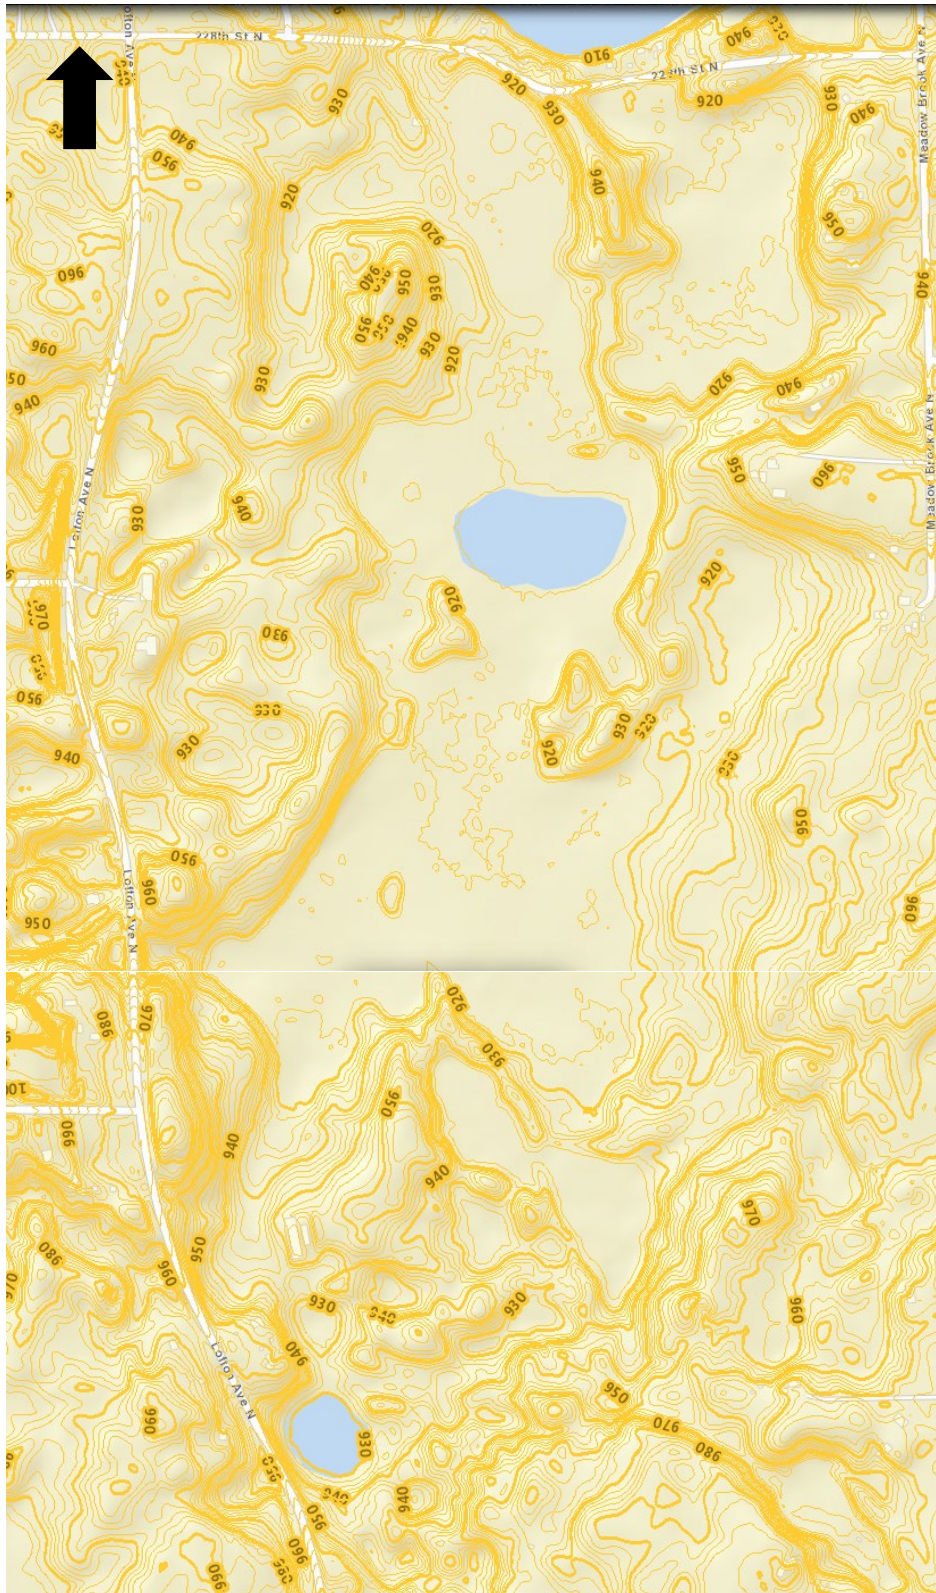
Figure D. Topography

Topography map of the Bone Lake South Nature Area. <https://mntopo.dnr.state.mn.us/>

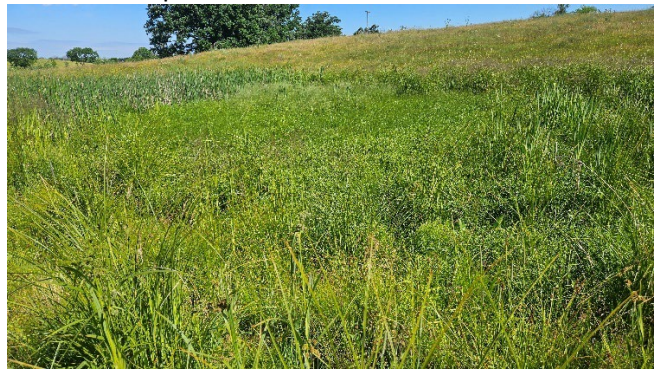
Northern Rich Fen located on the eastern "shoulder" of W2

- Recommended Activities
    - Invasive species control / management – remove any invasive species encroachment (glossy buckthorn).
    - Restore a continuously saturated hydrologic regime suitable for peatlands via Primary Wetland Goal 2/Objective 1, while ensuring Primary Wetland Goal 2/Objective 2 (flood storage) does not negatively impact the rich norther fen habitat.
